HISTORIC UNION COUNTY COURTHOUSE

HISTORIC STRUCTURE REPORT & RELATED SERVICES
JANUARY 23, 2017

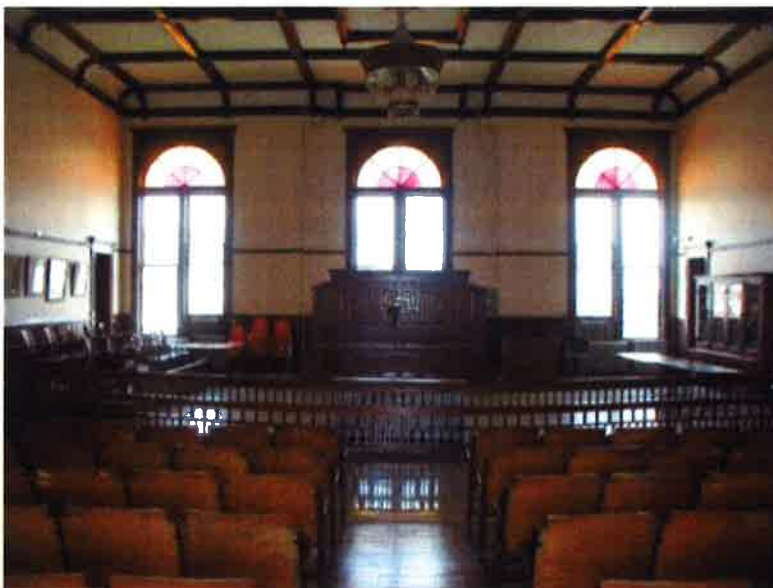
Courtroom interior facing judge's bench, 1893 Franklin County Courthouse in Ottawa, Kansas (original interior)

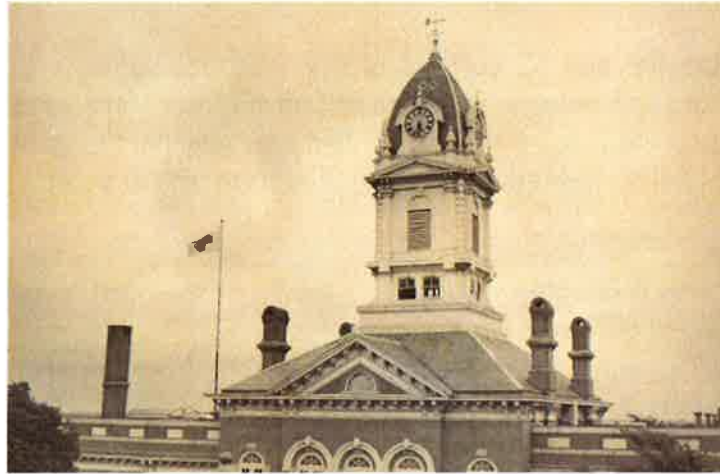
1928 - Significant Additions and Alterations Completed

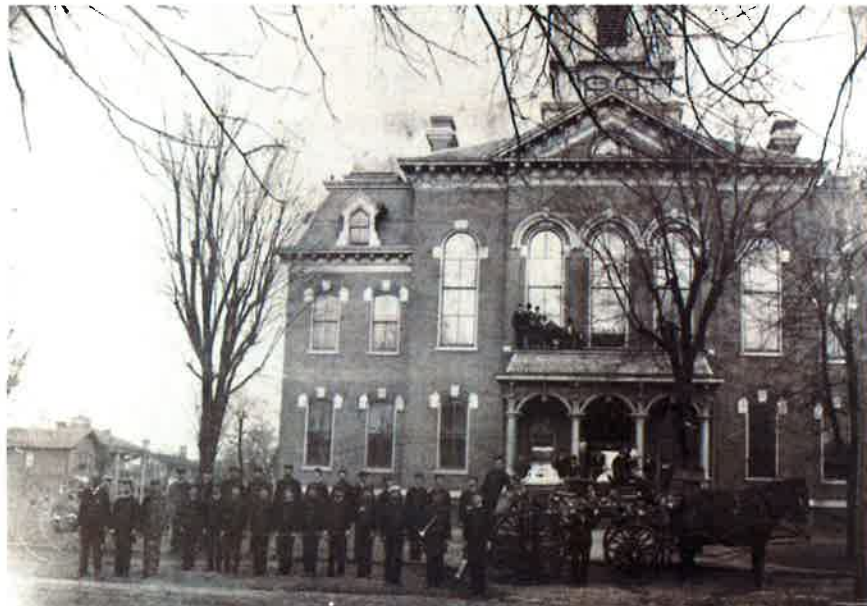
1895 Photograph showing original double-hung sash windows at courtroom.

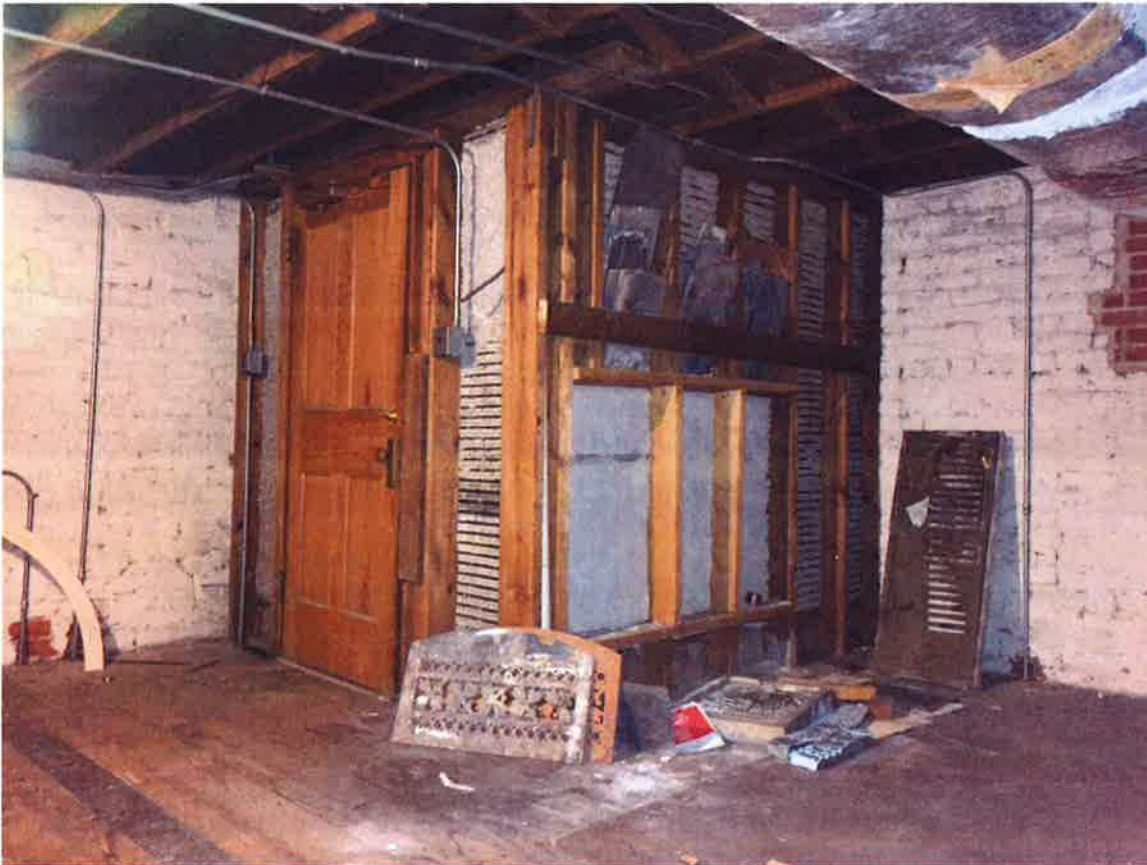
- New opening made in south wall for access from hall addition to balcony.

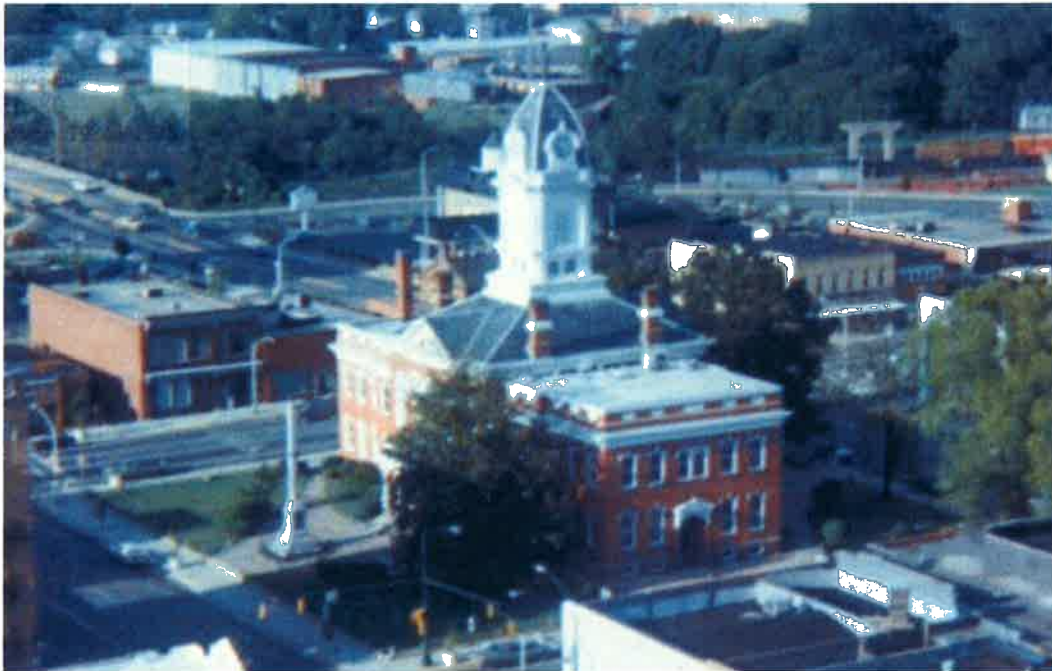
1998/1999 – Phase of Minor Exterior and Site Work

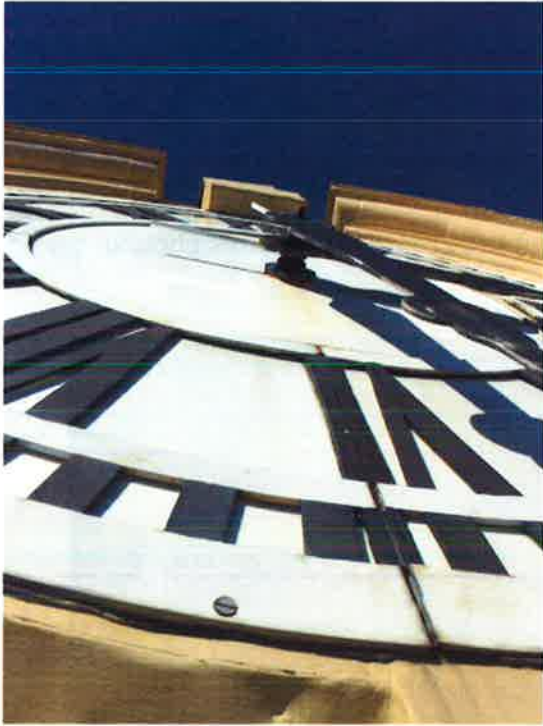
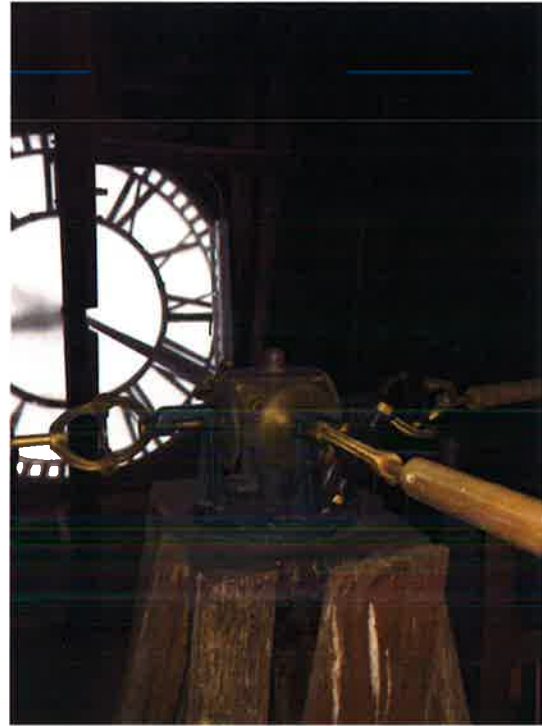
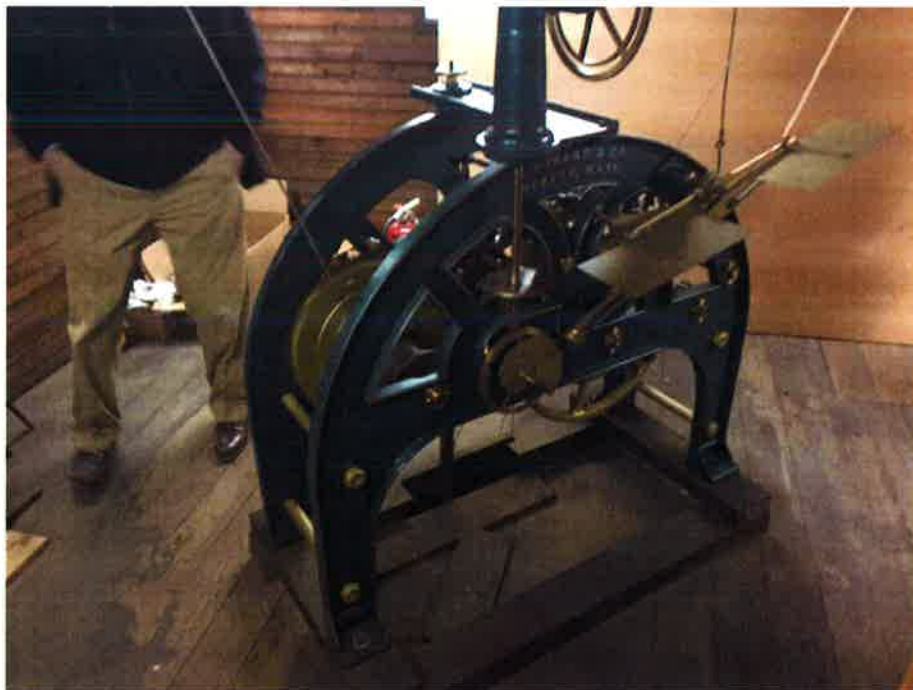
2003 – Phase of Minor Interior and Exterior Work

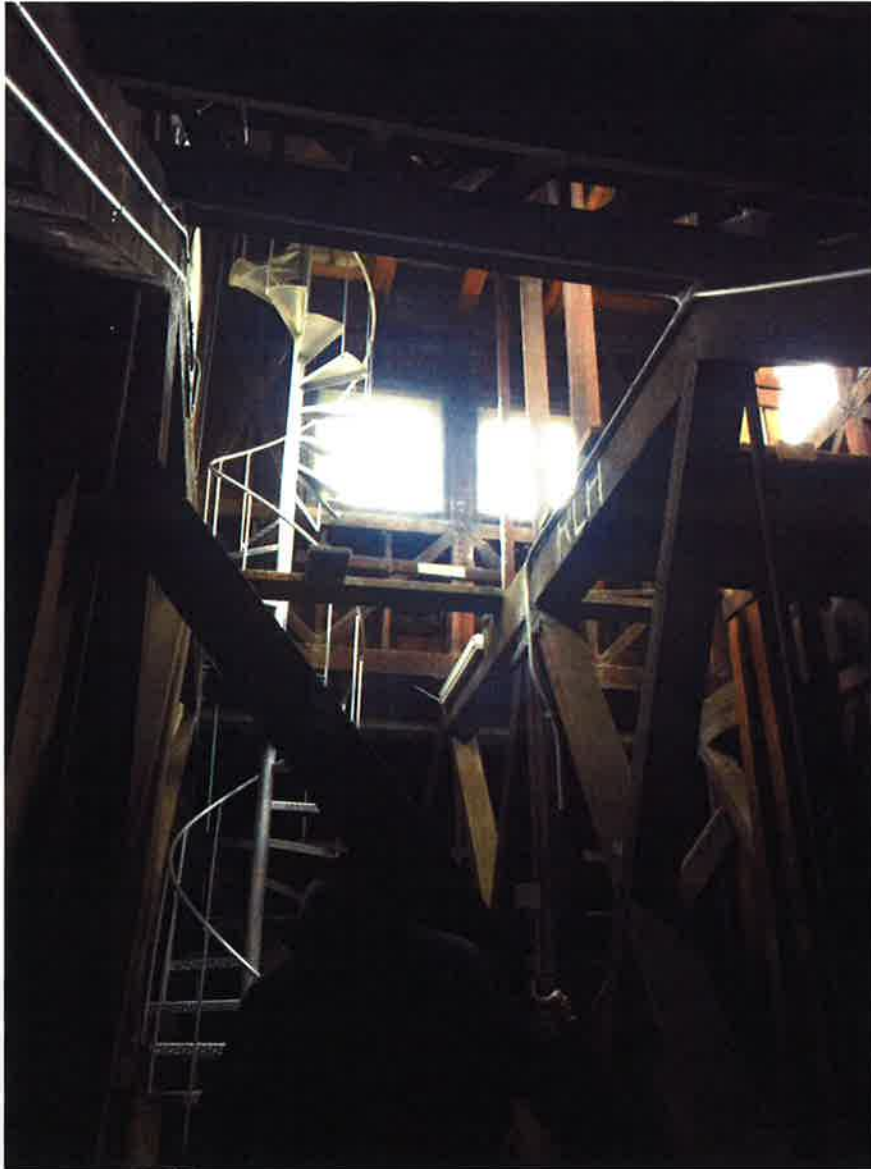
- Termite damage to wainscot and baseboards at North and South entrances, and elevator entrance, repaired.
- Second french drain and sump pump installed.
- Stair treads and floors in common areas refinished.

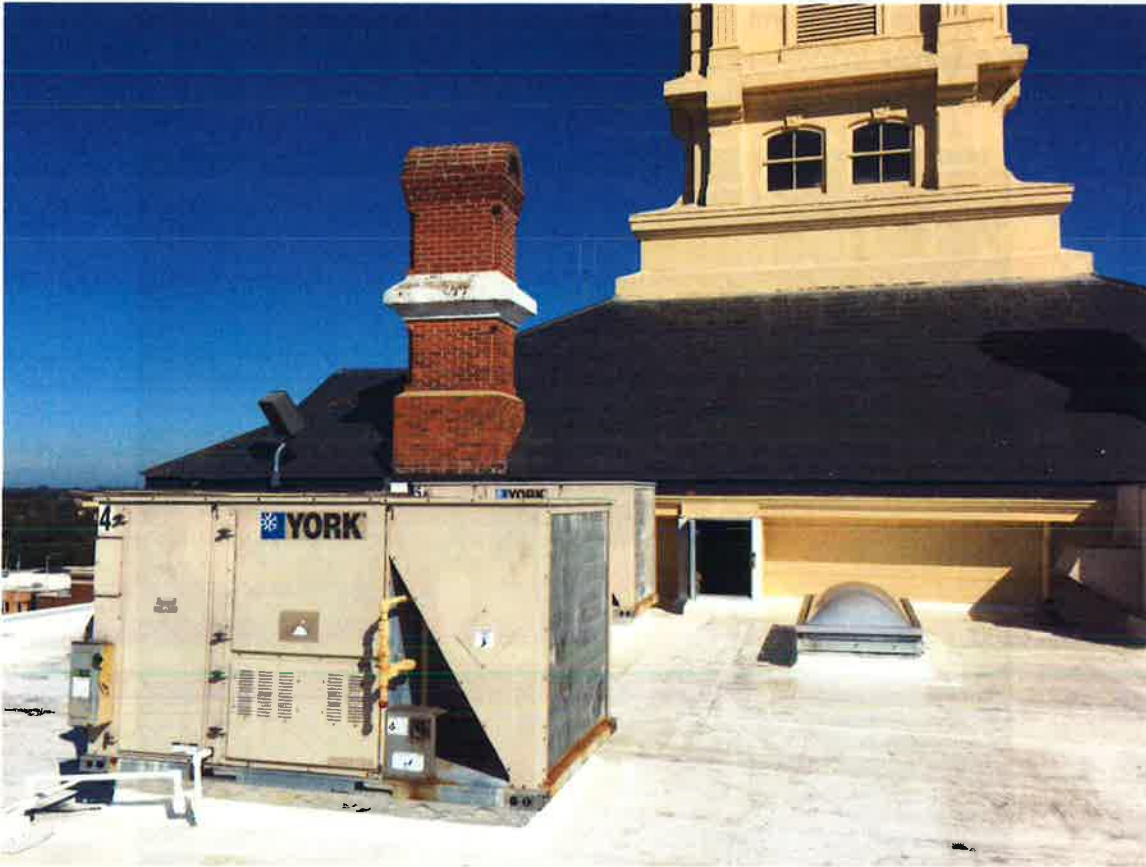
- Handrails added at North and South side steps.
- Exterior masonry cleaned.
- Cast stone parapet cap and foundation repaired.

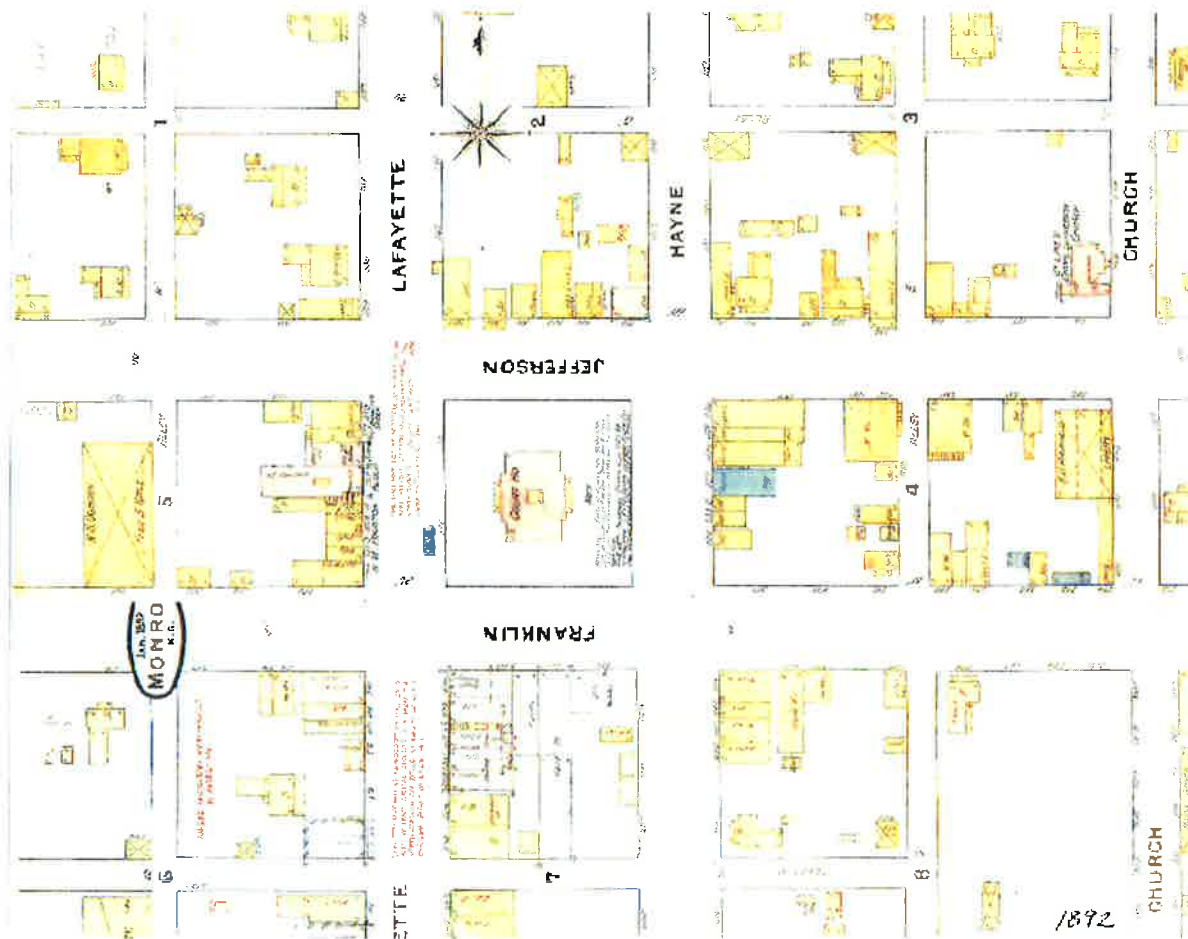
The masonry courthouse was completed in 1888, and appeared on the 1892 Sanborn map. The building is shown as a two-and-one-half story masonry structure, with a five-story wood frame tower, and two one-story wood frame porches on the east and west elevations. The roofing is indicated as slate, tin and shingle. The building is shown sitting equidistant from north to south on the block, but closer to the west side than the east. In his book "The Union County Courthouse 1843-1981", Wayne Durrill notes the business district was developing to the west of the courthouse square, so the west entrance was intended as the main entrance and located closer to the street.

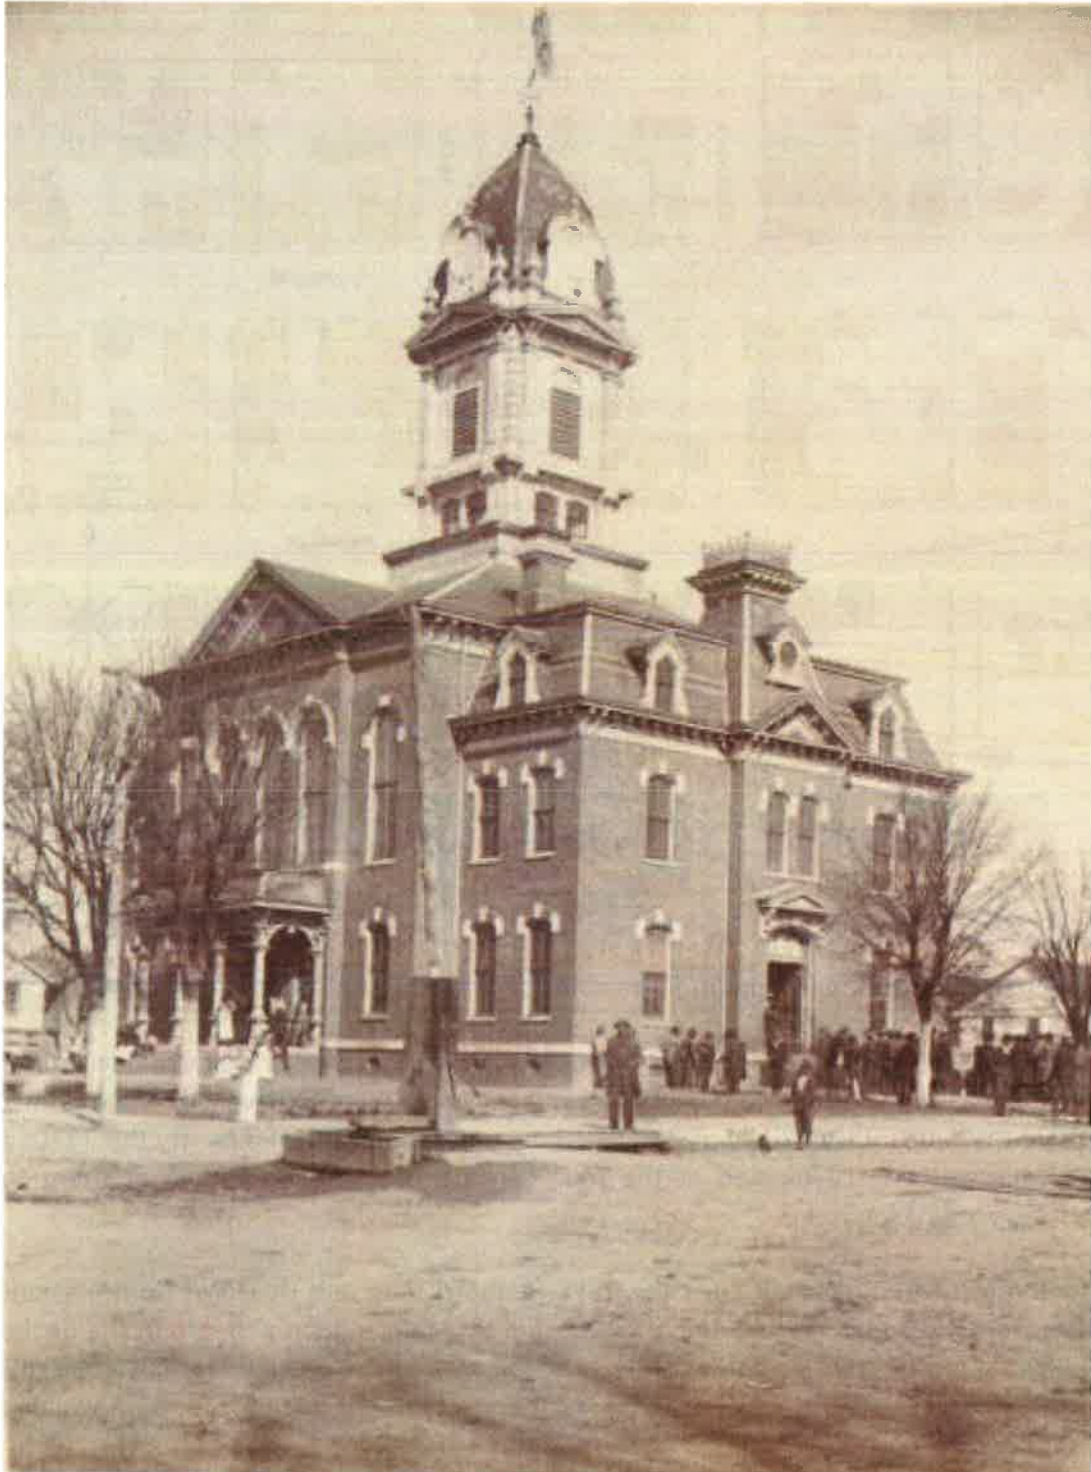
Two cast iron fountains, thought to be original to the courthouse square, have been restored by the County. One is currently displayed in the lobby of the modern courthouse. The other is stored in the historic courthouse. The company who restored the fountains, Robinson Iron, estimates their date of production to the 1890s. A photo dating to the 1920s, and an enlargement of the area of interest (both below), show one of these fountains located on the southwest corner of the courthouse square.

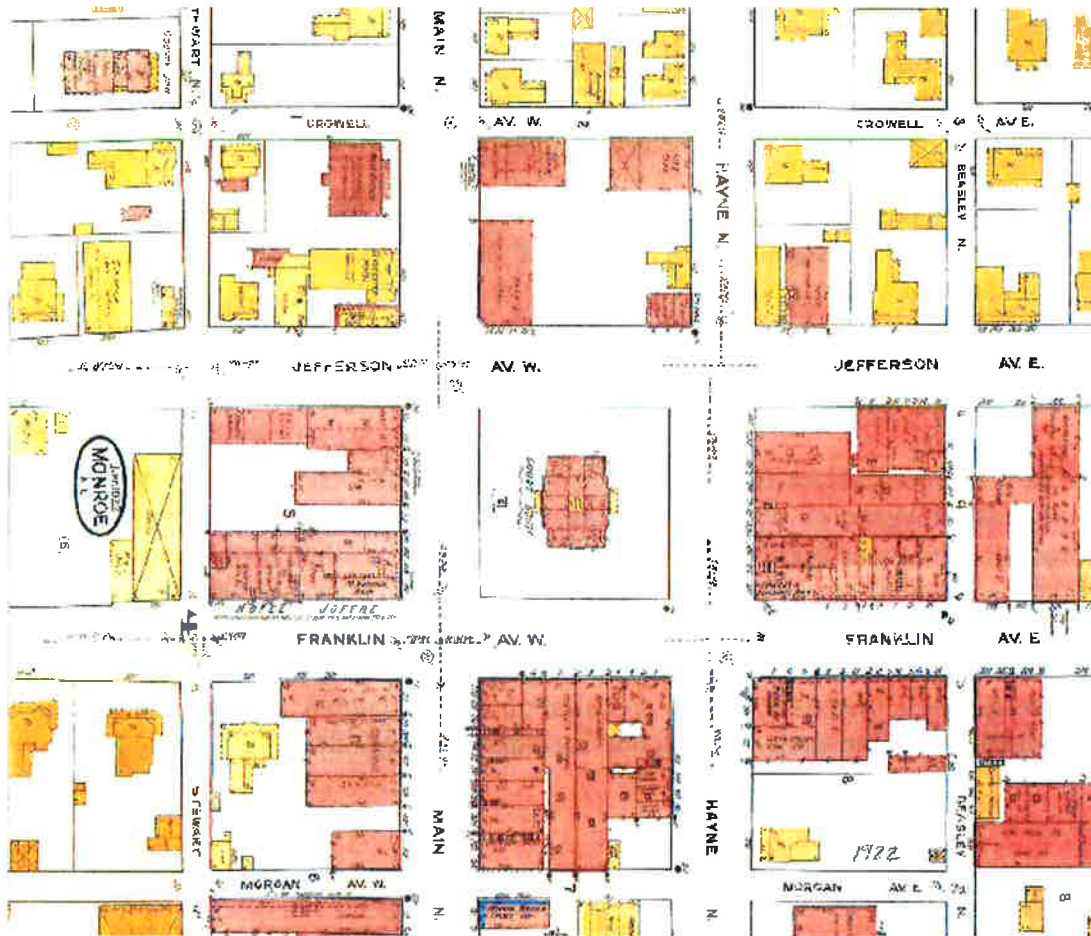
The 1922 Sanborn map shows the installation of new water lines at three of the four streets bordering the courthouse square. The two 4" lines on Hayne Street were consolidated into a single 8" line. The 8" and 4" lines on Jefferson Street were consolidated into a single 10" line. The 6" line on Franklin Street was replaced with a 10" line.

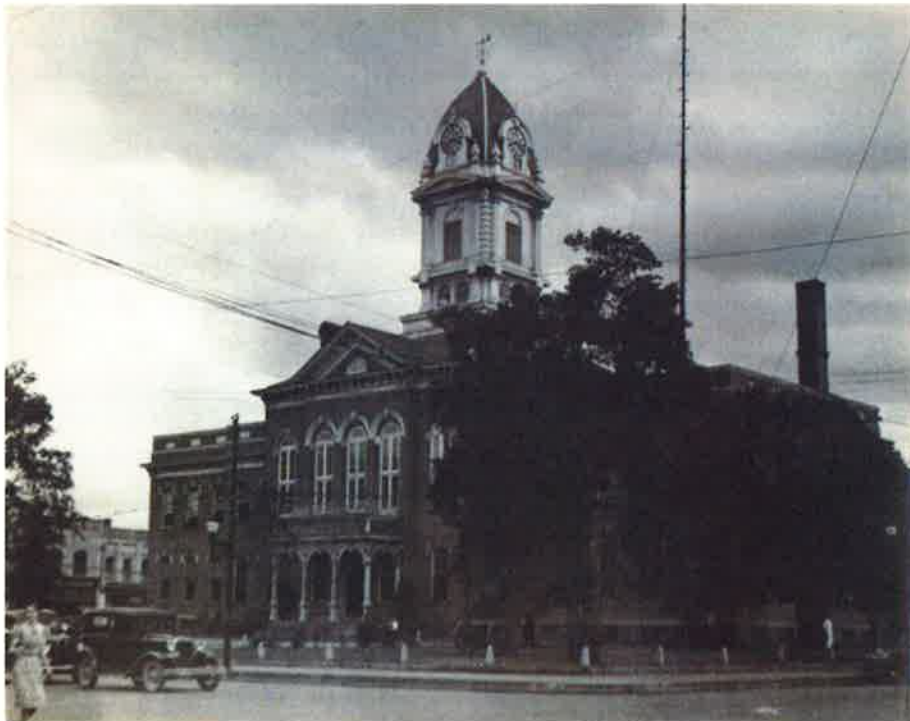
1950s – World War Two Monuments Placed

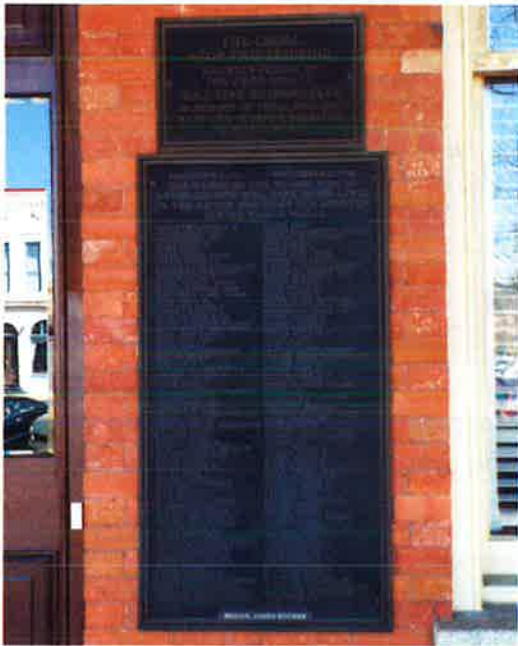
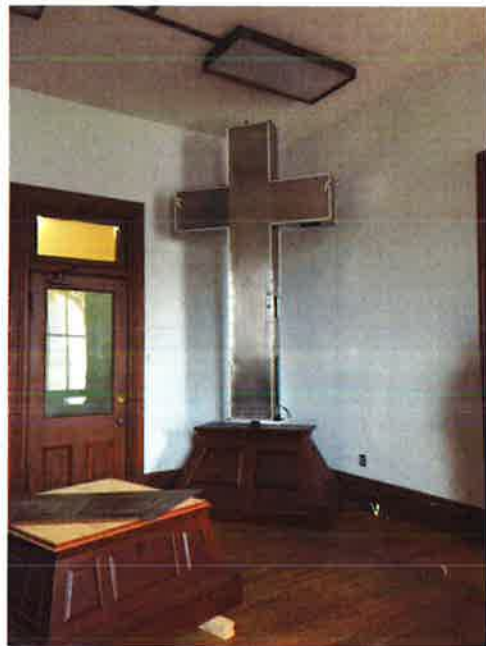
1985 – Vietnam Memorial Placed

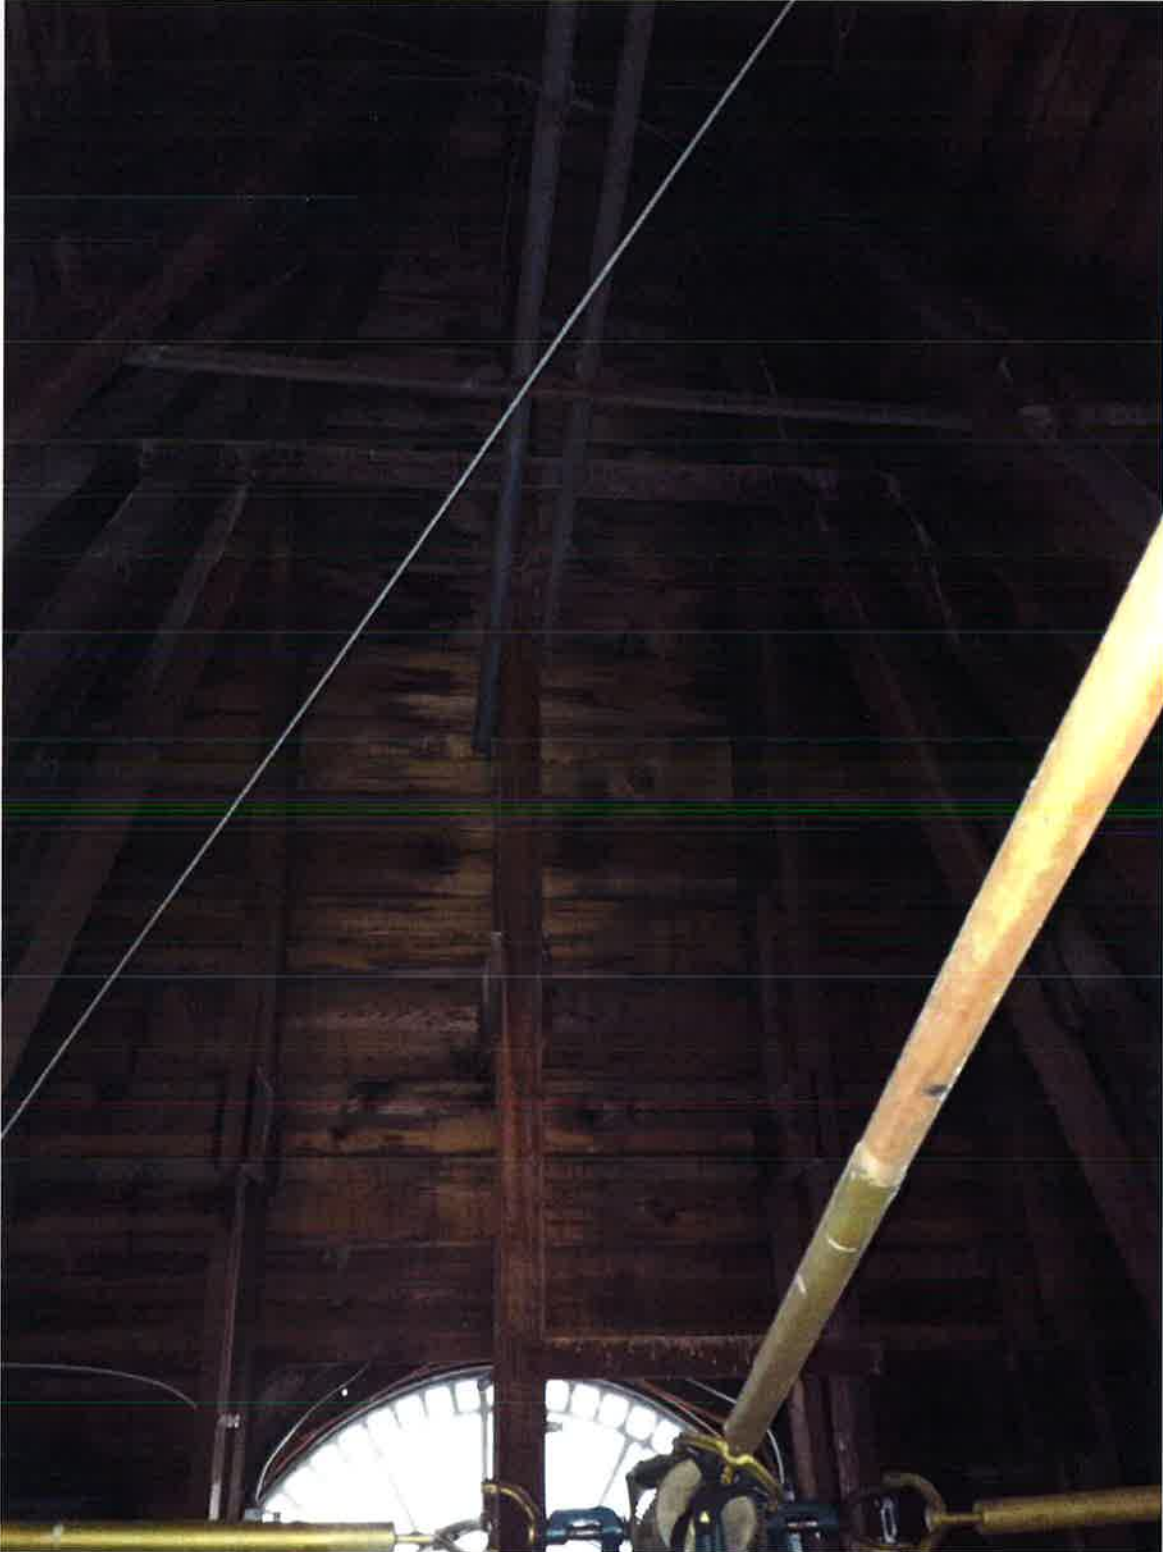
Water appears to be “washing” the interior face of the cupola decking boards. We assume the flashing at weathervane atop of the cupola has failed allowing water to penetrate the roofing assembly.

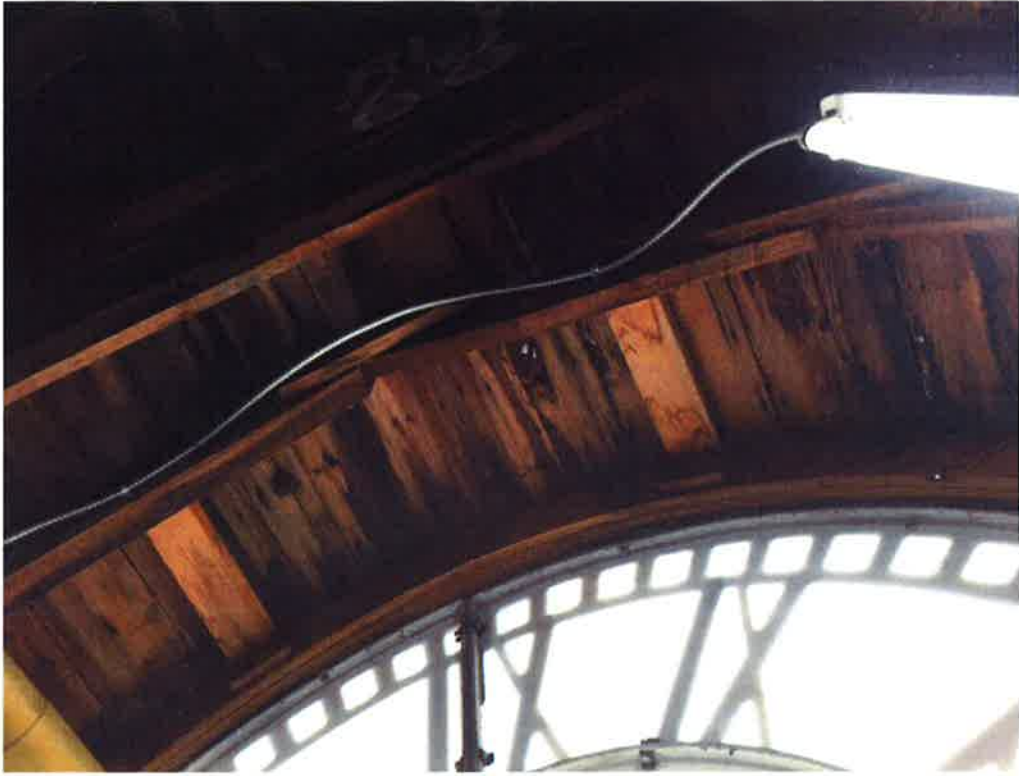
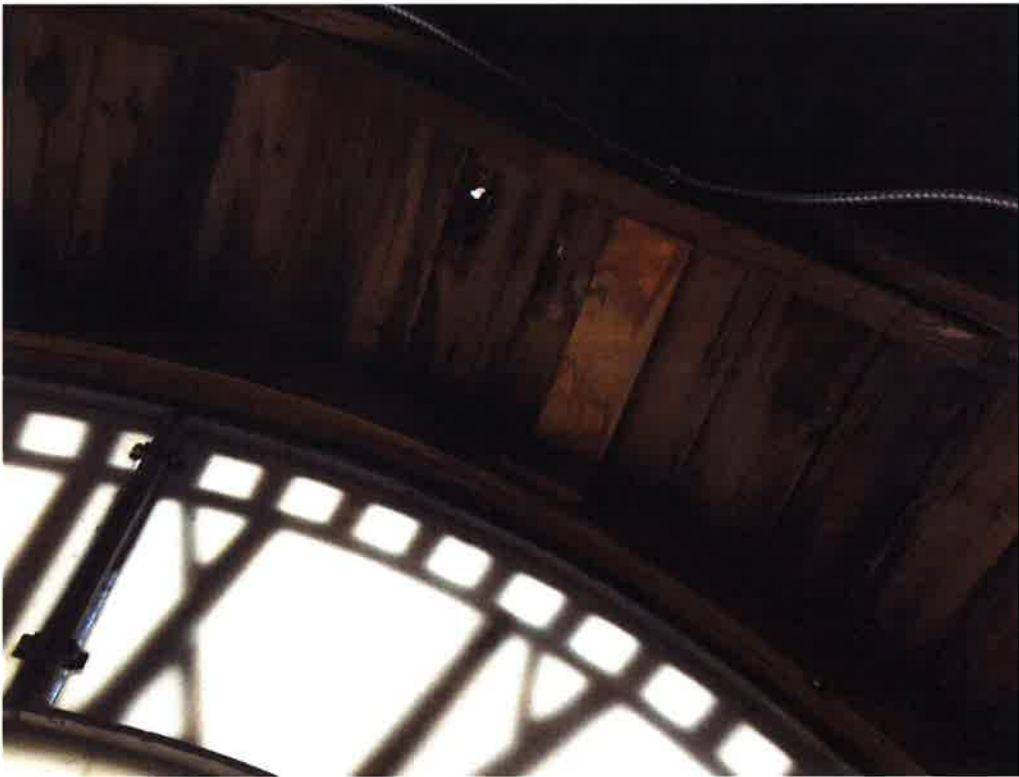
Water is penetrating the hoods above the clocks in all four locations. Bolt holes where the finials are attached have been some of the first areas of decking to deteriorate.

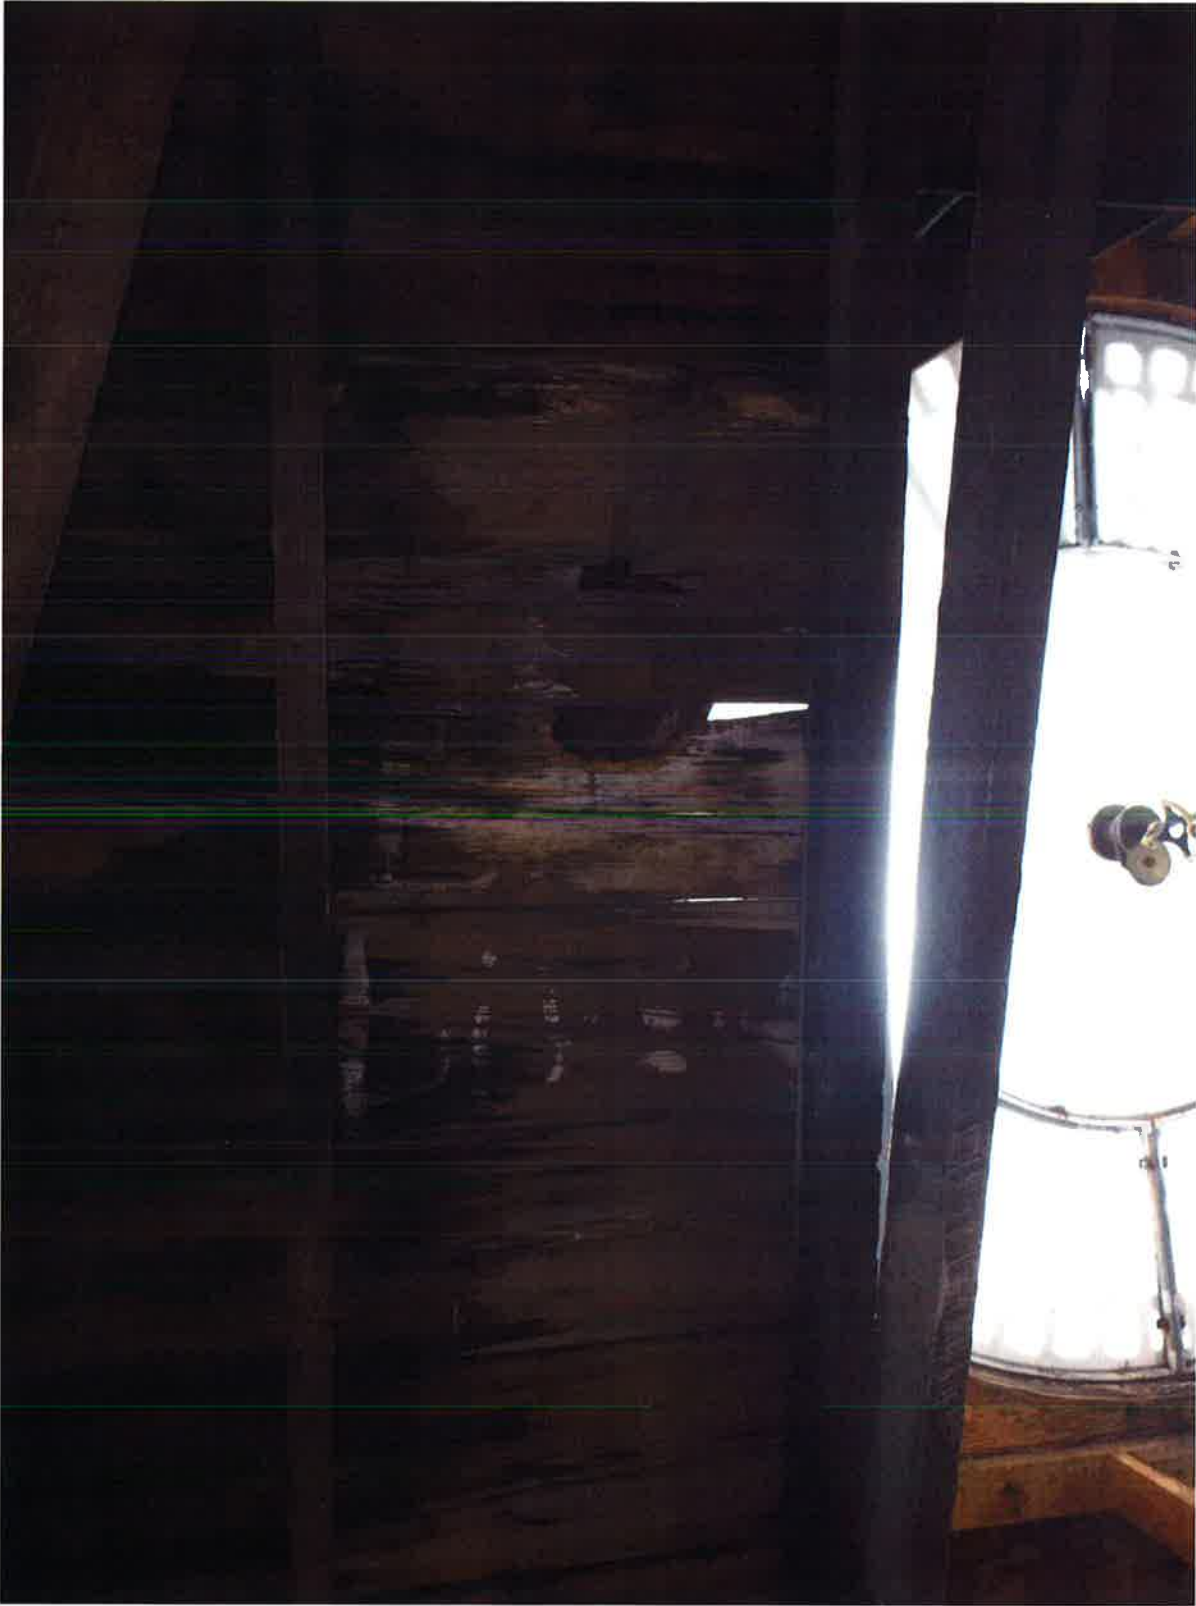
The decking below the valleys created where the clock hoods meet the roofing, has significantly deteriorated in some locations.

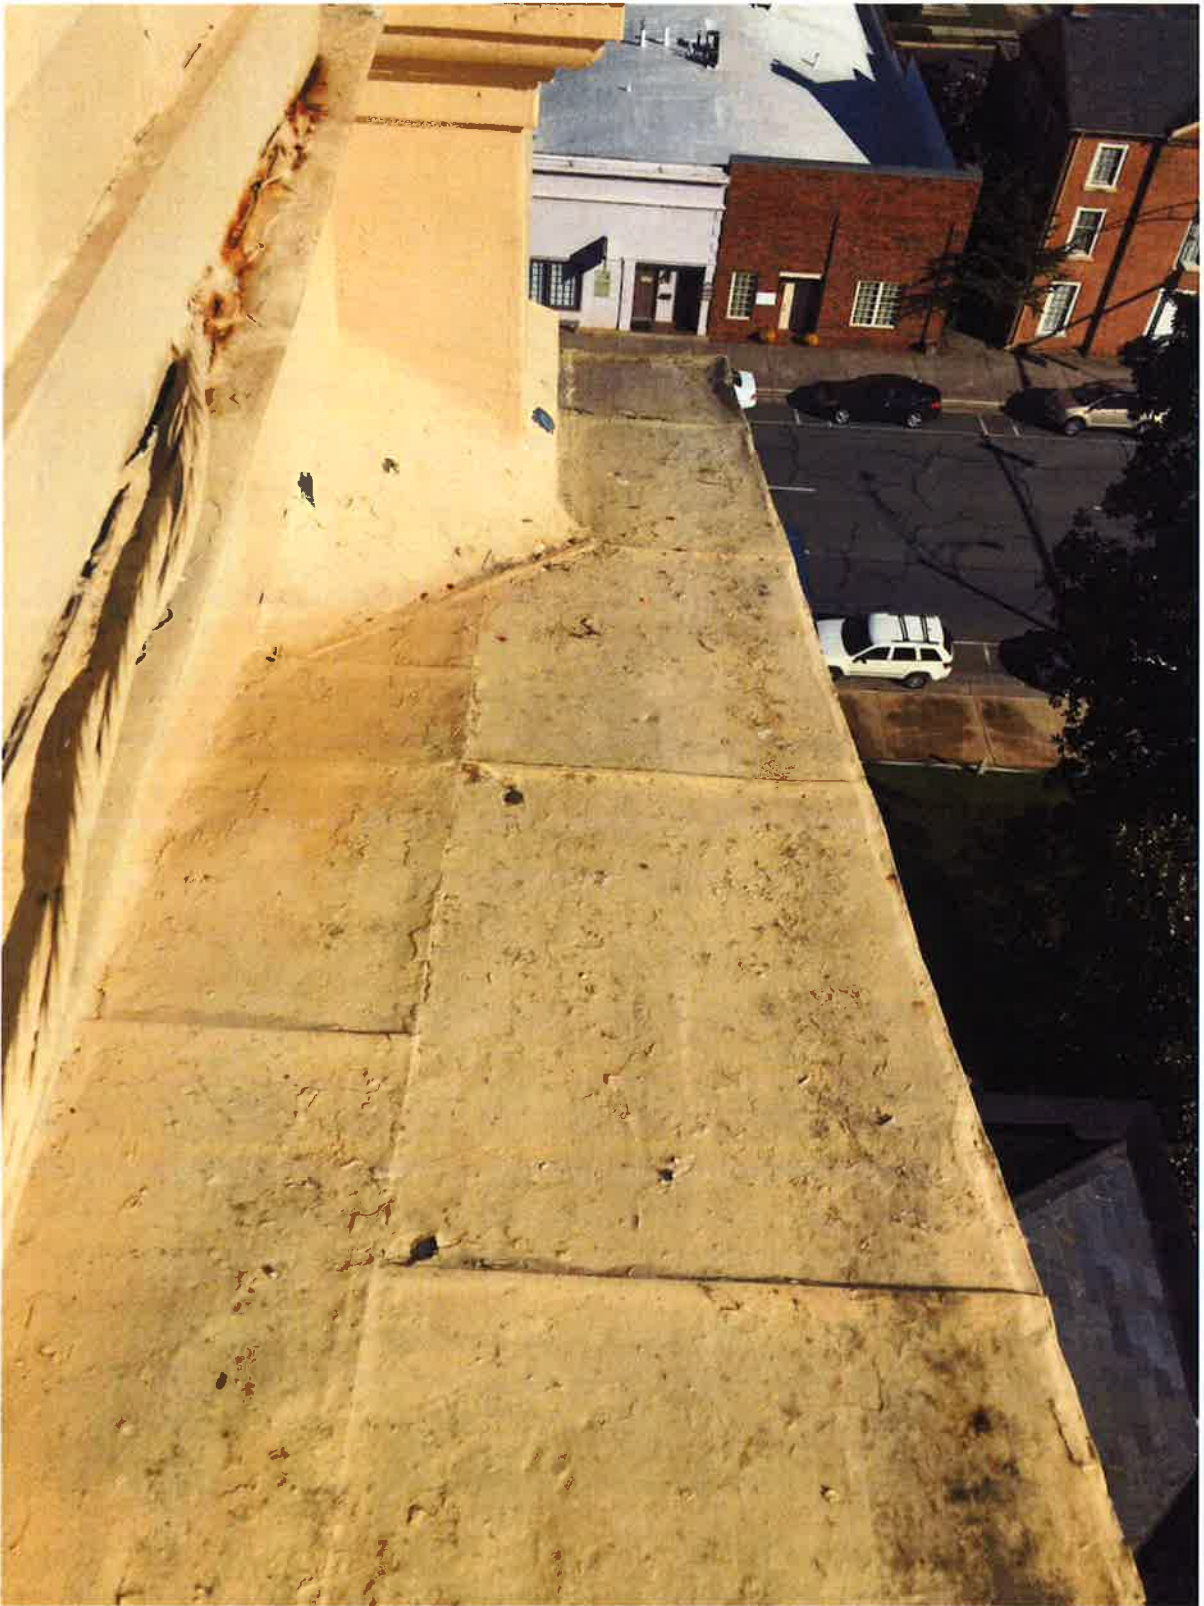
The sheet metal roofing just below the clocks is in good shape, with only minor areas of rust and paint loss.

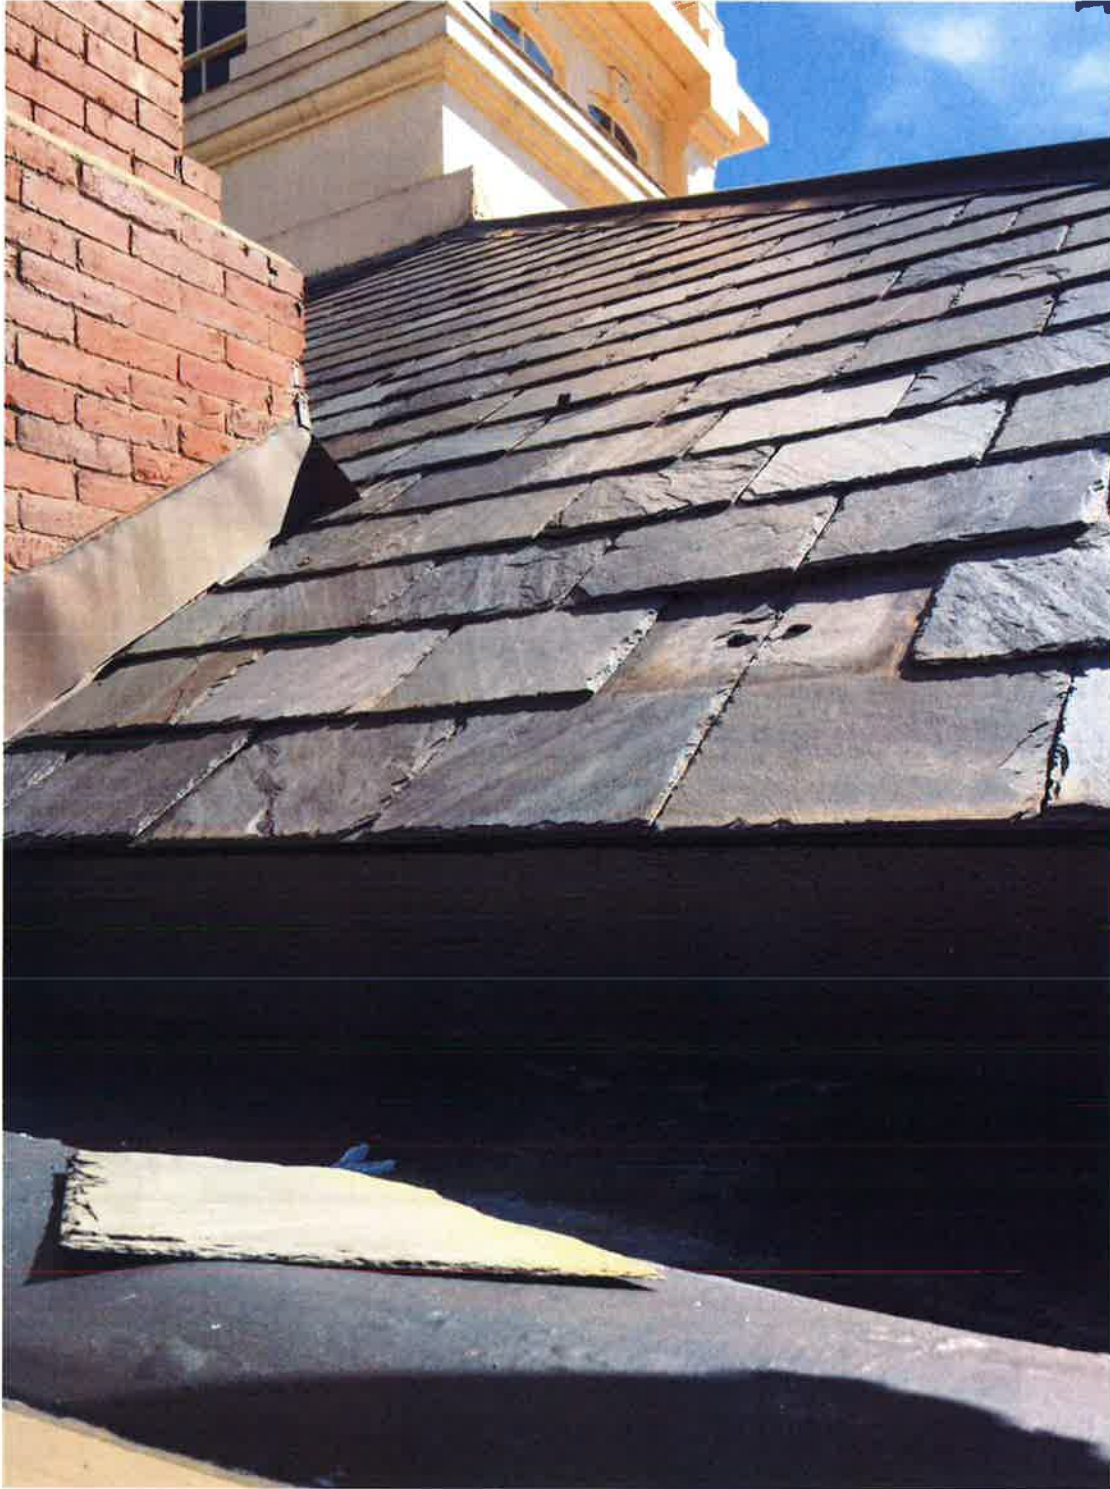
The 1990 slate roofing work is less than ideal. Reglets were cut into the brick chimneys where step flashing should have been installed. The anchors holding the slate are beginning to fail as evidenced by fallen slates and inappropriate "tab" copper temporary repairs which are also failing.

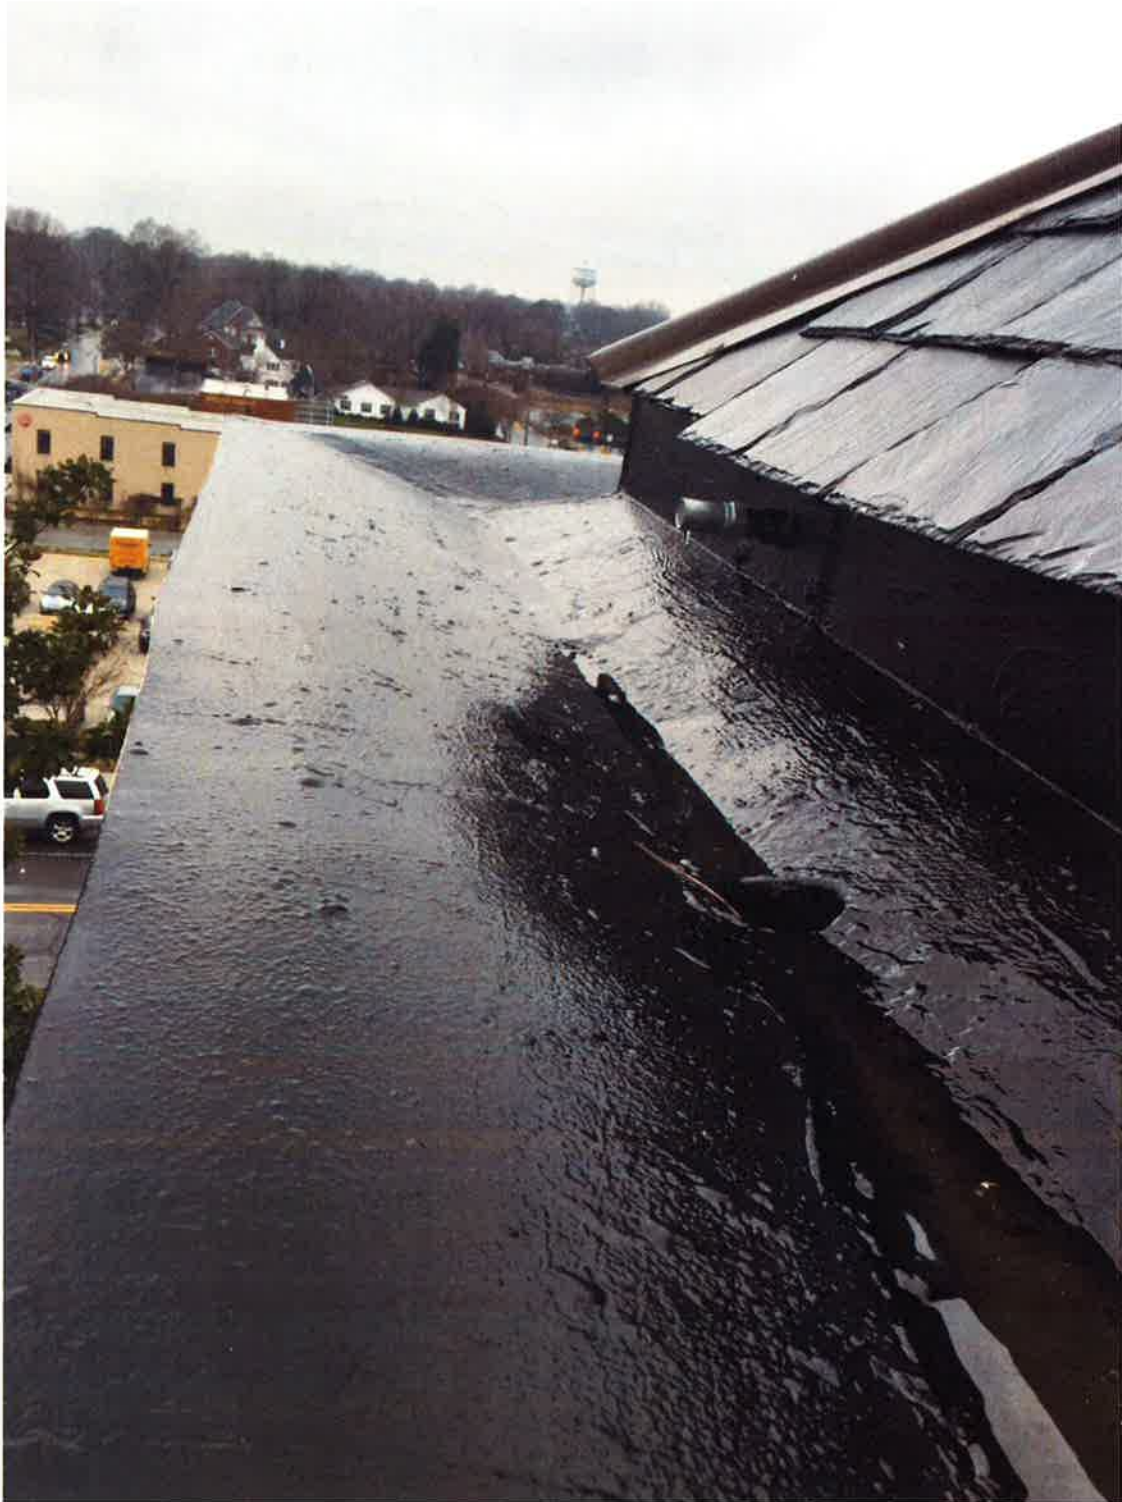
The open gutter around the slate roof is far too shallow and has no retaining edge. Water washes over the edge of the gutter, down the face of the metal cornice and brick below. In heavy rains, the water cascades over the gutter to the flat roof below and splashes back onto the brick wall below.
