HISTORIC UNION COUNTY COURTHOUSE

HISTORIC STRUCTURE REPORT & RELATED SERVICES
JANUARY 23, 2017

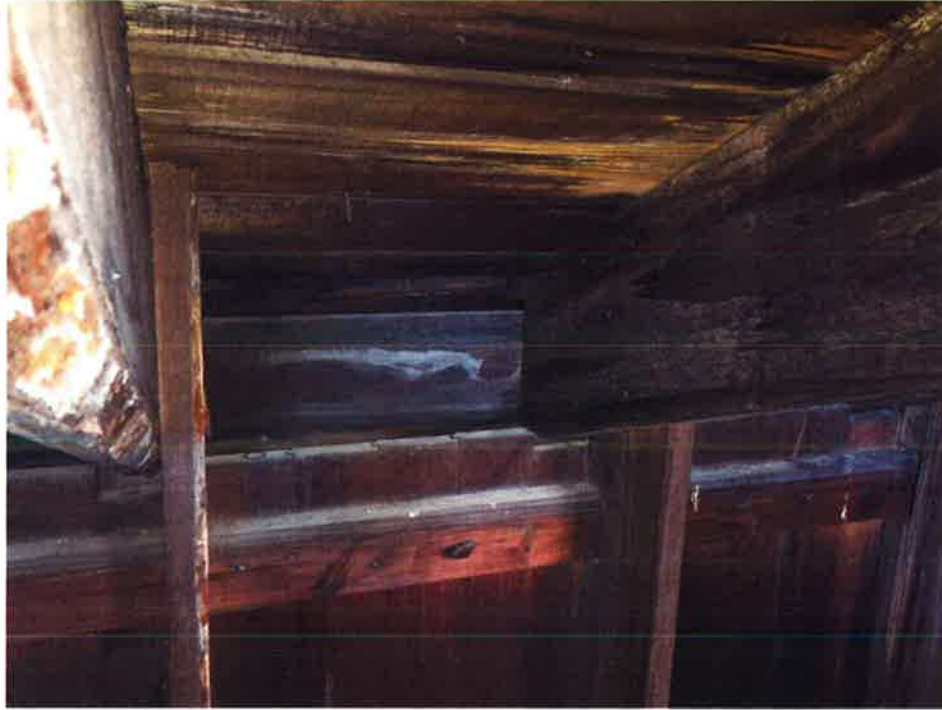
Water penetration at the slate roof can be seen as water staining and damage to the roof plate, rafters and decking below.

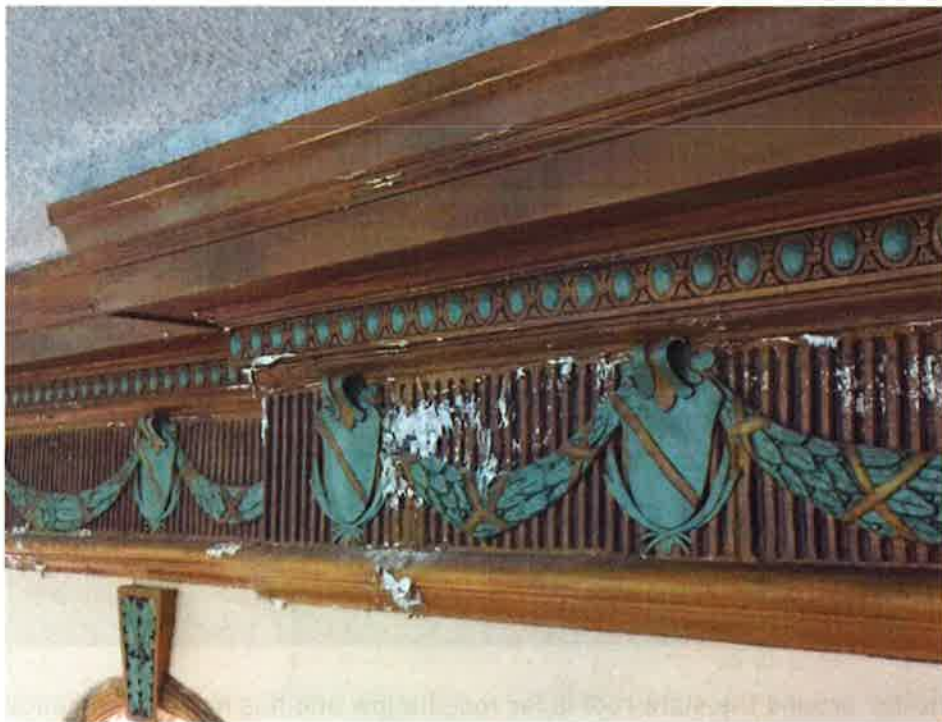
Water penetration from the slate roof and box gutter, has caused significant deterioration of the plaster frieze in the courtroom below.

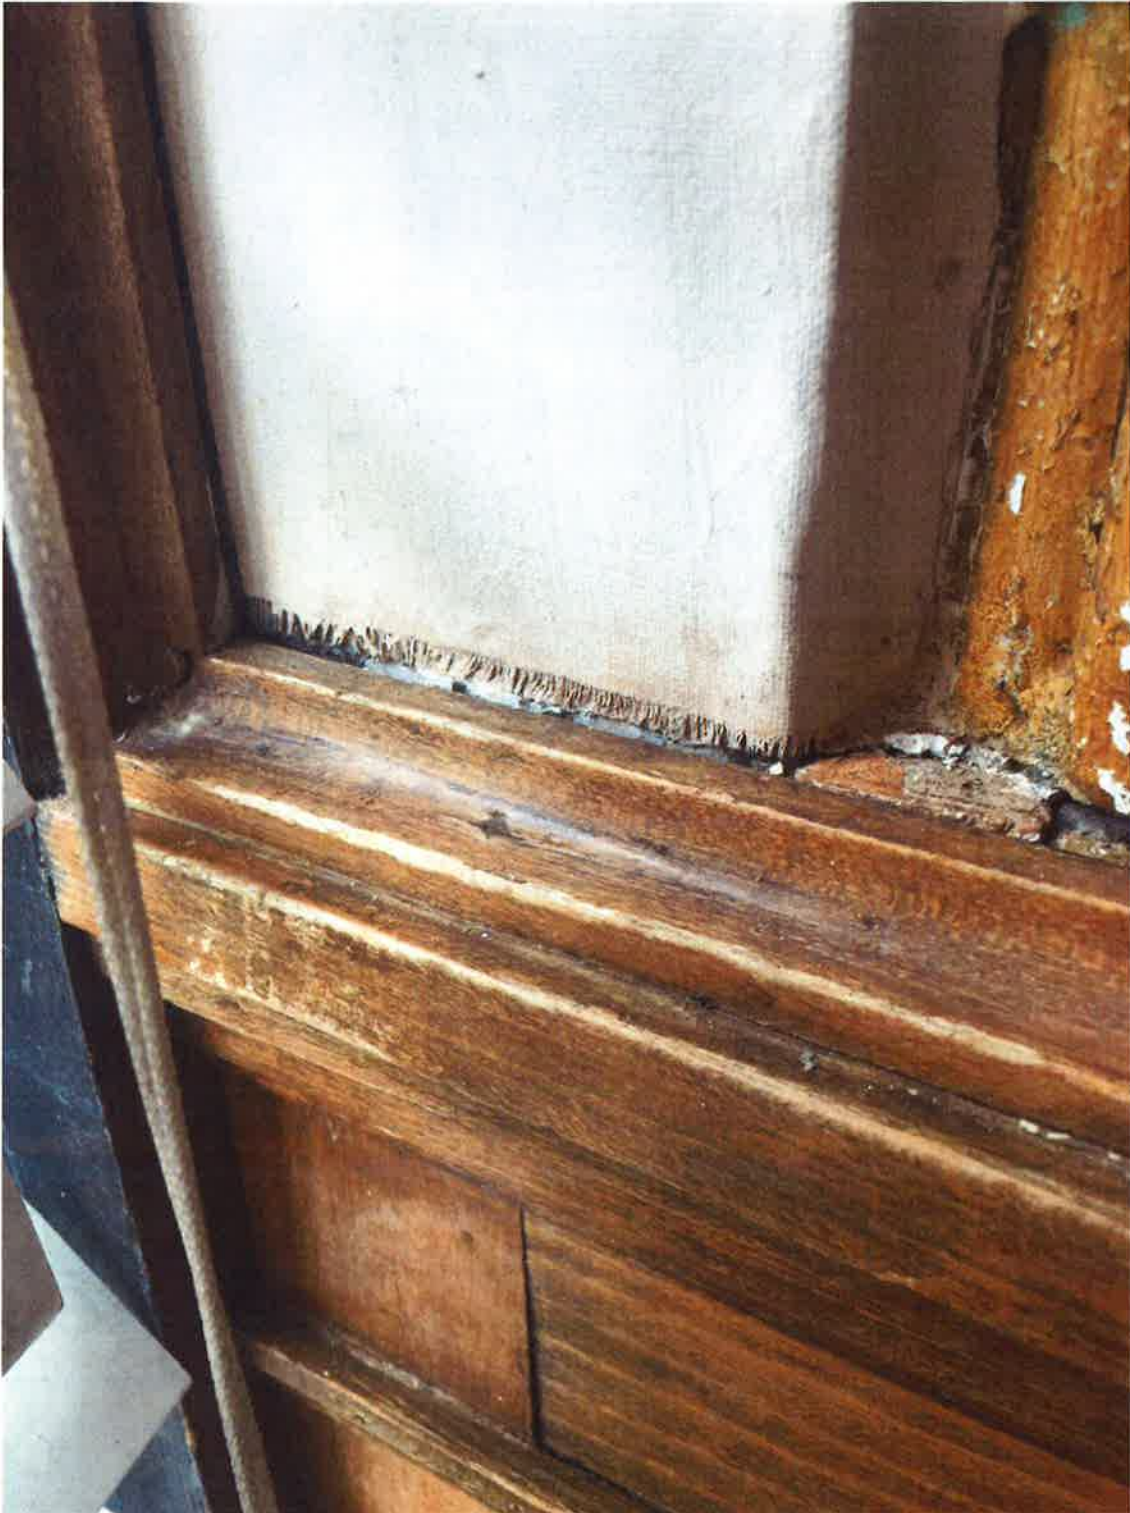
In the courtroom, some walls have been covered in fabric to cover cracks and other forms of plaster damage.

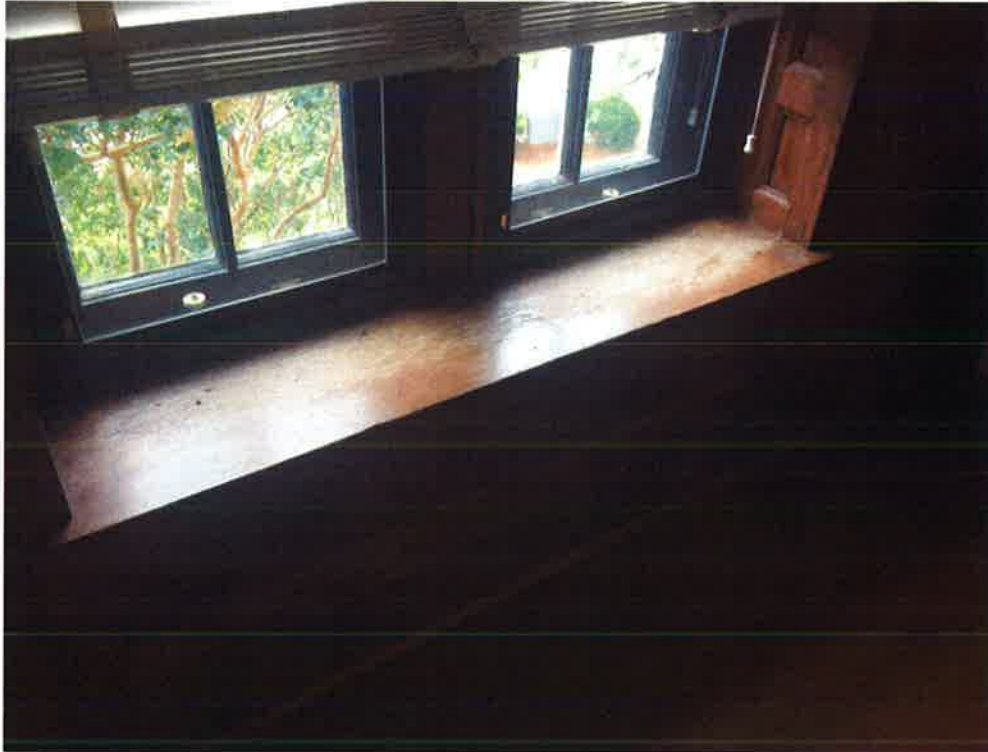
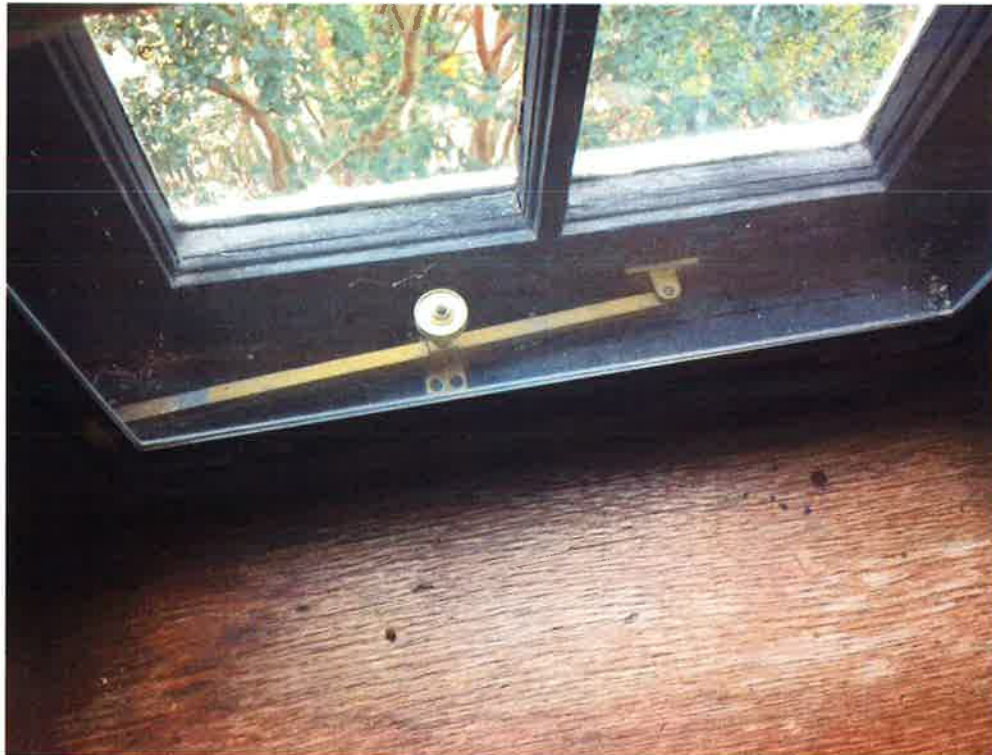
At the courtroom windows, heat caused by the interior storms and UV damage has damaged the wood at the interior face of the window sash. The interior sills have also suffered UV damage.

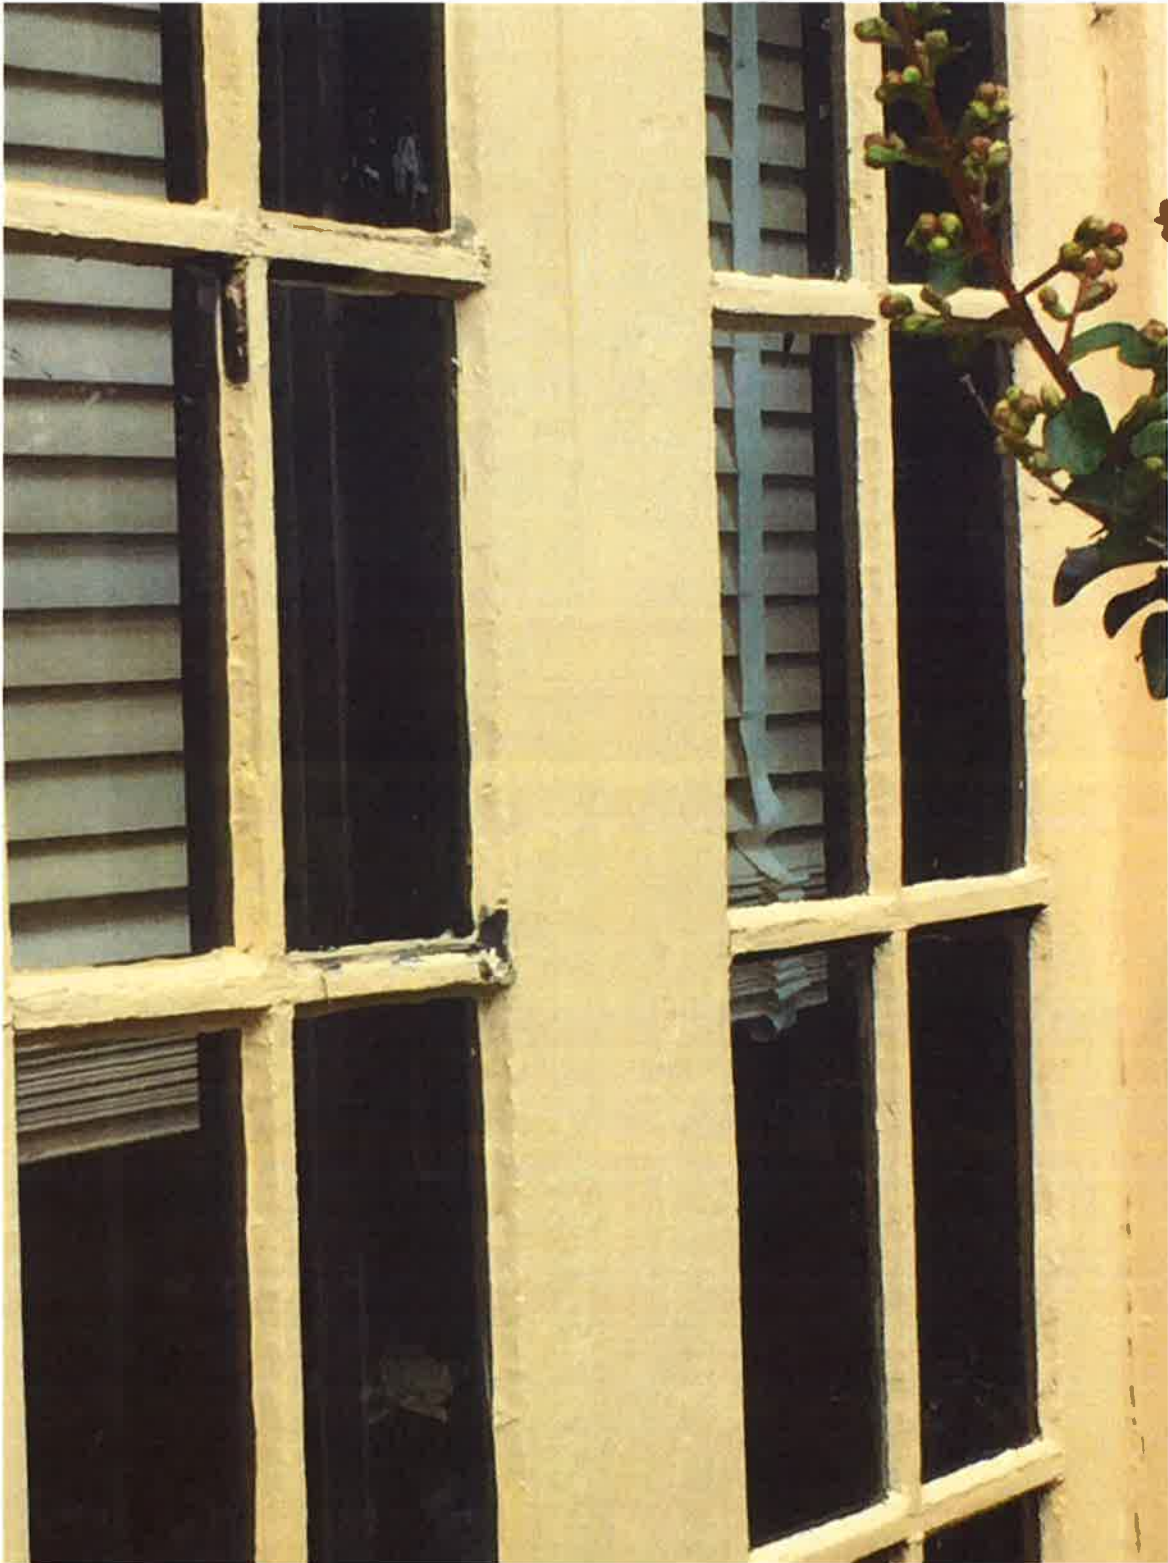
Exterior window muntins appear to have been rebuilt with wood filler and hastily re-glazed in several locations.

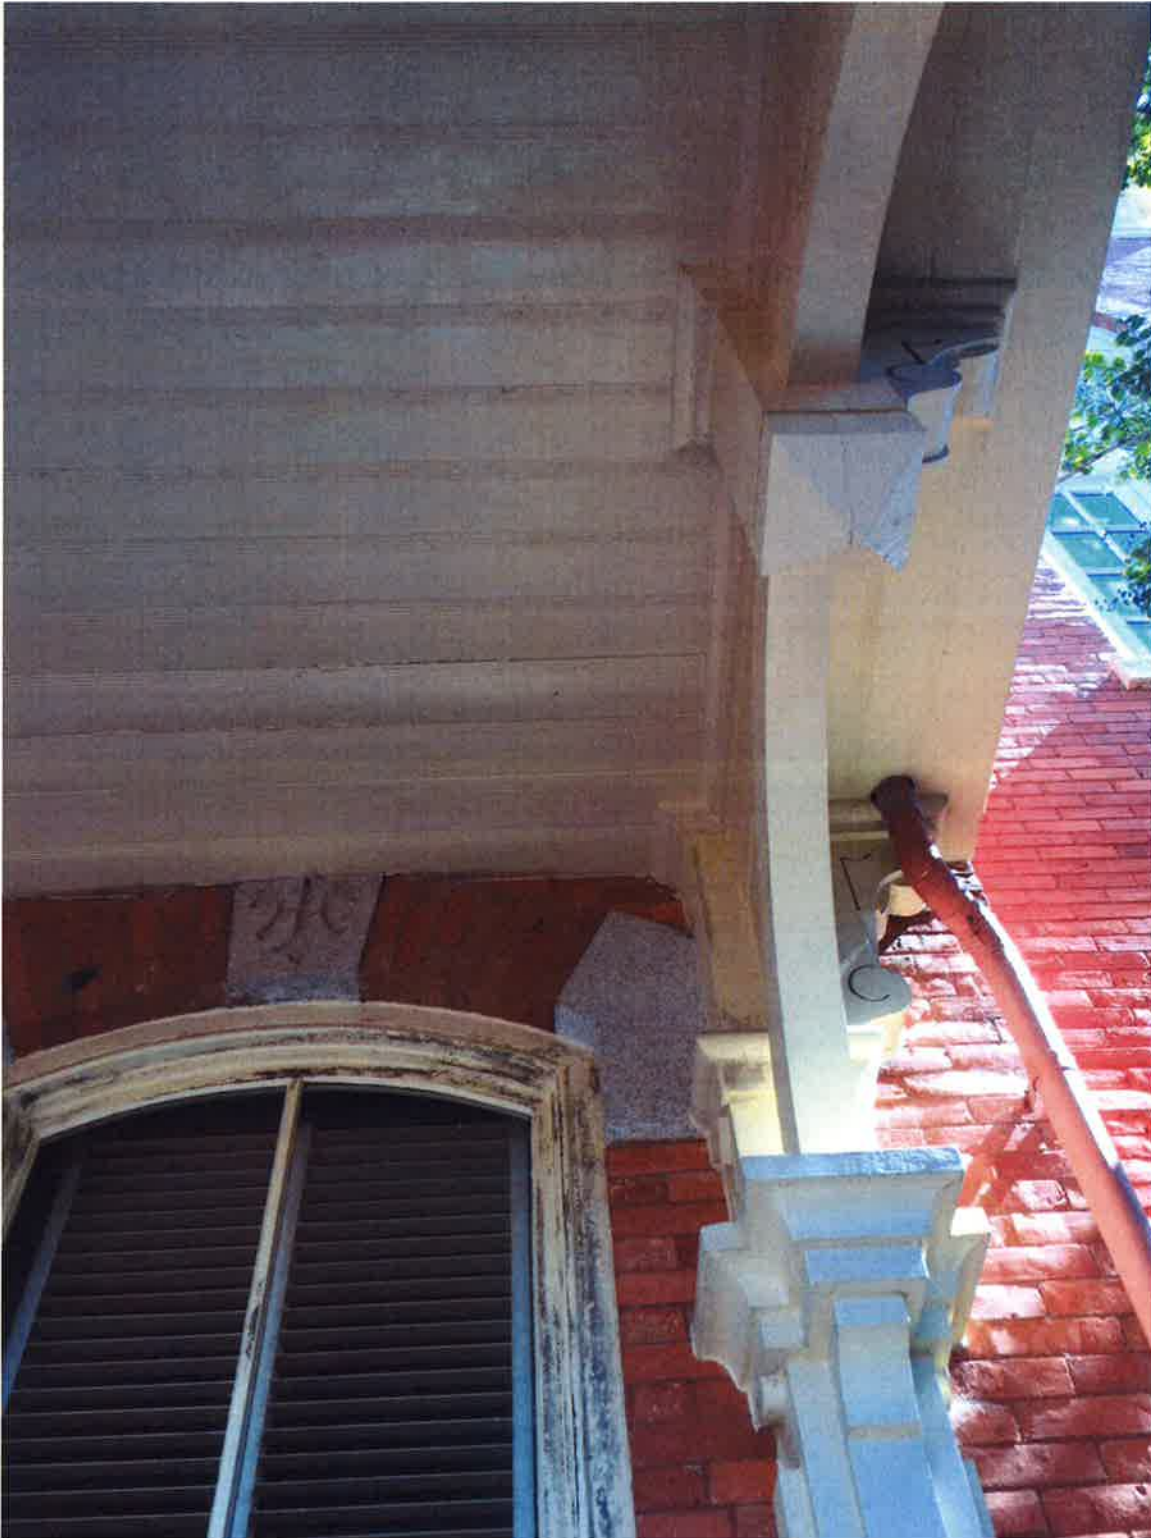
Moisture penetration from the roof above has caused paint deterioration at the portico ceilings and mildew at the windows.

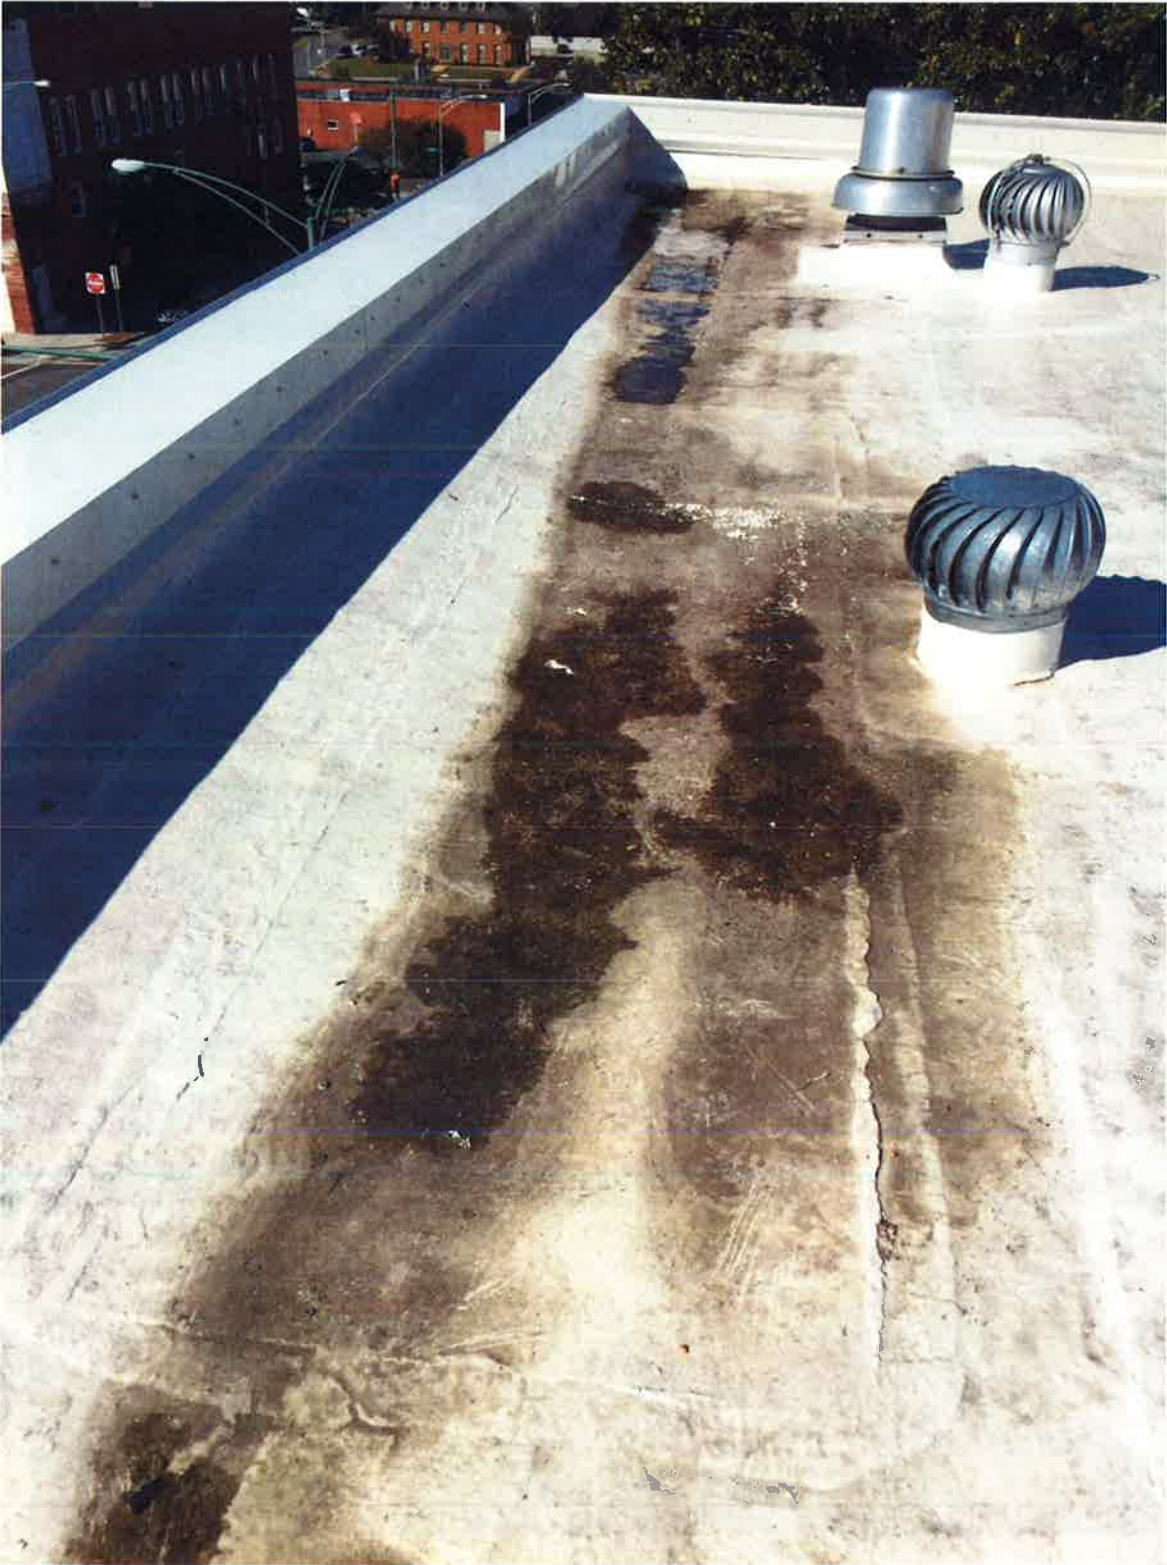
The flat roofs on the 1926 wings are holding water, specifically at the far south and far north edges.

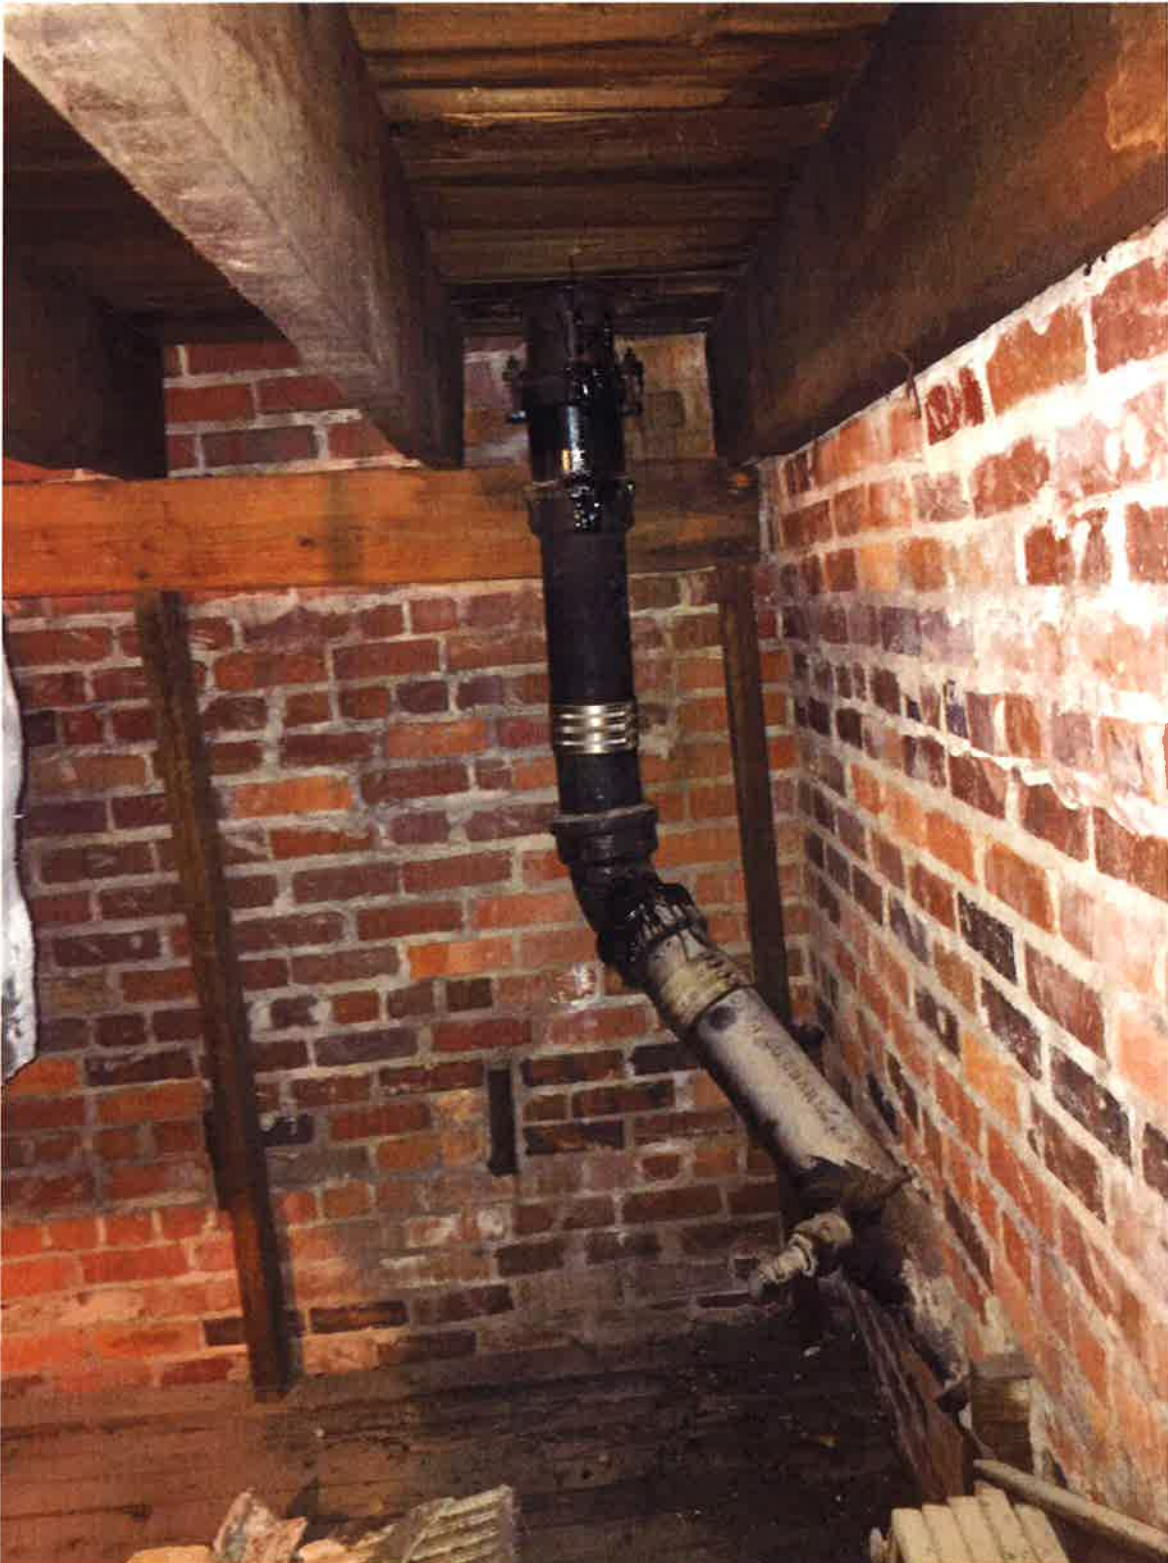
Water penetrating the flat roofs, specifically at the SE corner, has damaged the roof decking, attic flooring and the ceiling in the room below.

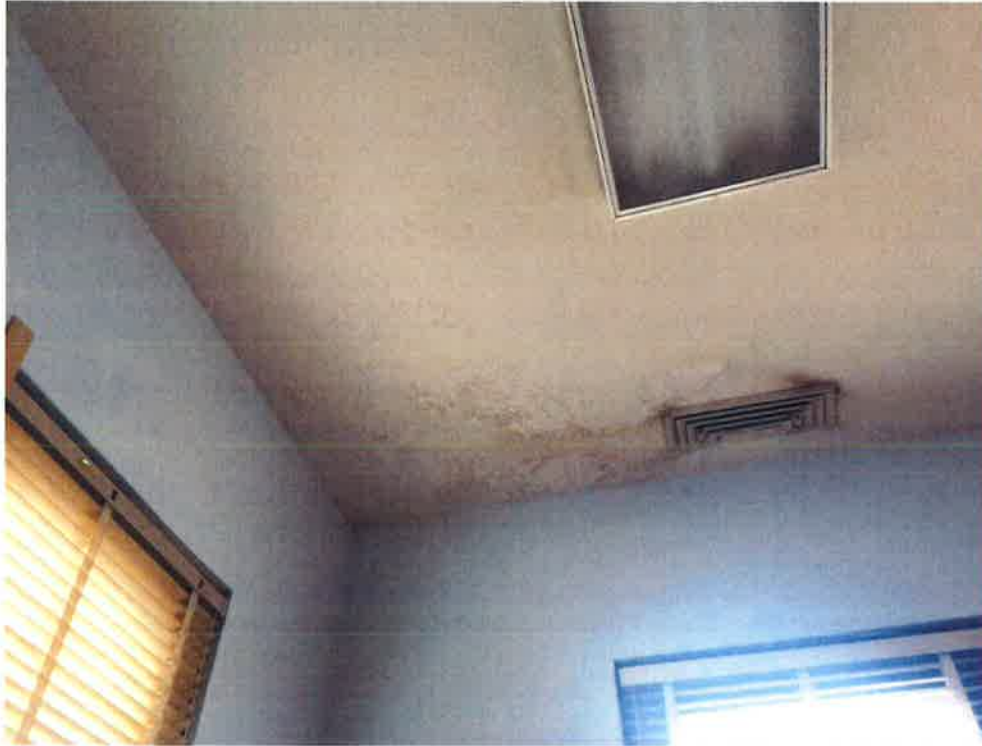
Water has damaged the ceiling in the room at the NW corner of the second floor.

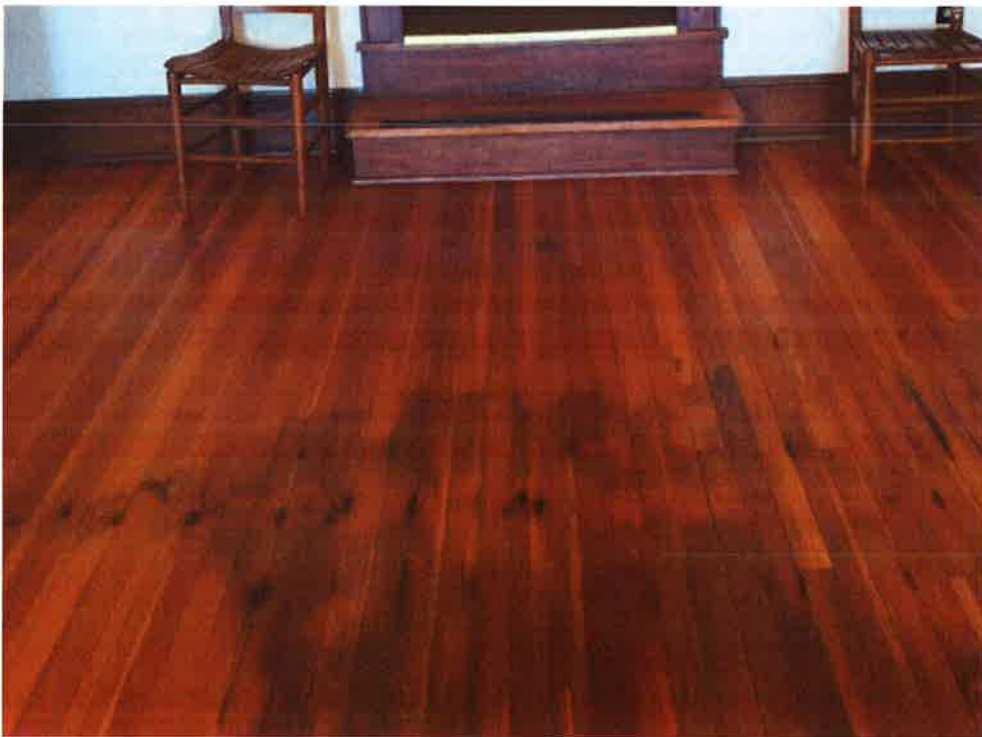
Past roof damage has caused water staining to the flooring in the room at the SE corner of the second floor.

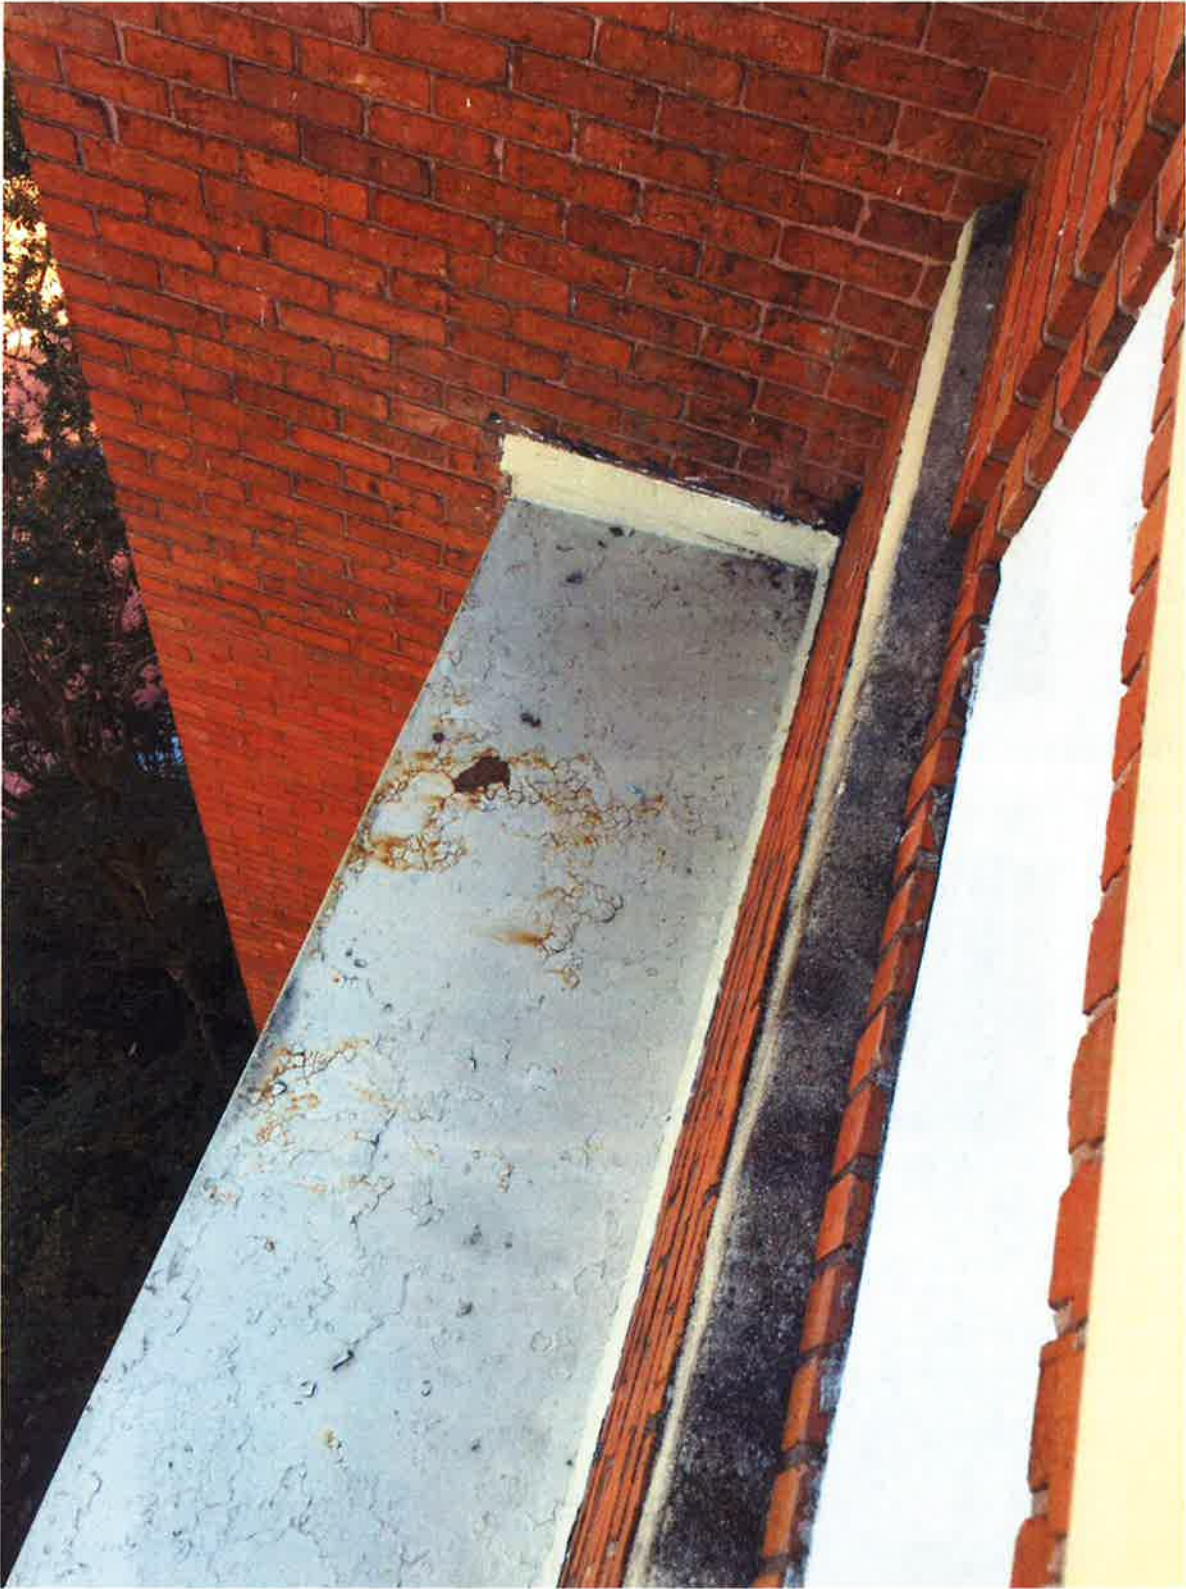
The pent eaves at the 1926 wings are beginning to spot rust in many areas.

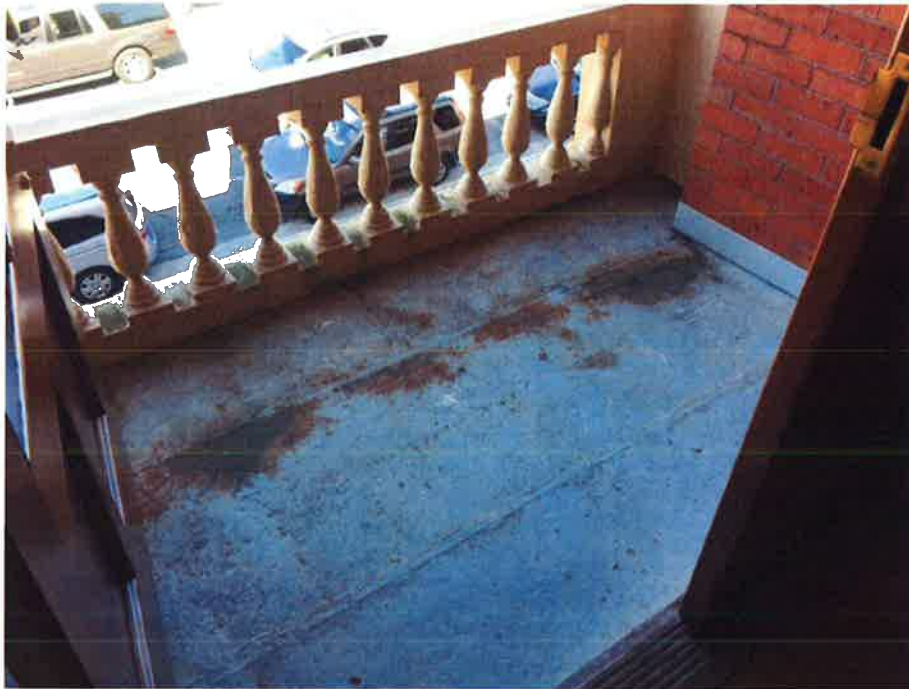
The flat seam metal at the balcony flooring has begun to corrode.

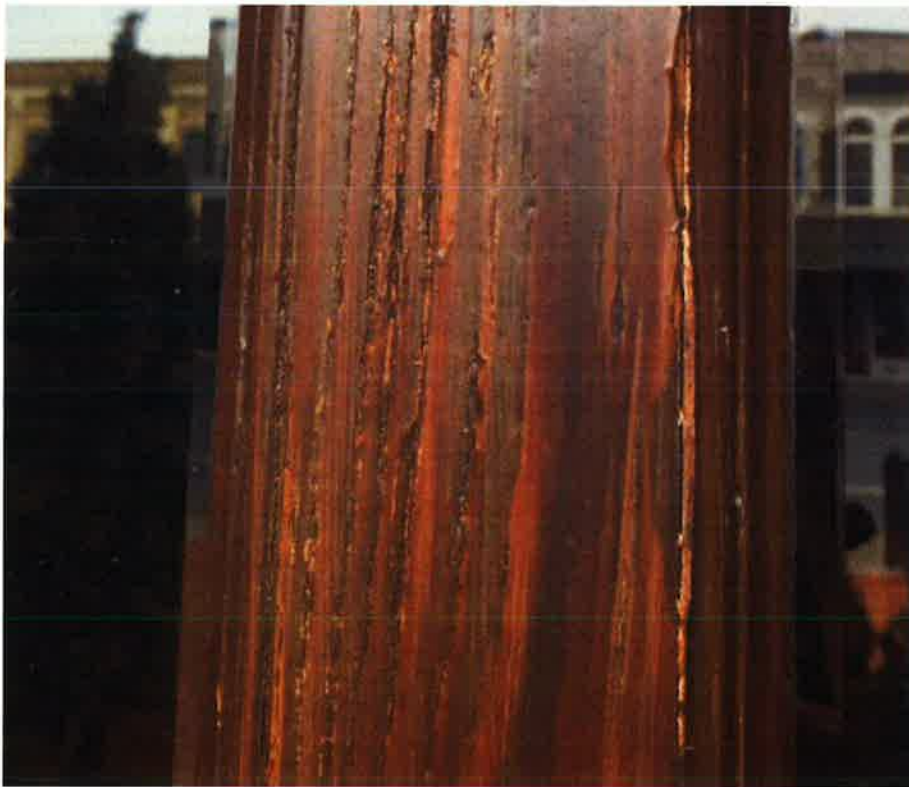
The finish on the exterior doors, specifically the south pair of doors, has begun to fail.

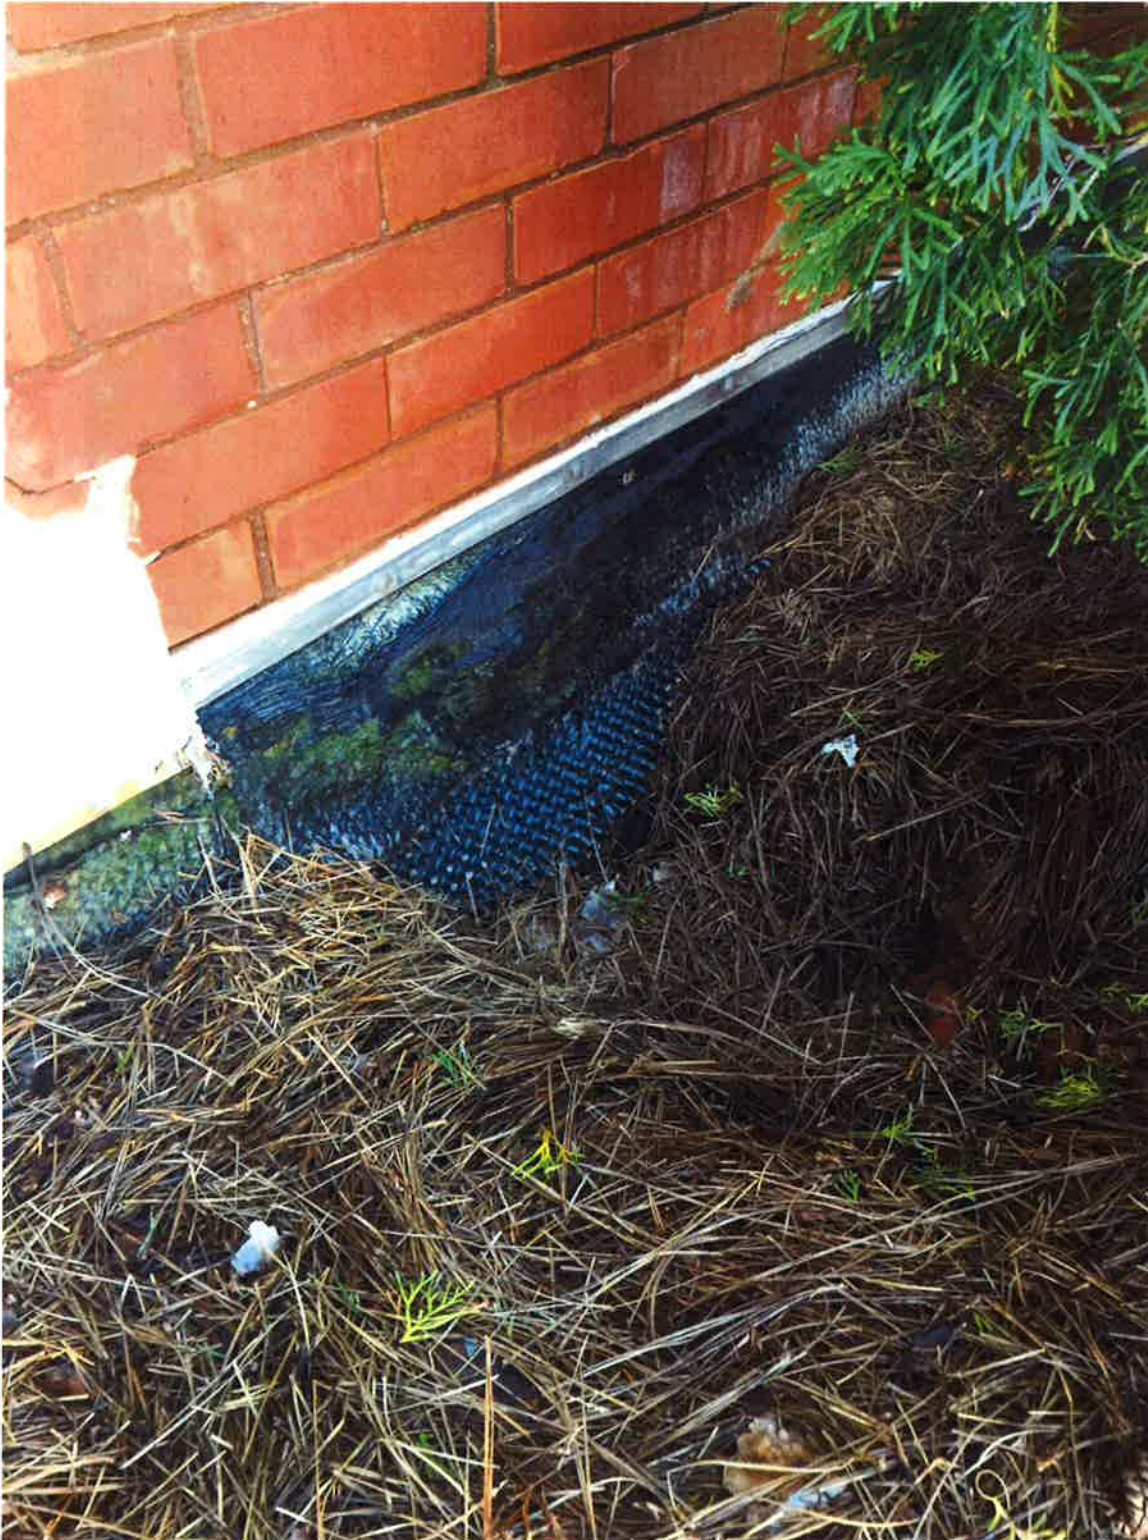
In 1998/1999 a waterproofing was applied to the sub-grade level of the 1926 wings. This waterproofing has begun to deteriorate.

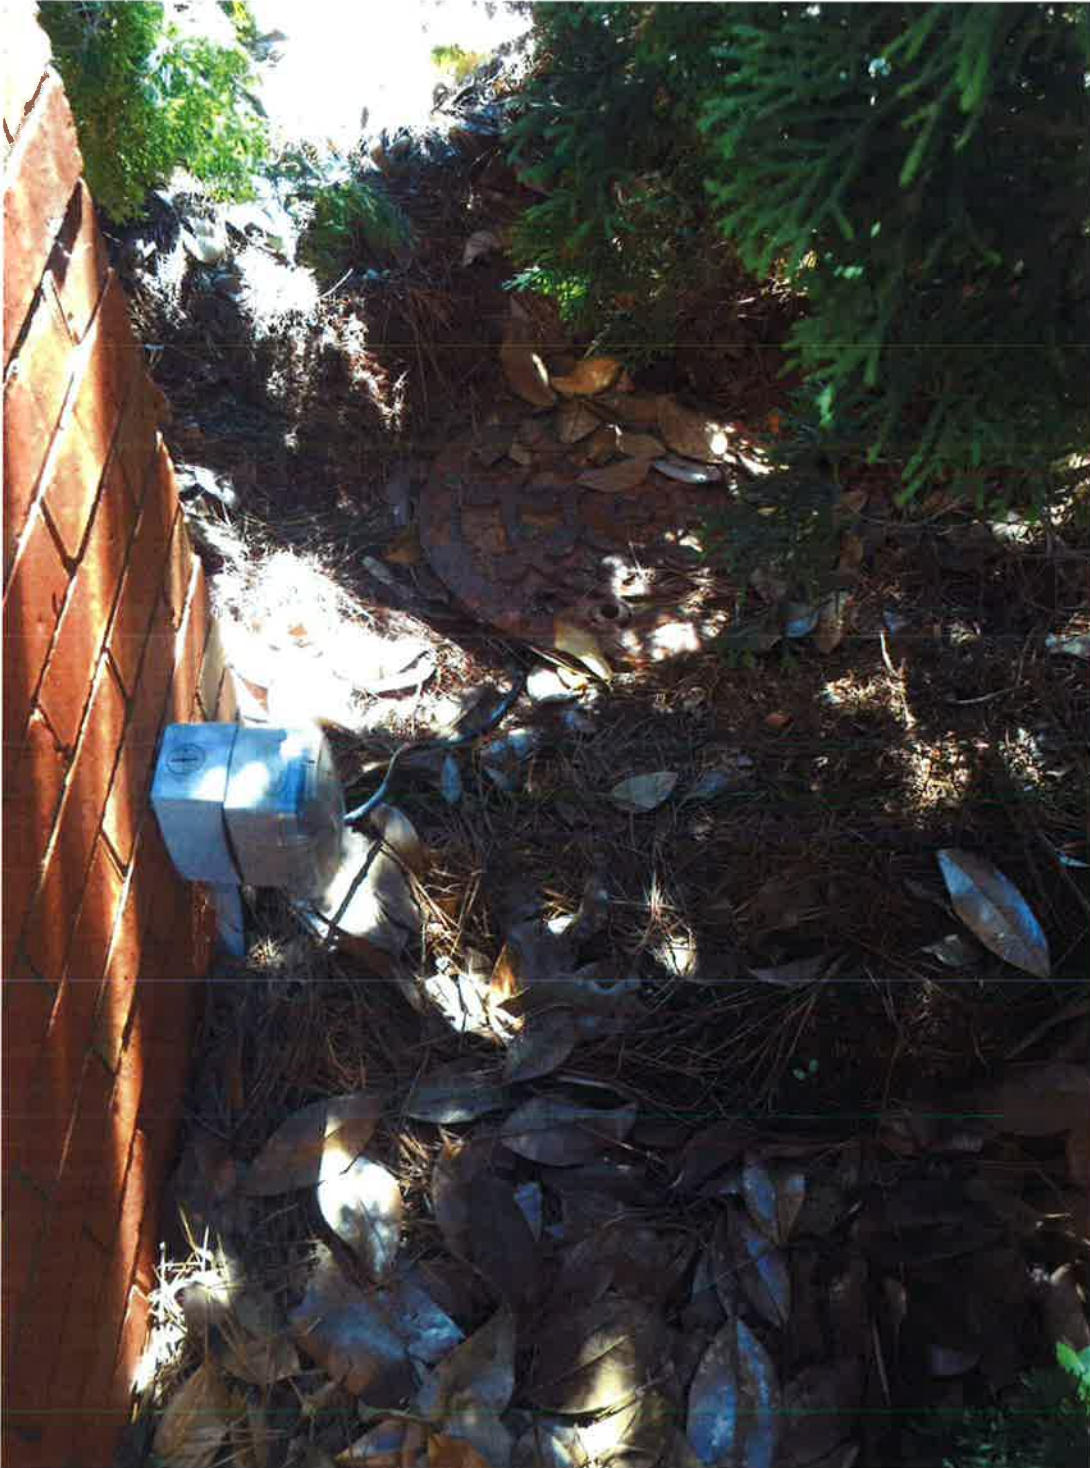
At the same time a sump pump was installed at the SW corner of the building. This pump is no longer functional. According to Union County Public Works staff, the sump pump limited water infiltration into the south basement for several years after it was installed, while it was functional.

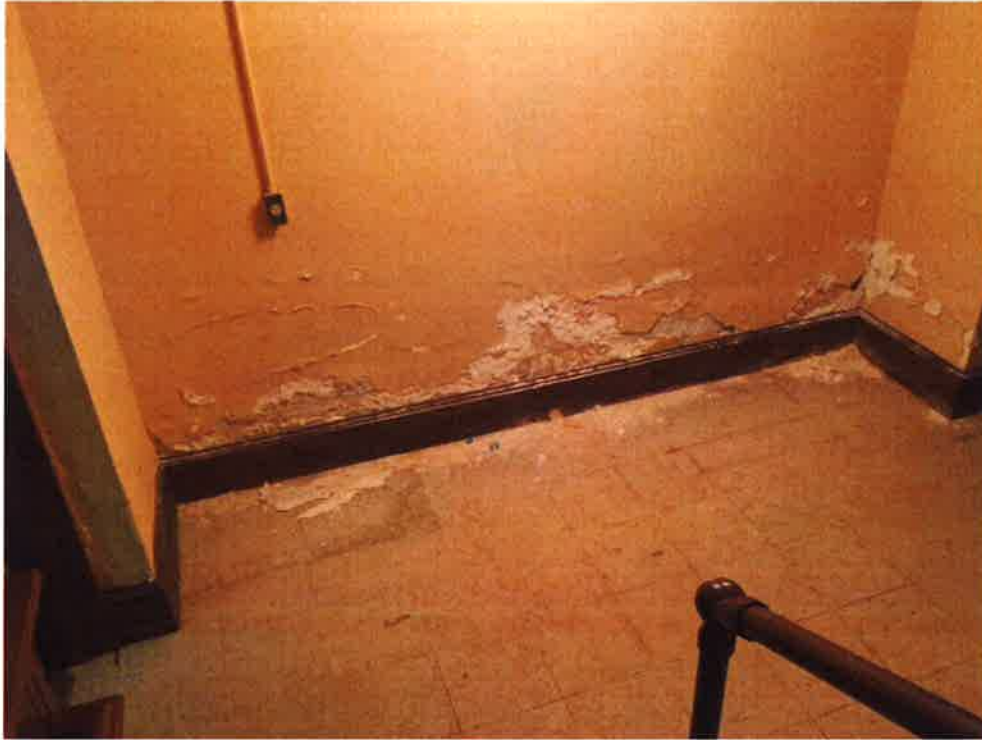
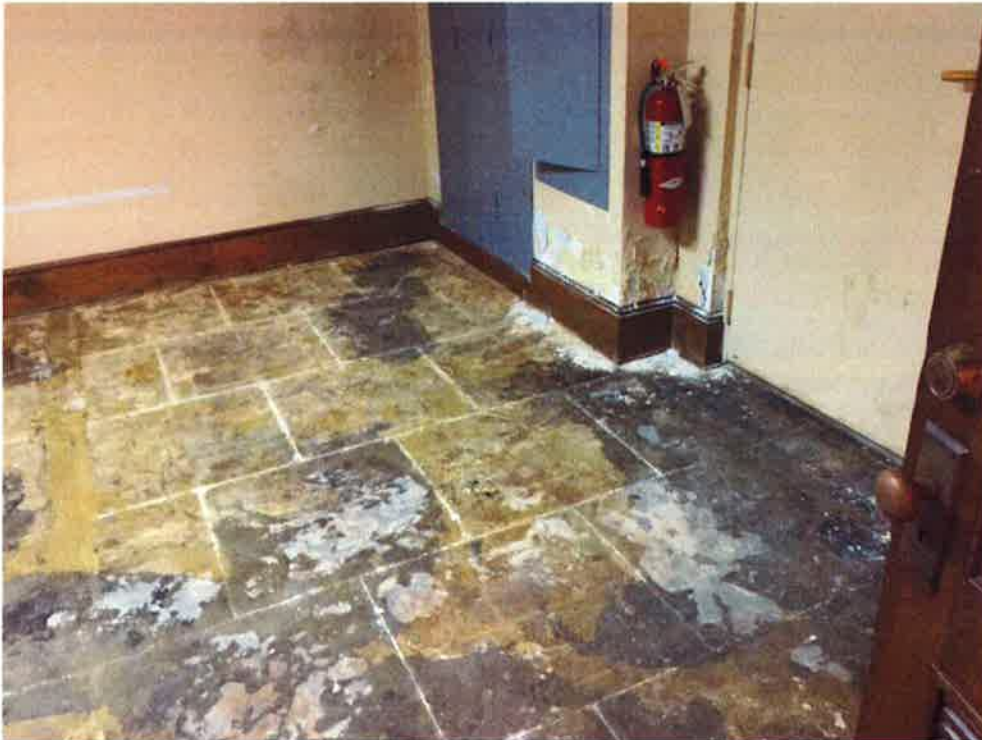
According to Union County Public Works staff, the basements of the 1926 wings flood during heavy rainfall events. Infrared photographs do not indicate the types of saturation conditions that would be expected if water intrusion was due to groundwater.
