HISTORIC UNION COUNTY COURTHOUSE

HISTORIC STRUCTURE REPORT & RELATED SERVICES
JANUARY 23, 2017

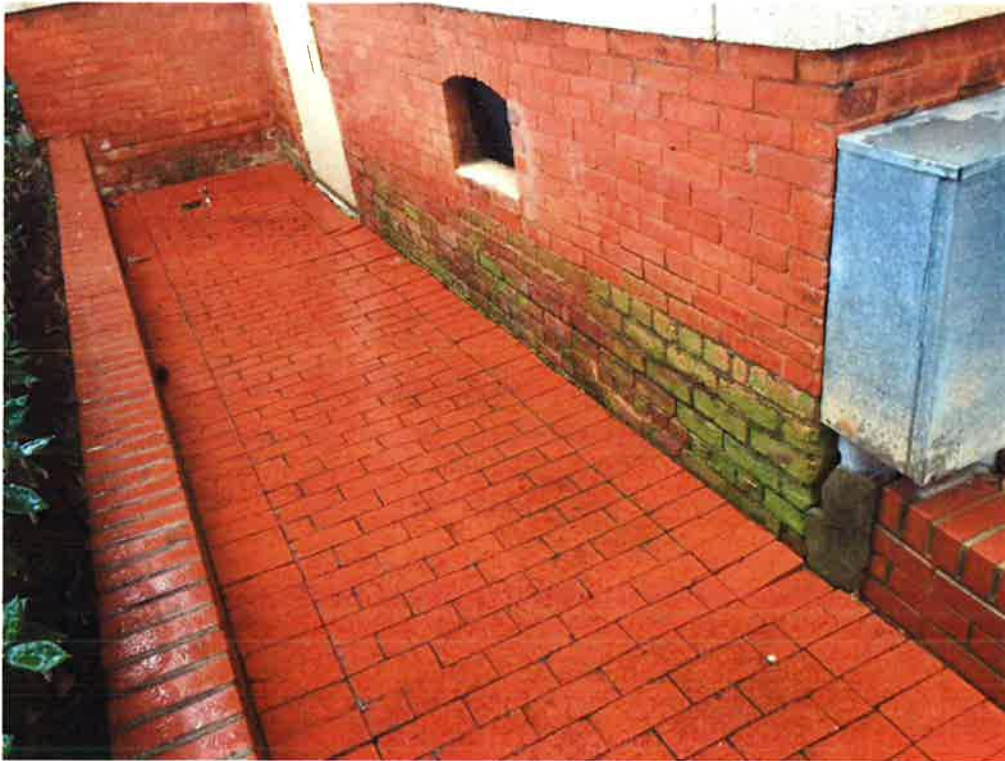
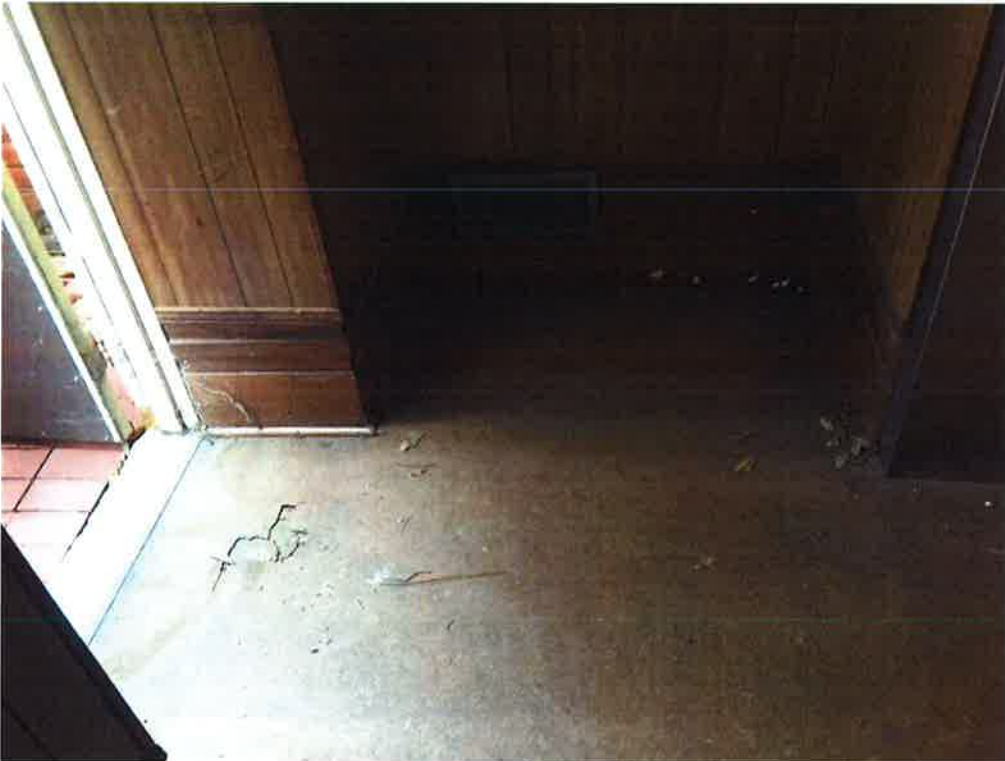
Water penetration at the handicap ramp into the elevator lobby appears to be due to a clogged drain at the base of the ramp.

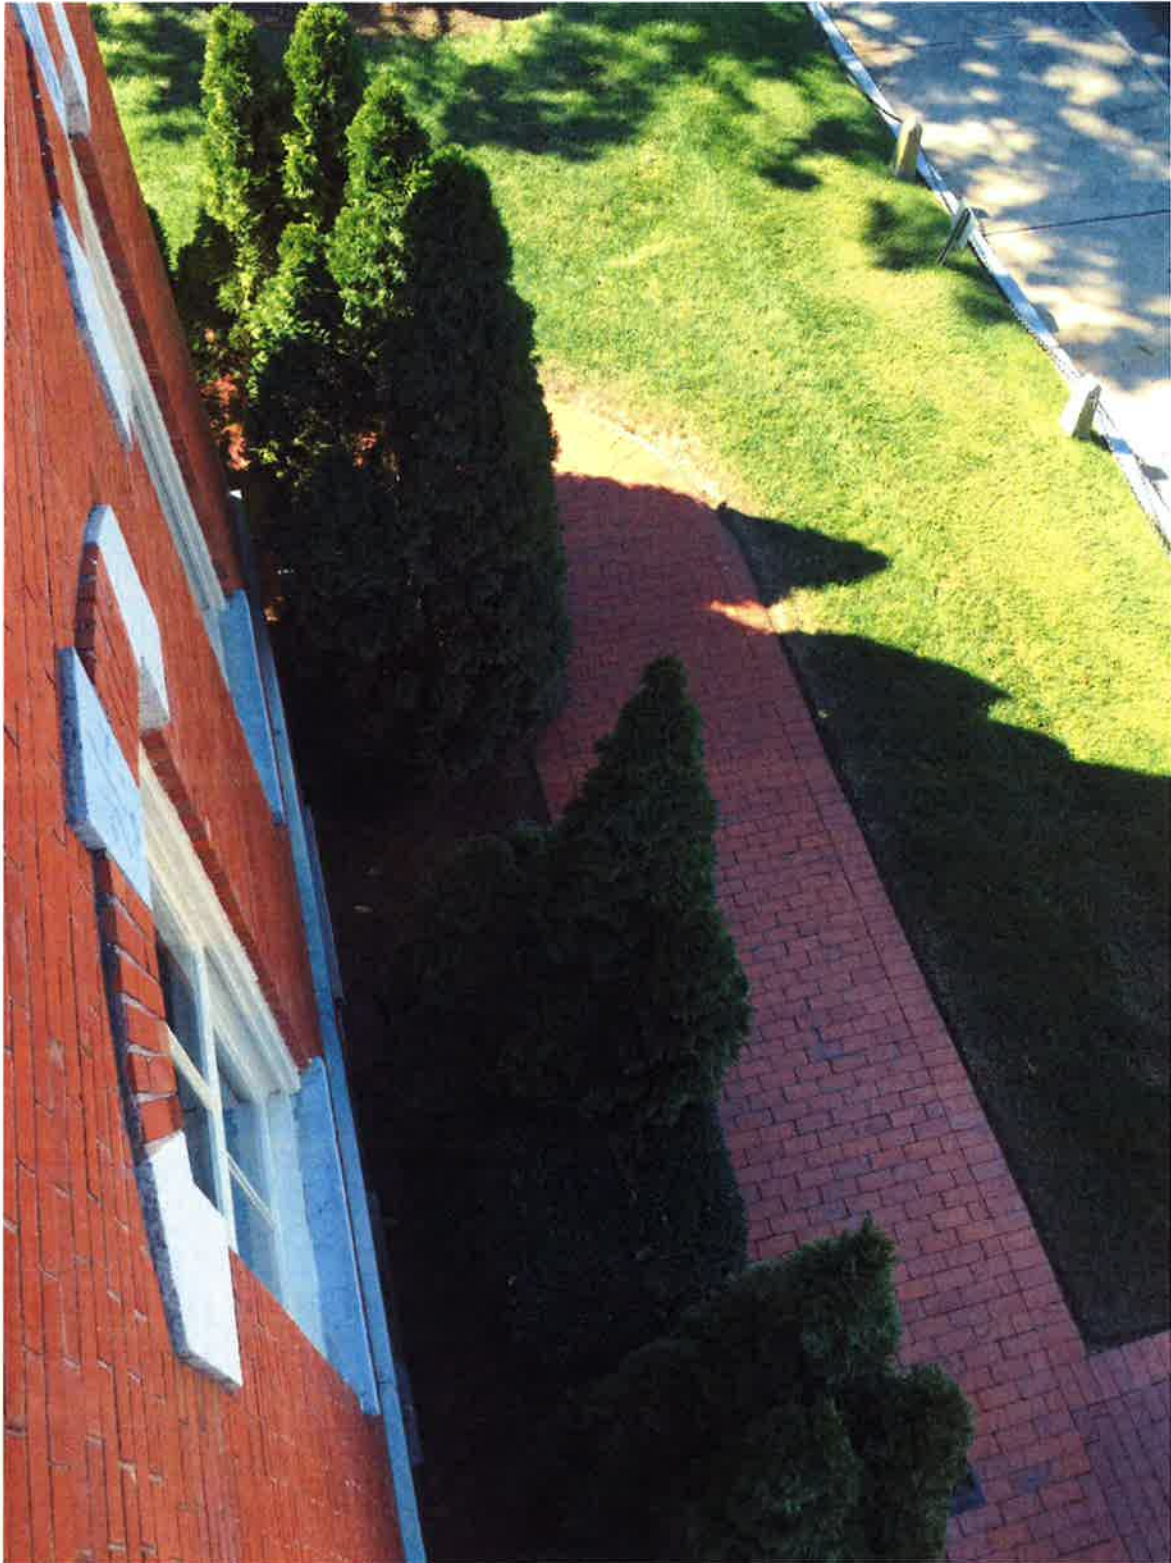
Large shrubs have been installed adjacent to the foundation of the building in all locations, excluding the four entrances.

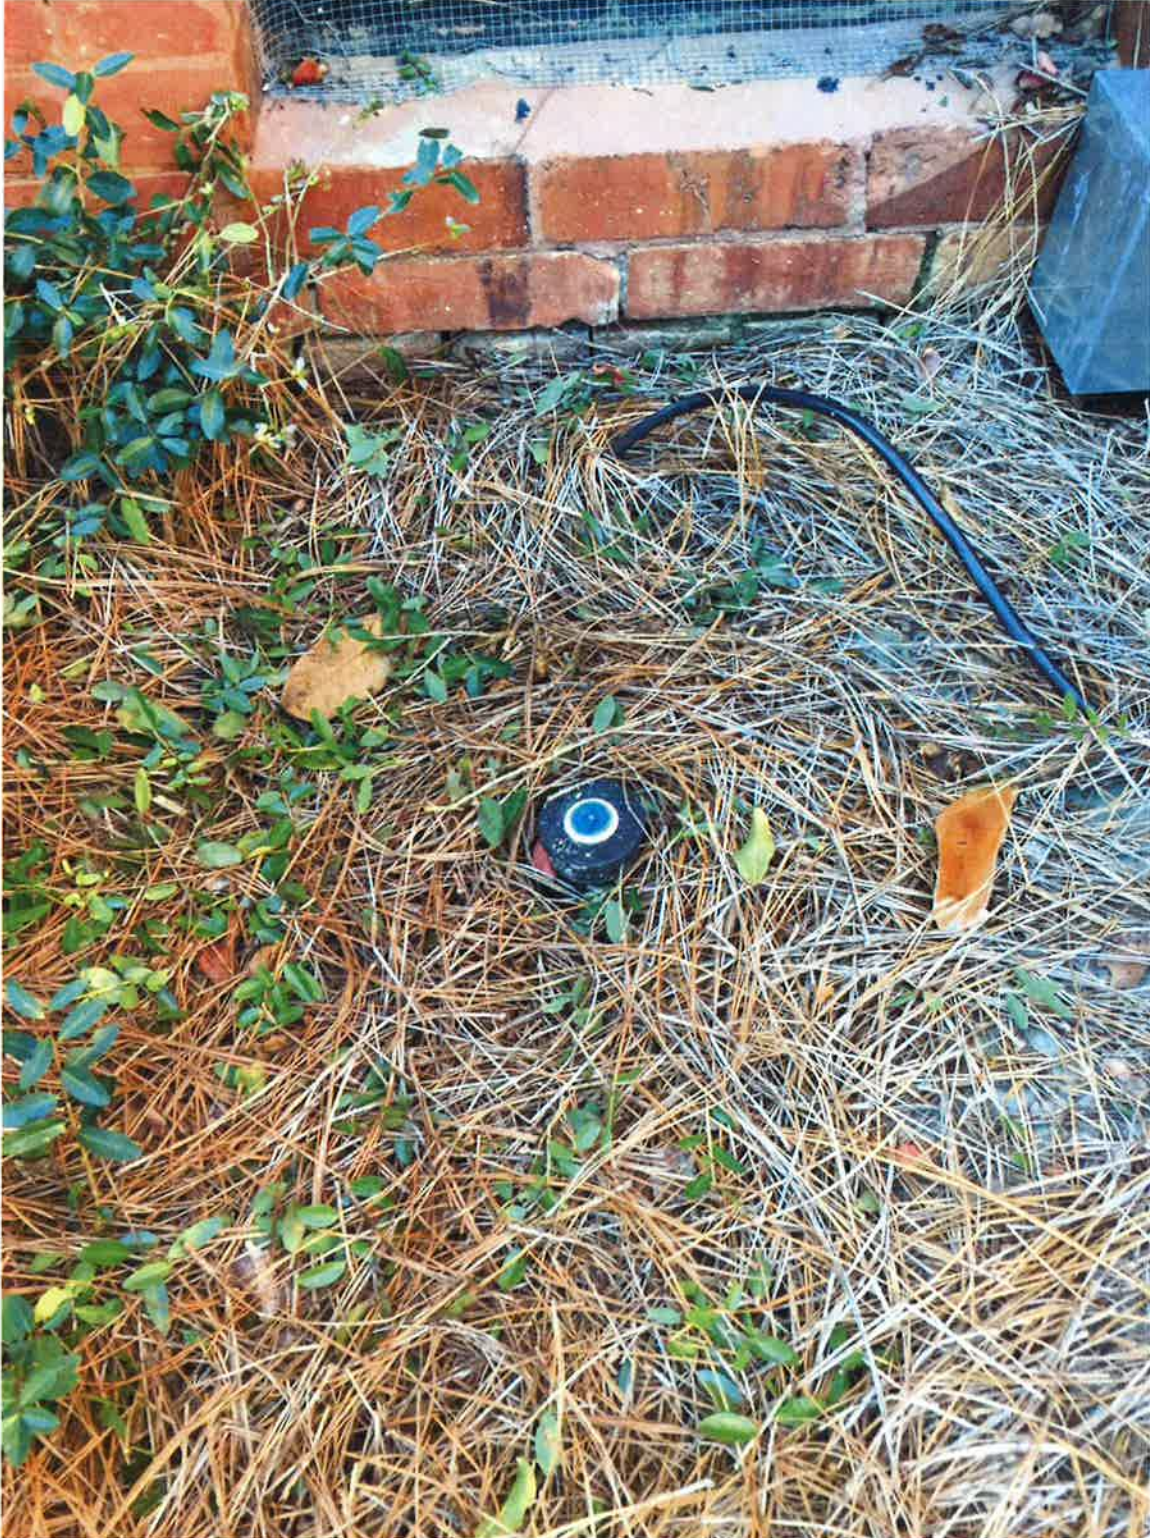
A sprinkler system has been installed to water the large shrubs. The sprinkler system is currently functional and used.

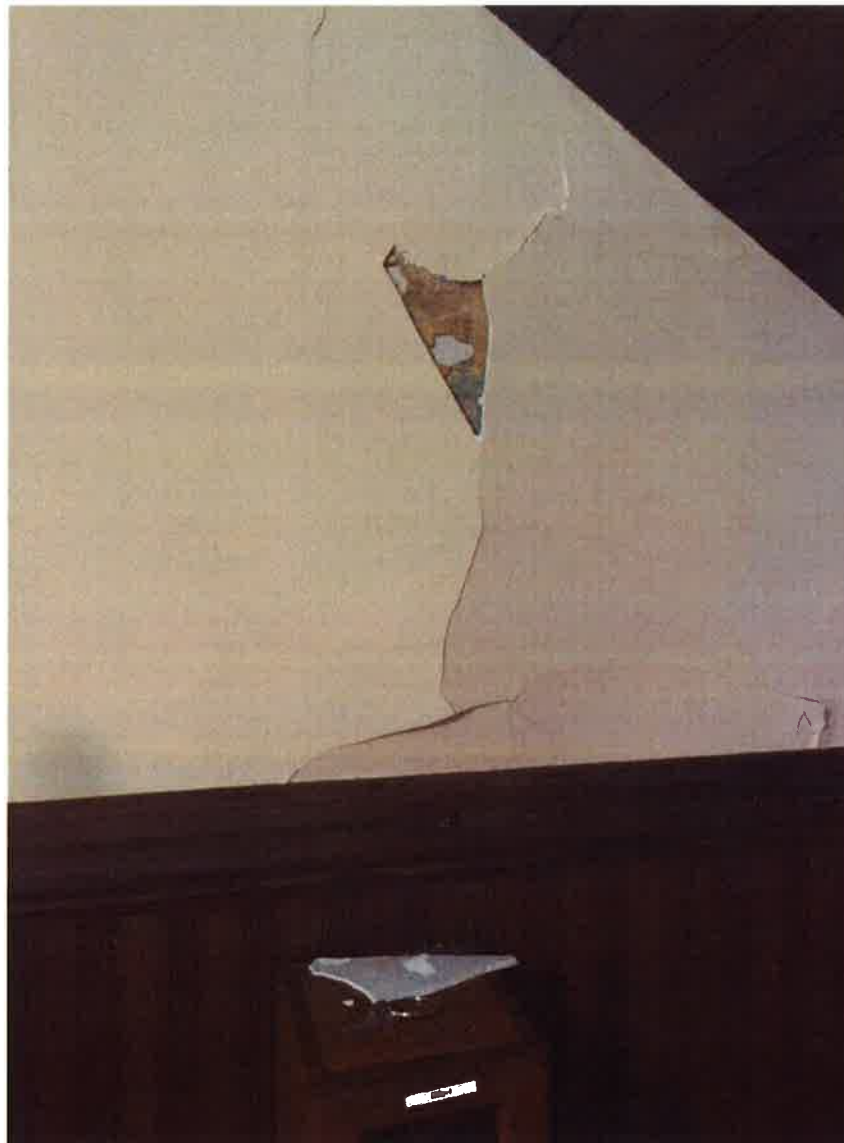
During the 1988 renovation, many of the plaster walls were “skim-coated” to cover areas of repair. This was a common technique at the time, but is no longer recommended. Over time, the thin layer of finish plaster fails, as seen in the above photo.

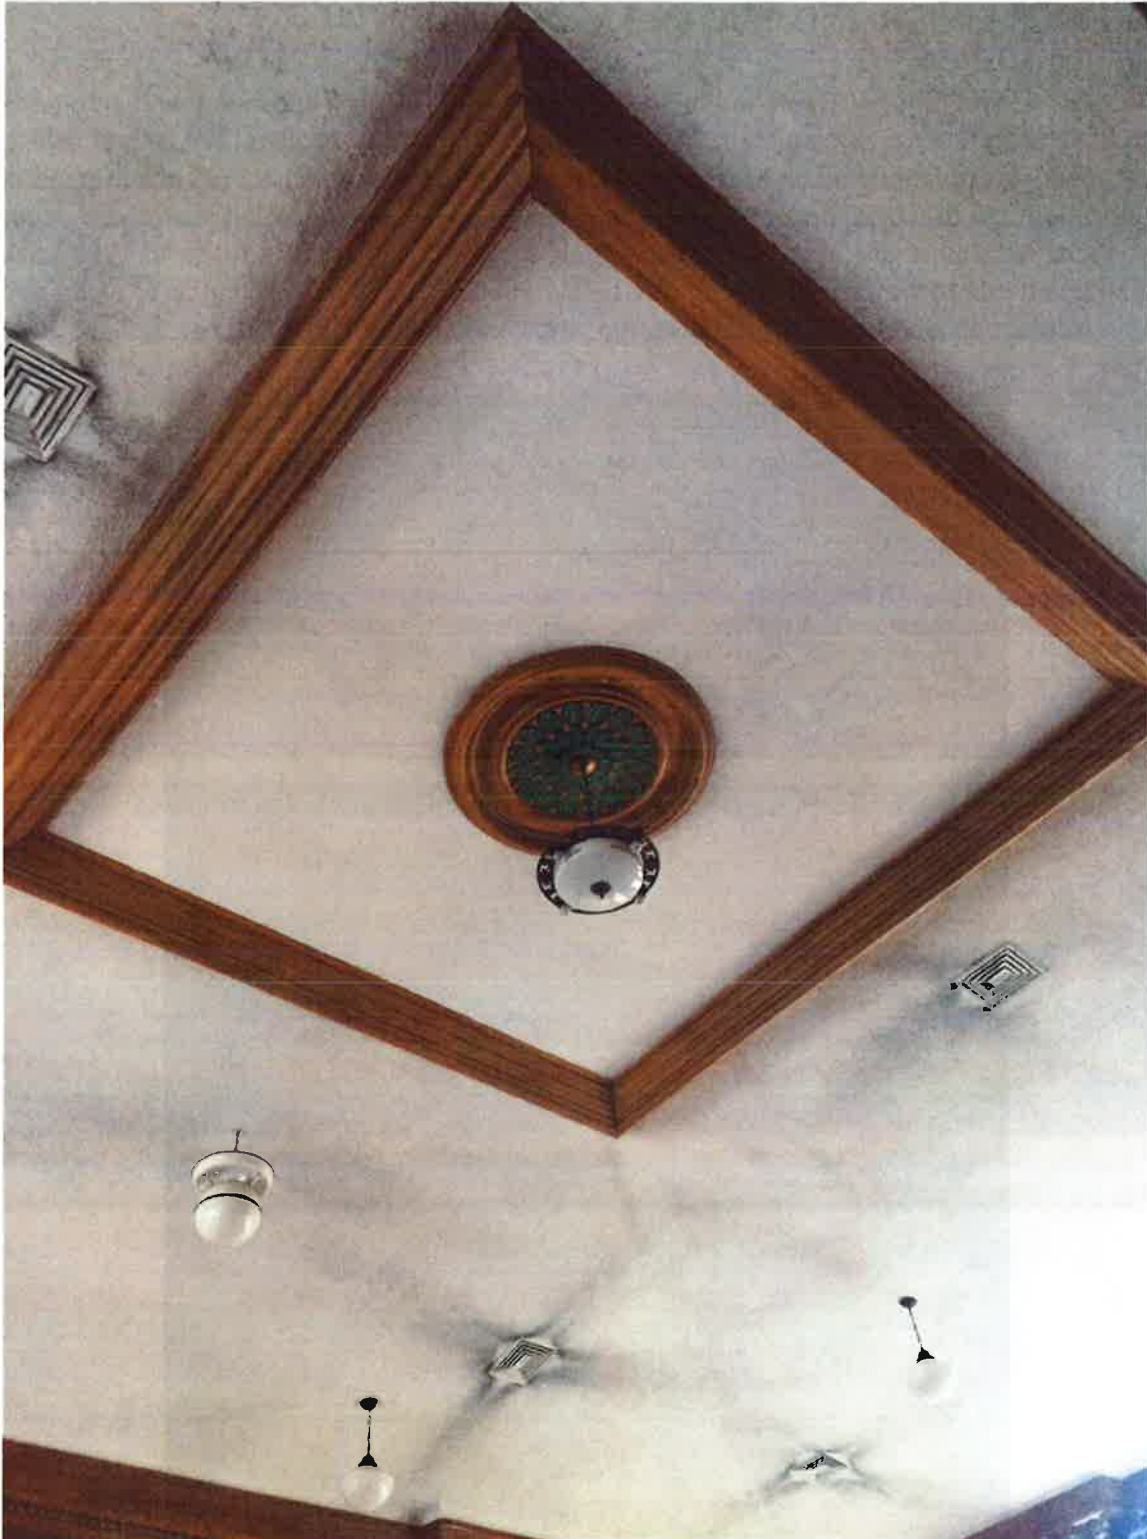
As part of the 1990 post-hurricane repairs, the 1928 flat plaster ceiling was replaced with a textured "popcorn" finish. This finish is historically inappropriate and has not aged well. There is unsightly staining at the air registers located throughout the ceiling.

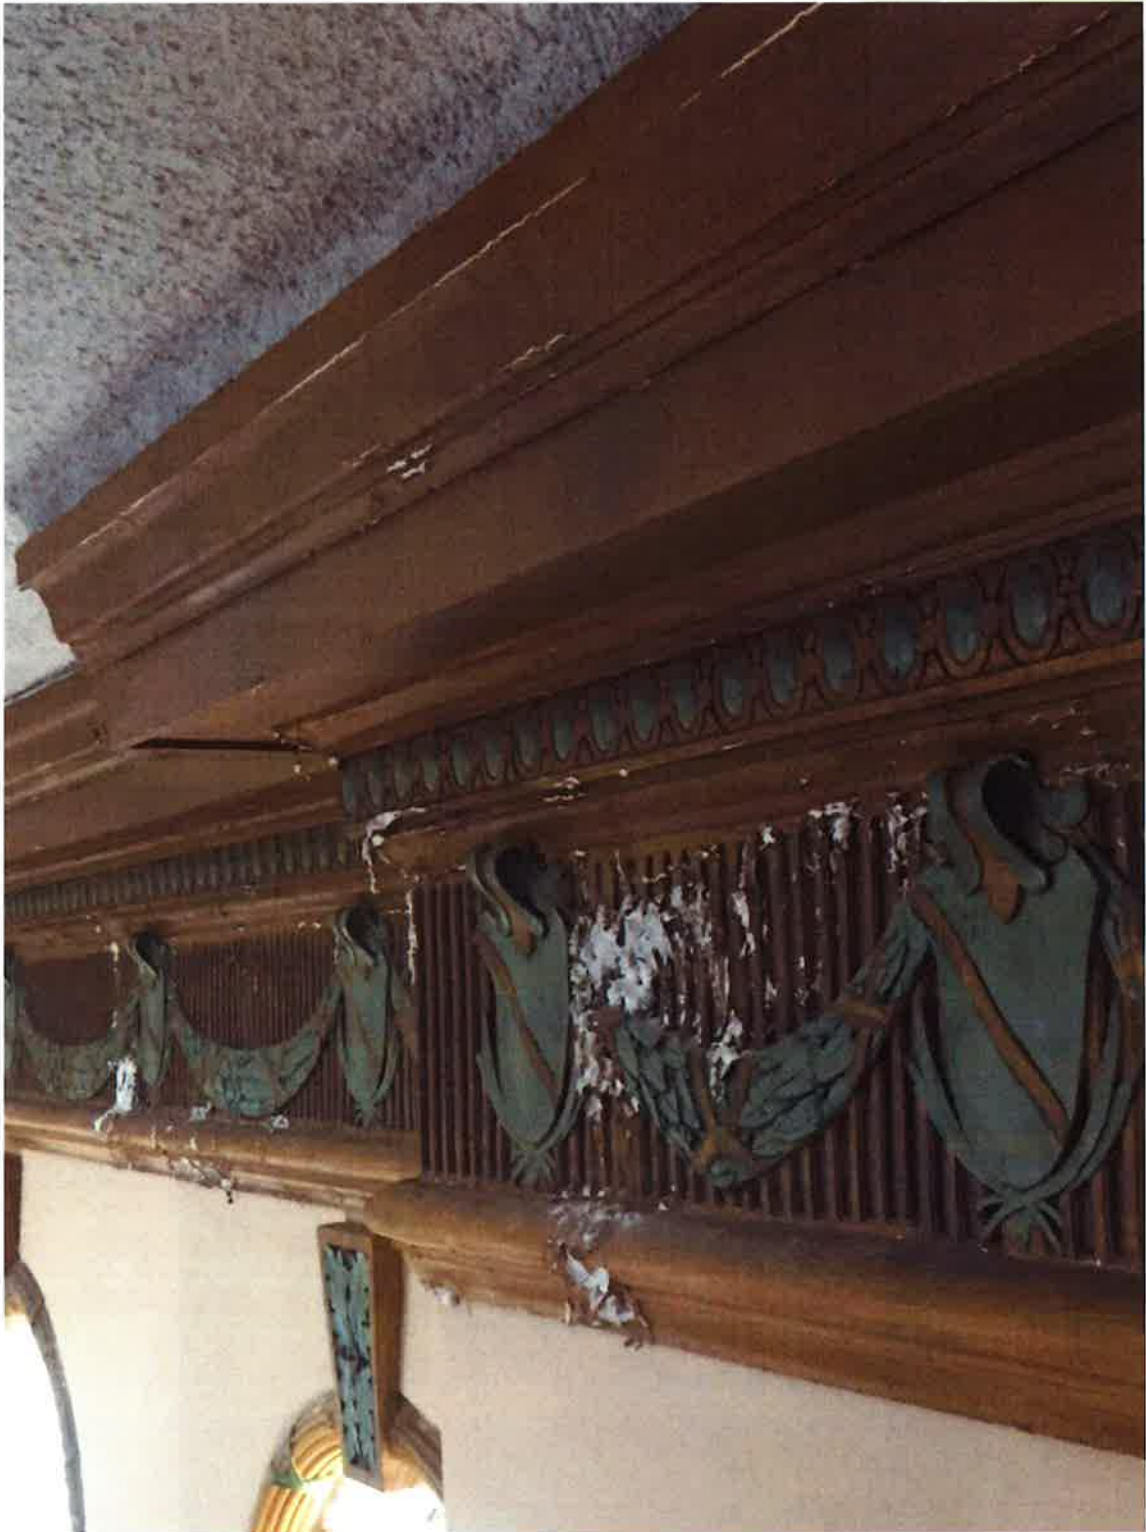
In 1990, the 1928 lime plaster frieze was replaced with fiber-reinforced gypsum plaster. Some of the formwork and unused pieces remain in the attic (see following photos). Due to water infiltration at the slate roof and gutters, the gypsum plaster frieze is failing.

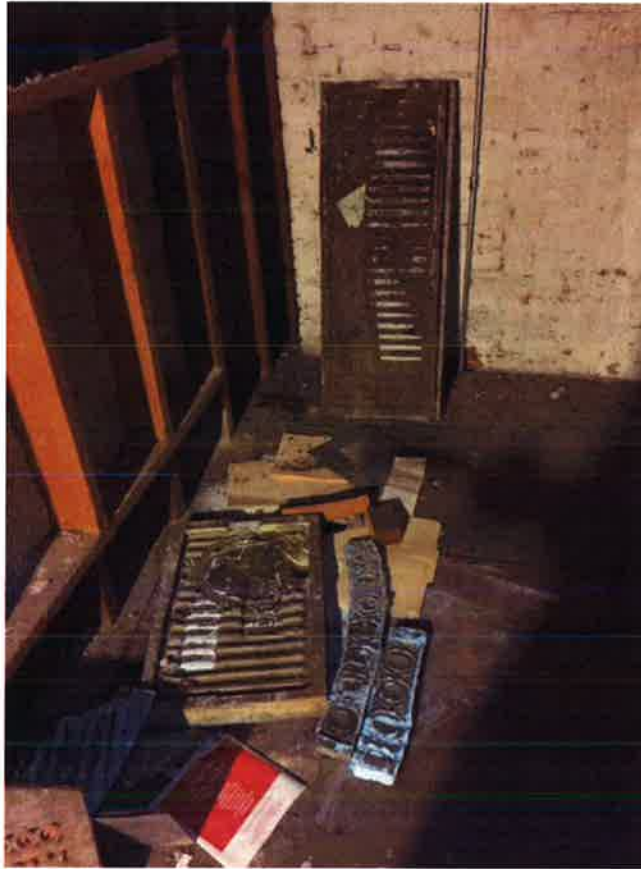
Foam formwork for 1990s plaster frieze.

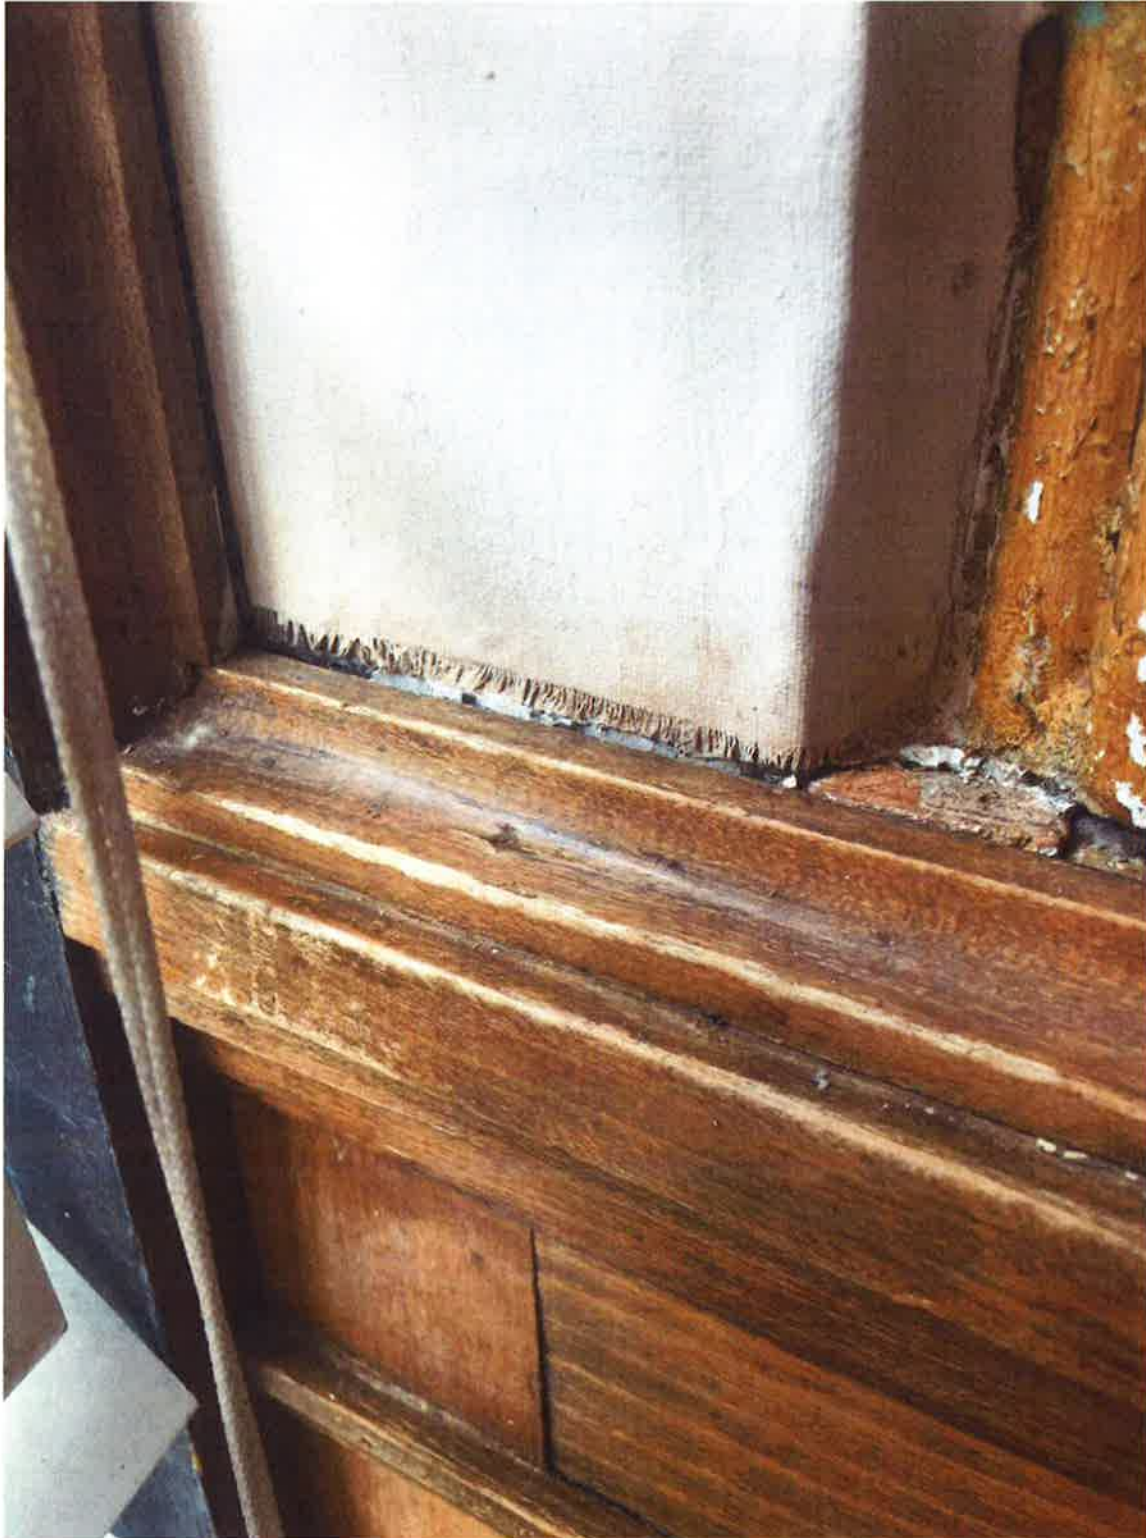
During the 1886 renovation, fabric was applied to areas of the courtroom walls to cover damage and cracking. This is no longer recommended. In addition to limiting the breathability of the walls, it alters the aesthetics of the wall surface and corners.

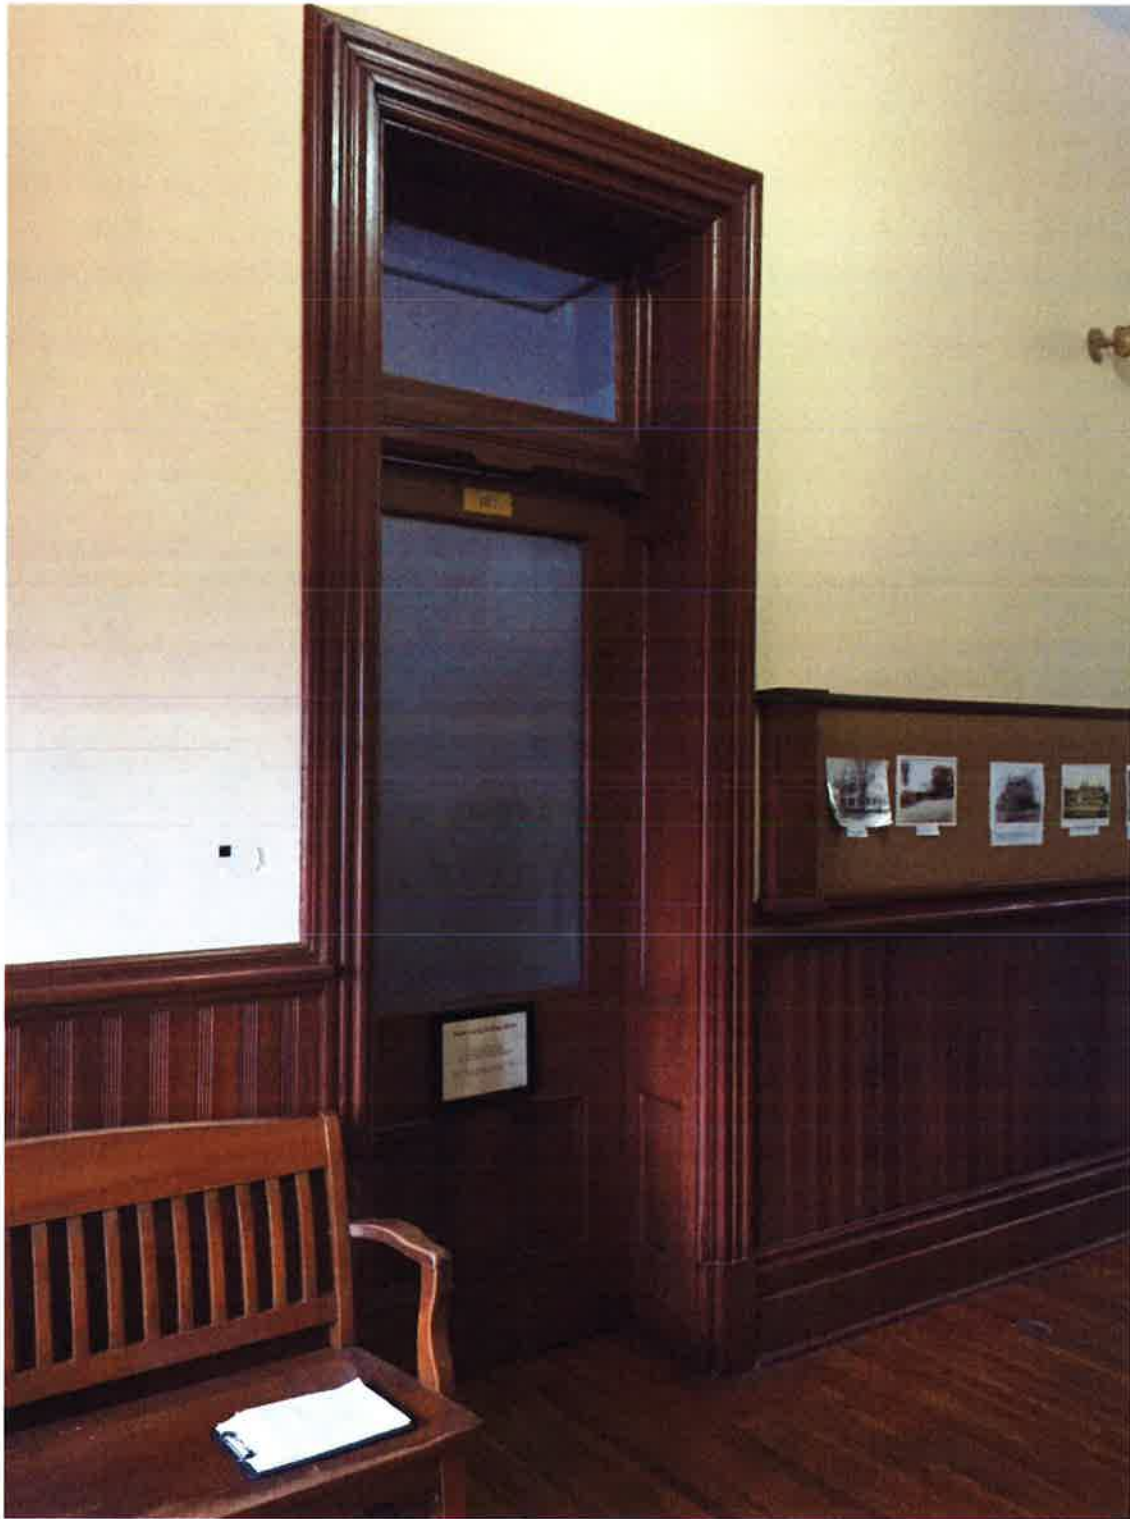
Most, if not all of the 1888 and 1928 woodwork in the building was repaired and refinished during the 1988 renovation.

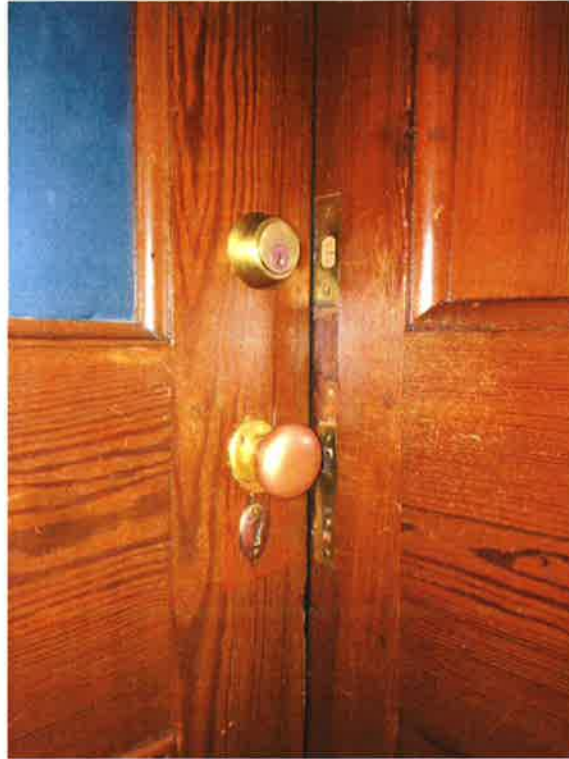
Hardware changes and use over the last 28 years have taken their toll on the doors and door surrounds.

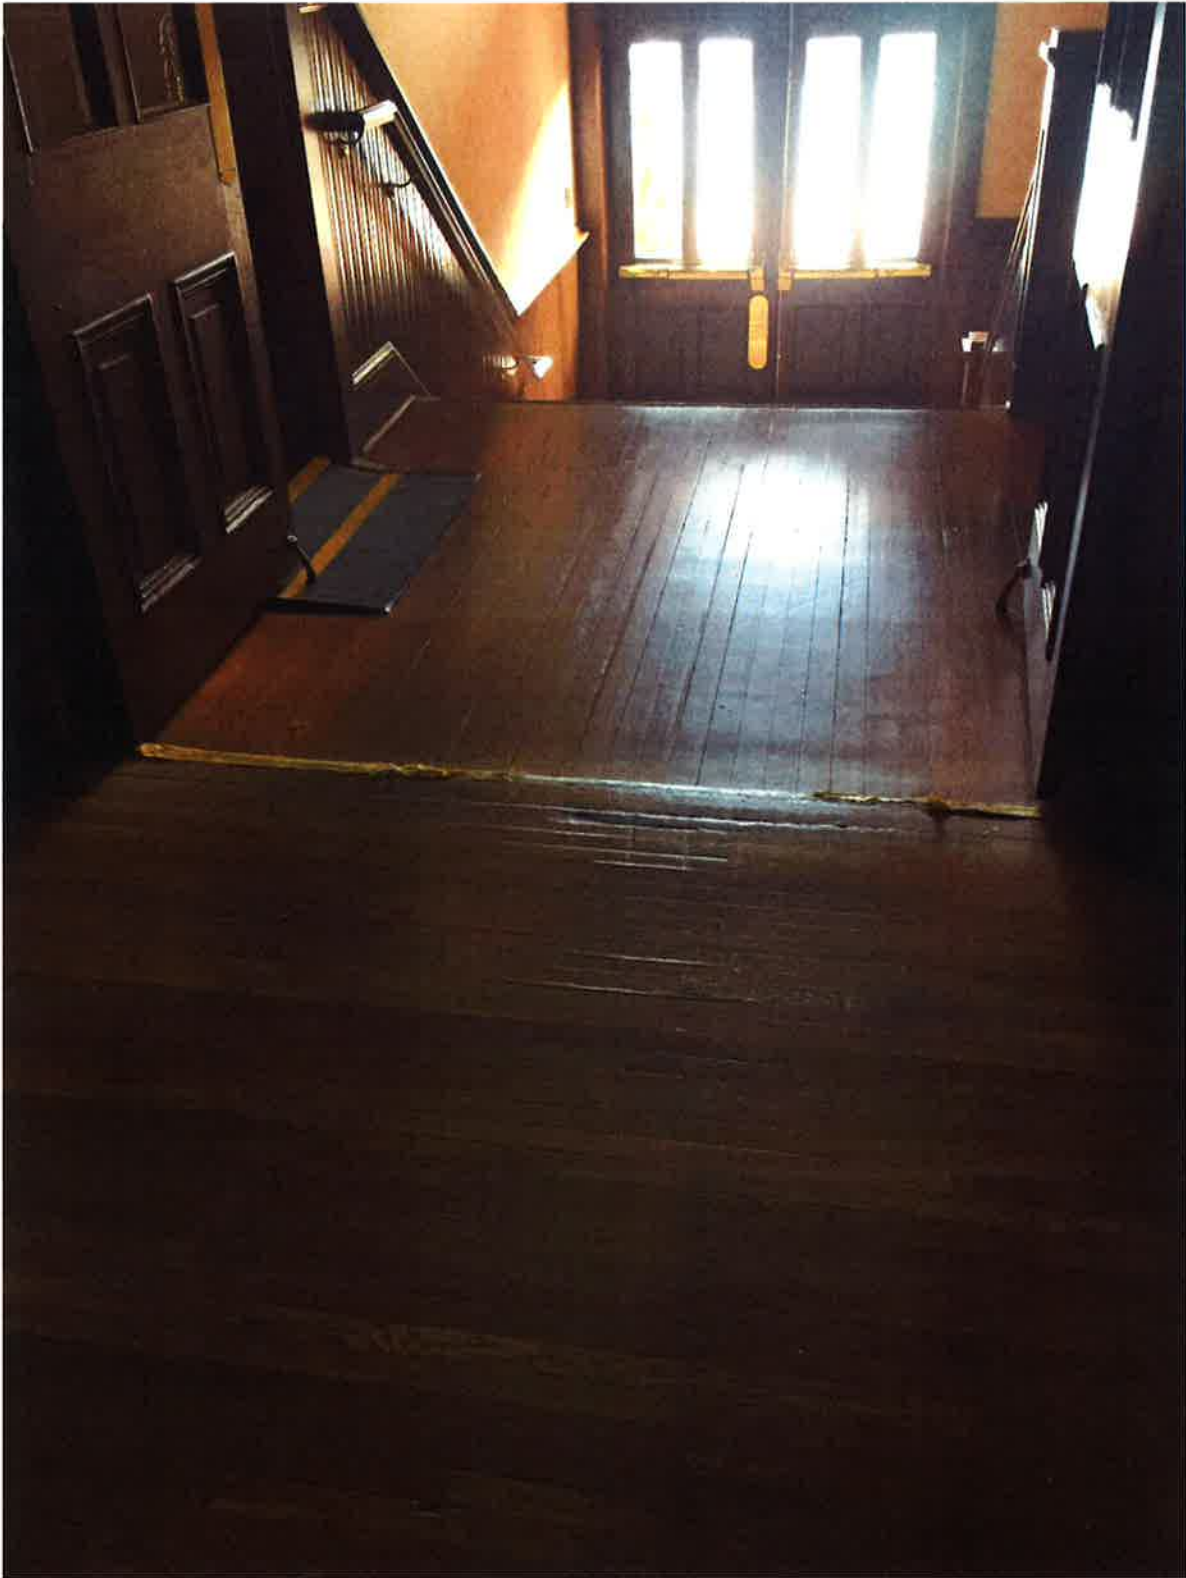
In high traffic areas, such as the south stair hall and exit, the 1928 flooring is showing wear.

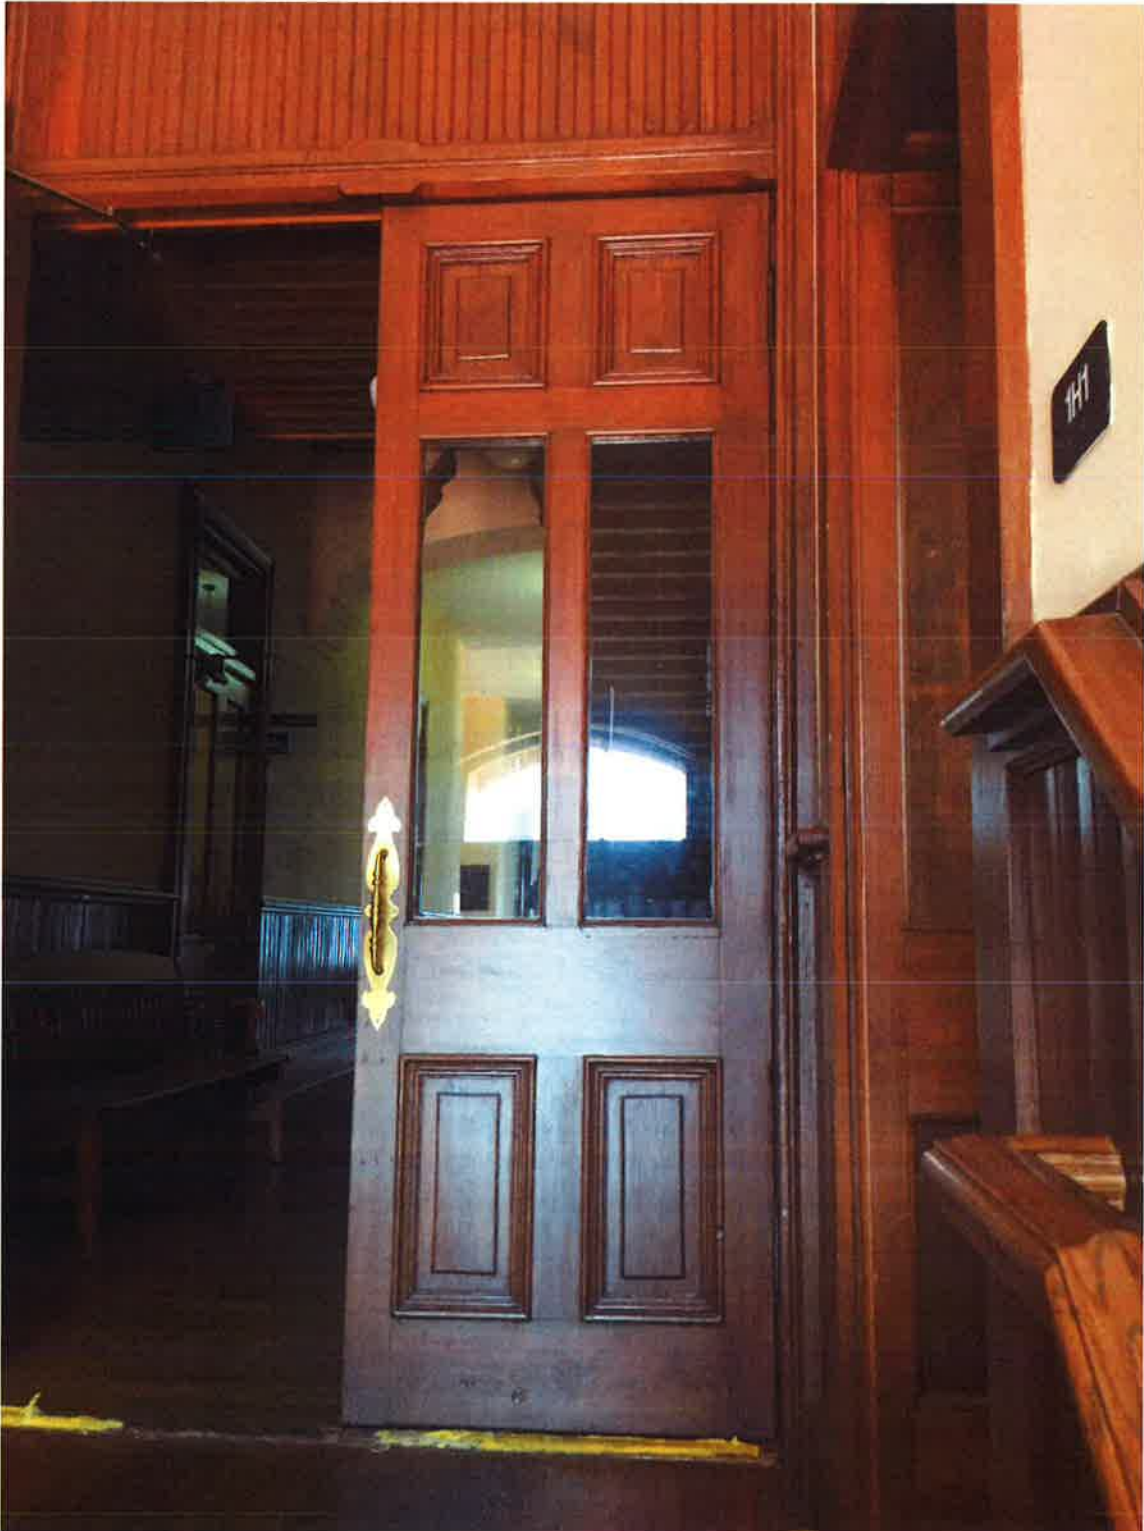
During the 1928 renovation, the original north and south exterior doors were repurposed as interior doors. The center raised panels were removed and replaced with glass to allow additional light into the north and south stair halls. The door hardware dates to the 1988 renovation.

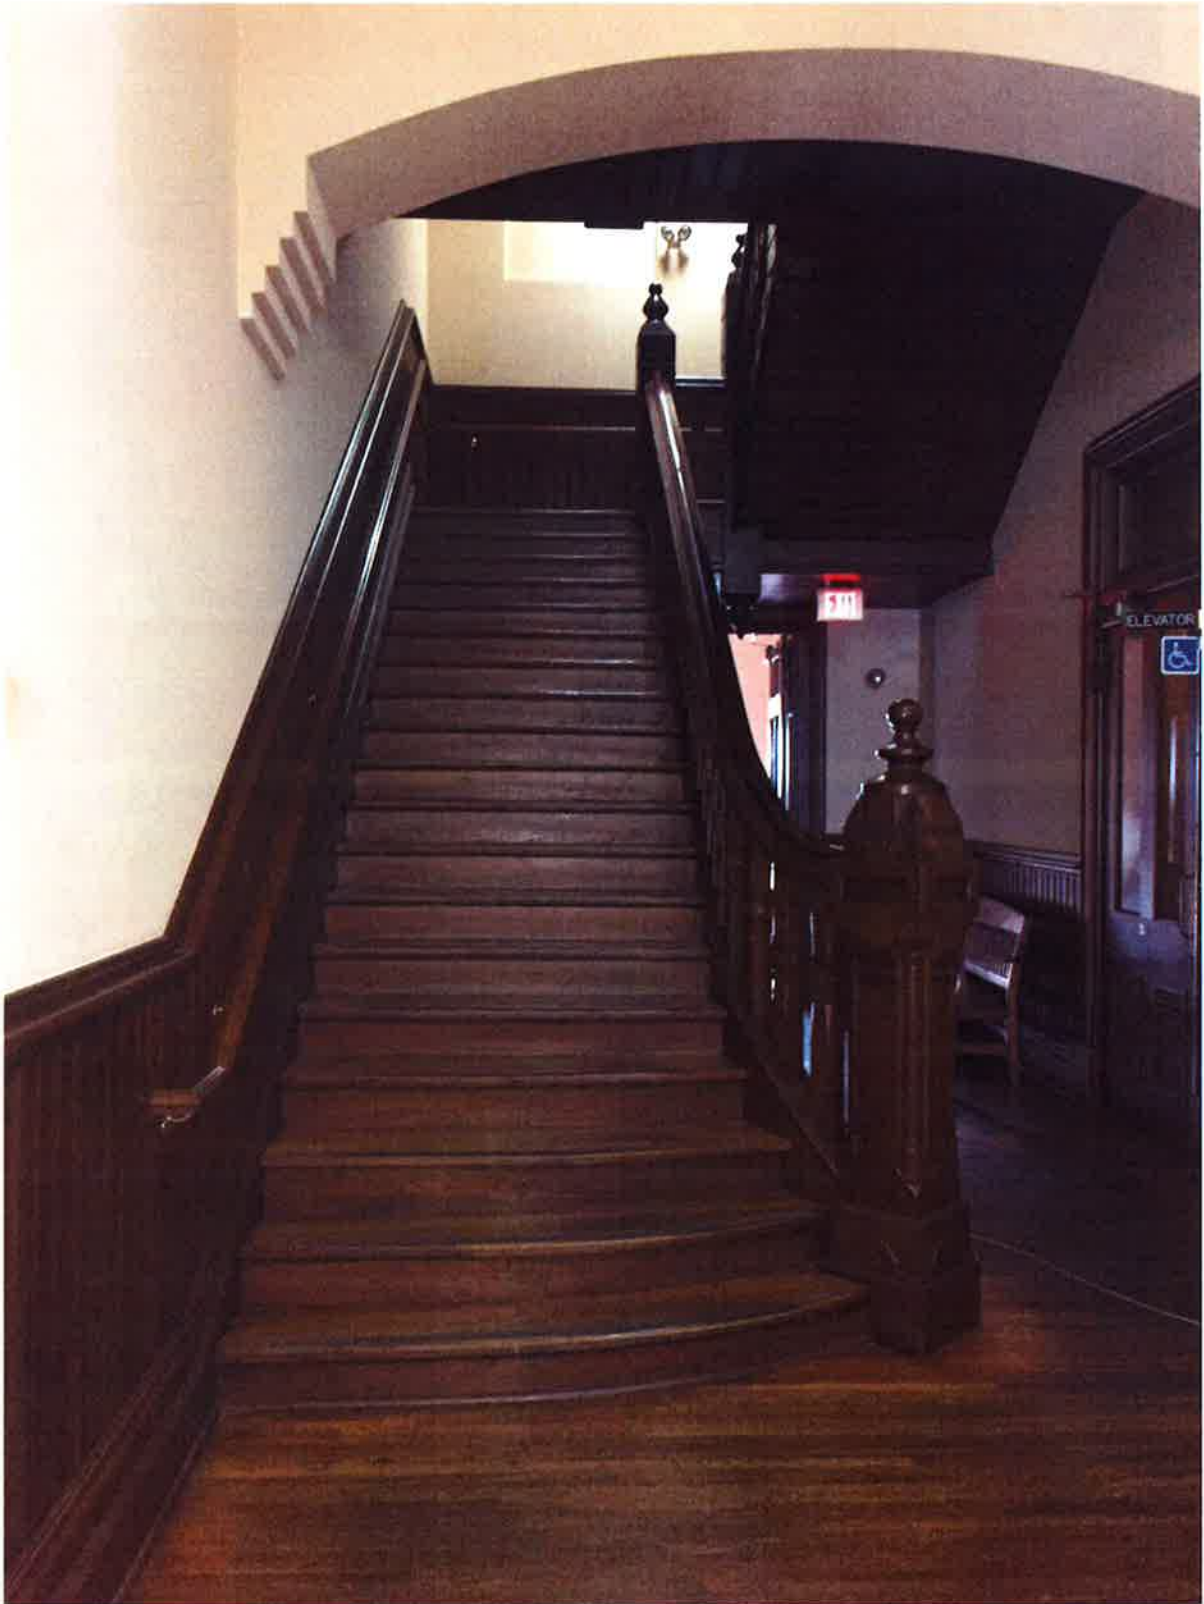
The stair stringers, treads and risers were replaced in 1928.

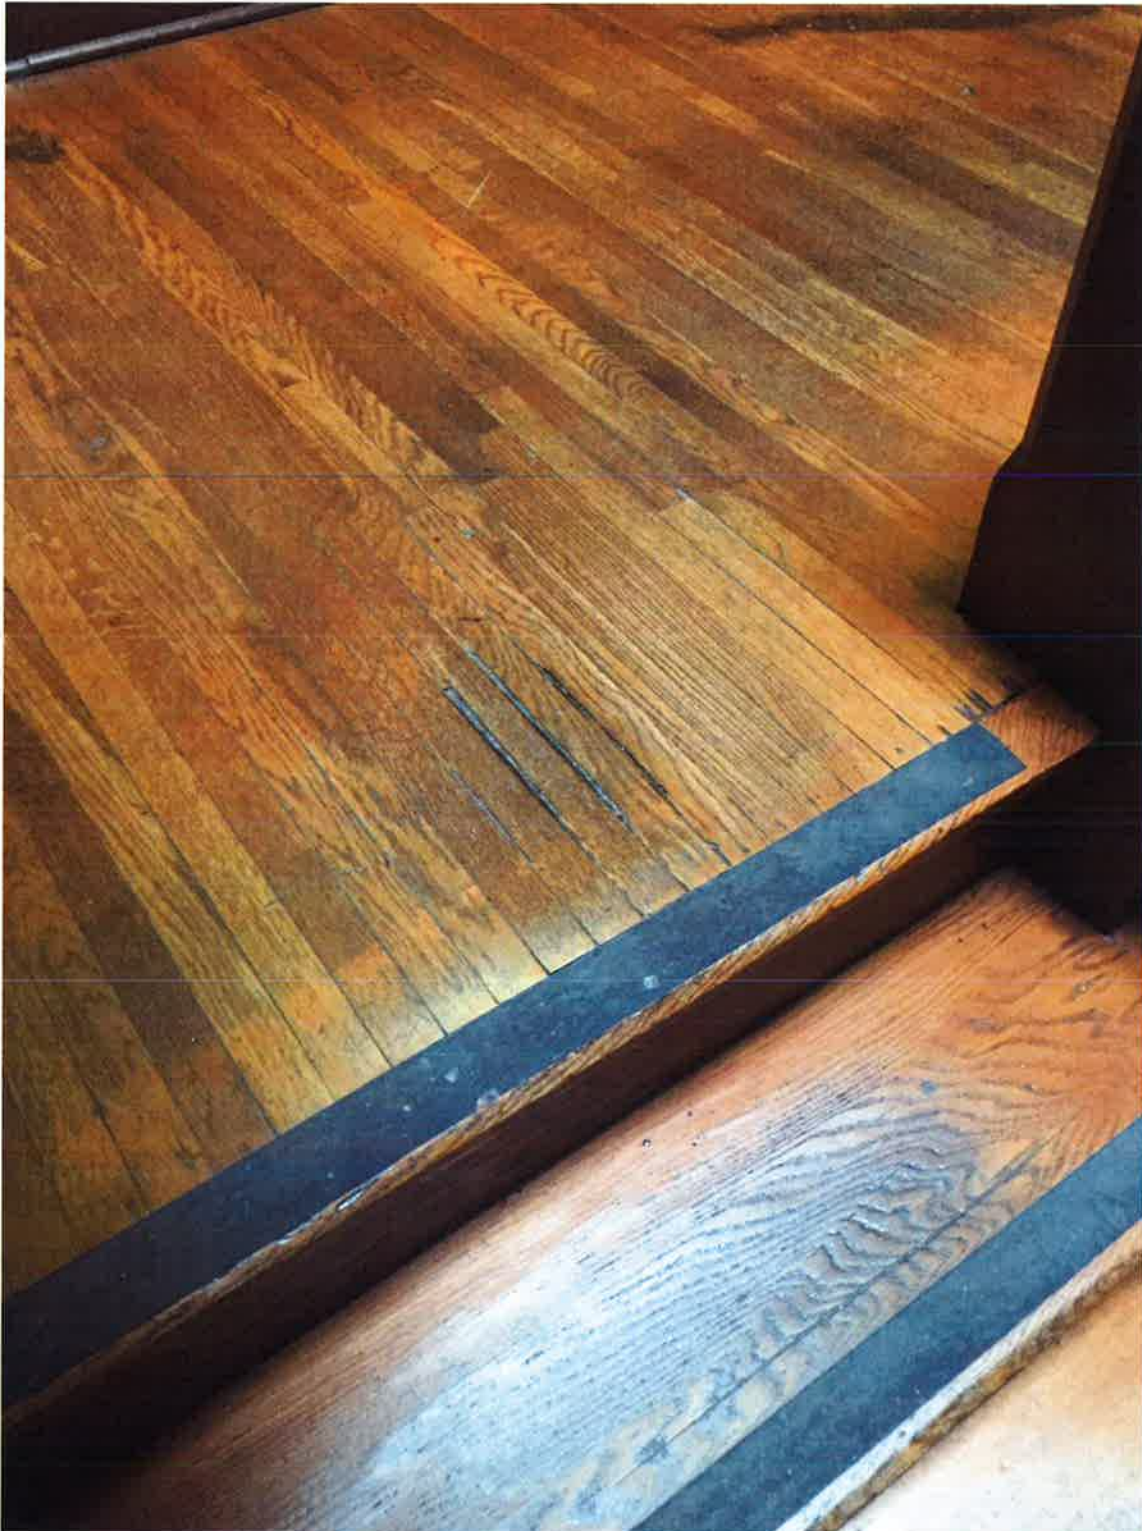
The stair treads are experiencing some wallowing due to use. The landing flooring, like the flooring at the main level halls, is worn to the point of damage. As the tongue-and-groove floor boards wear down, the top section of the grooved edge weakens and breaks away.
