HISTORIC UNION COUNTY COURTHOUSE

HISTORIC STRUCTURE REPORT & RELATED SERVICES
JANUARY 23, 2017

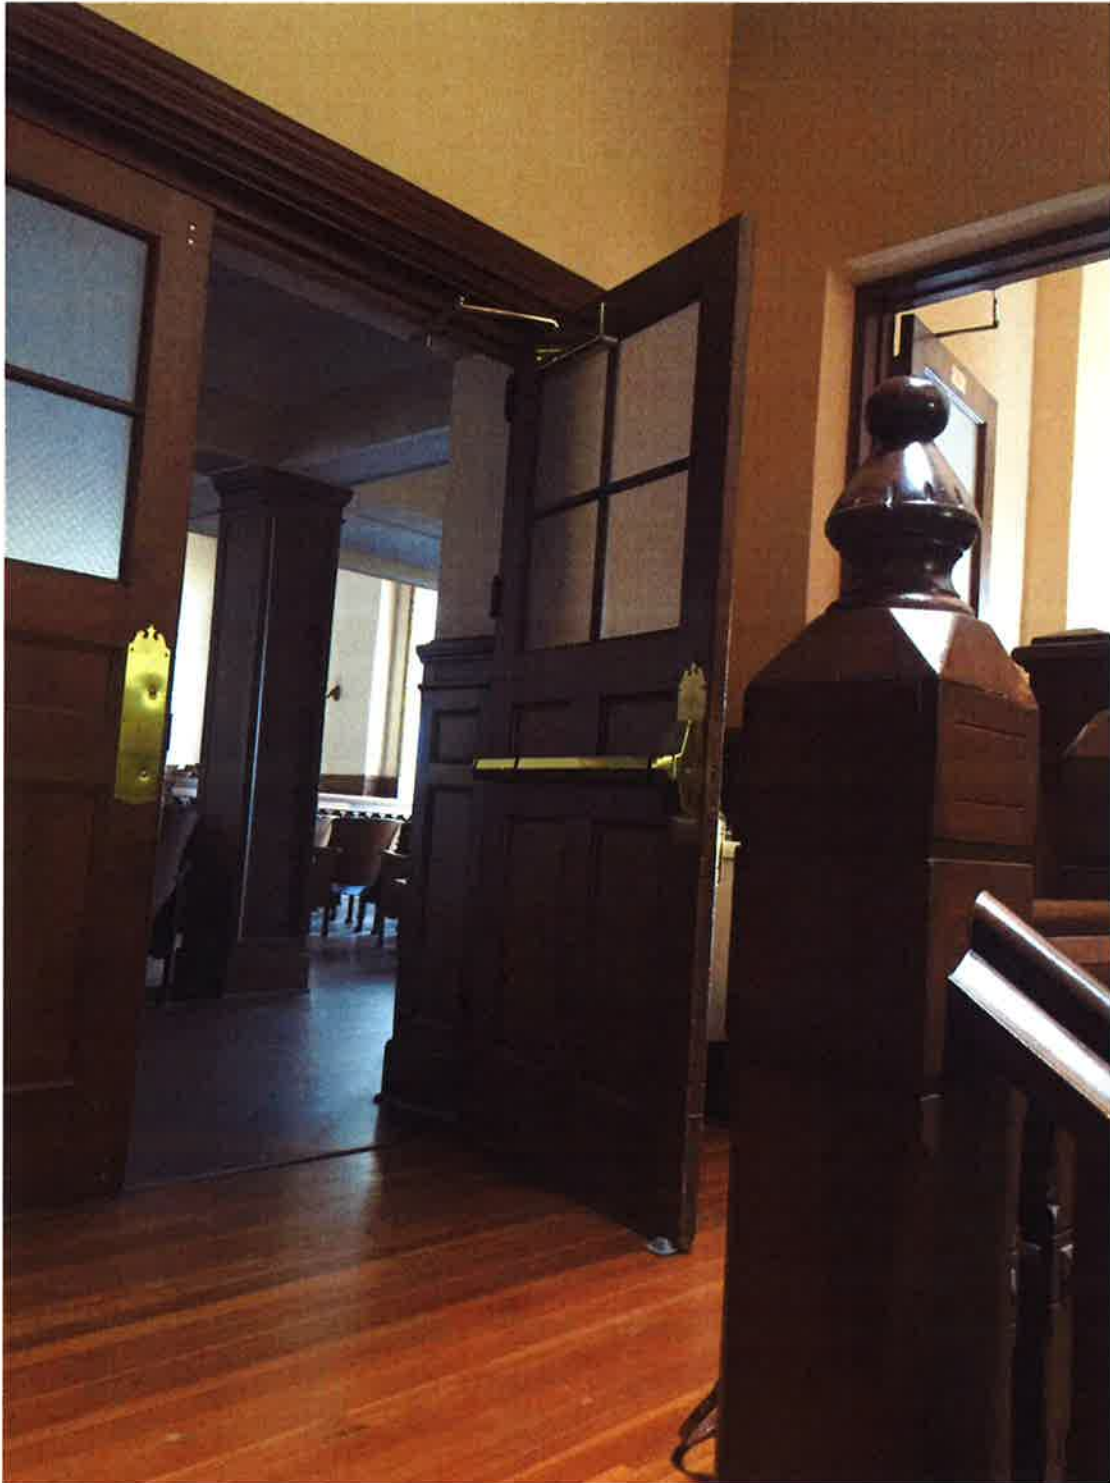
In 1928, the two original upper panels of the courtroom doors were removed and replaced with four panes of wire glass. This allowed light from the skylight (also added in 1928) to filter into the area below the balcony. Originally, exterior windows lit the north and south stairwells. In 1888, both stairwells were used for public access to the courtroom.

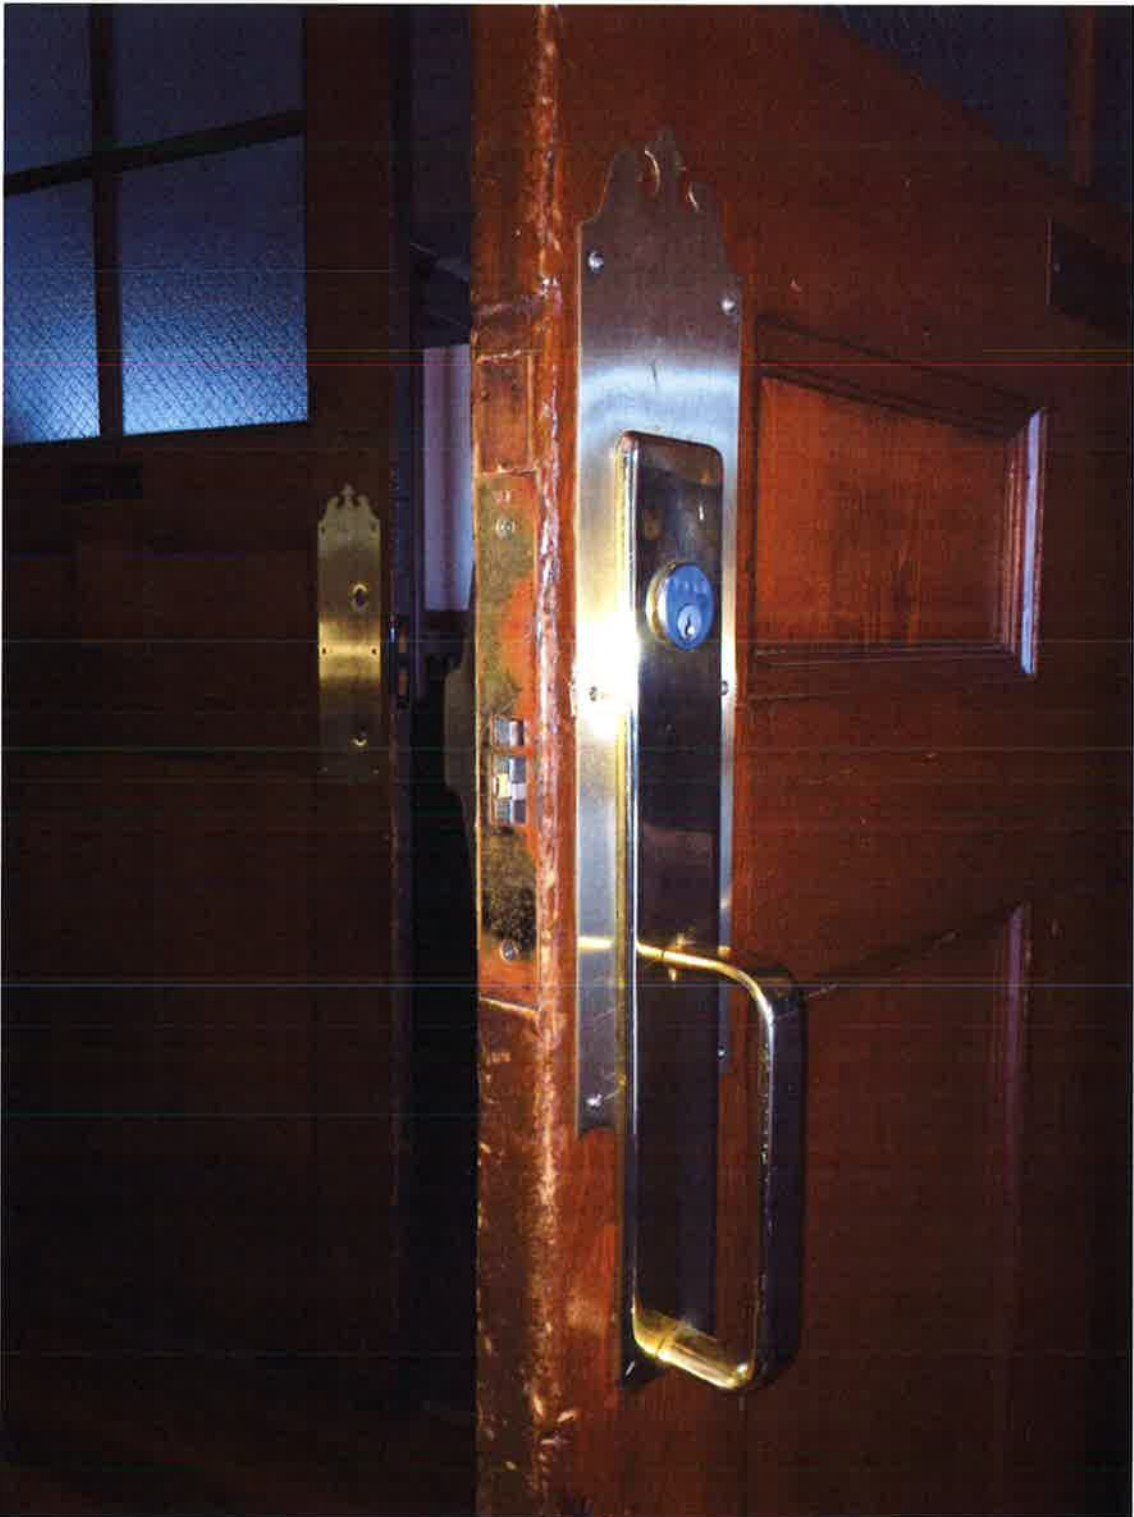
The hardware on the courtroom doors dates to three periods. The hinges are from 1928. The back plates date from 1988 and would have originally had decorative pulls, like the doors downstairs. The deadbolt and current pull have been installed since 1988.

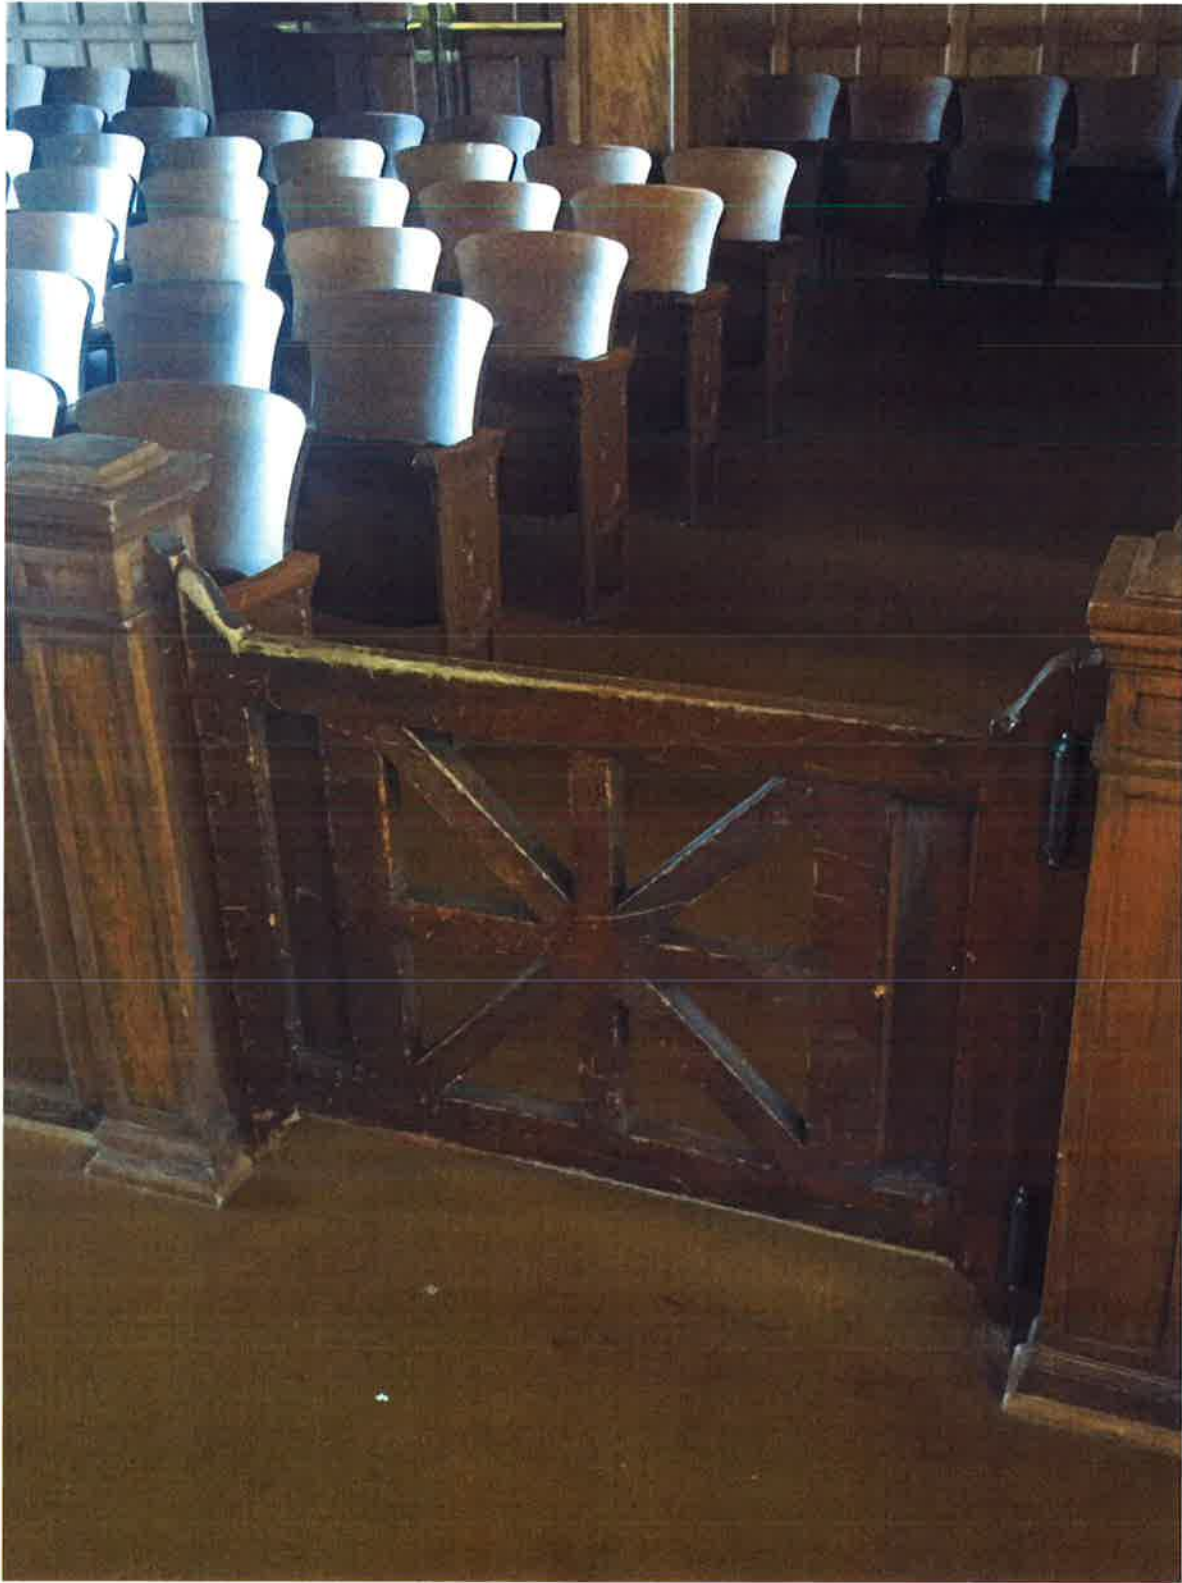
The finish on the top rail of the gates at the courtroom bar is worn away from use.

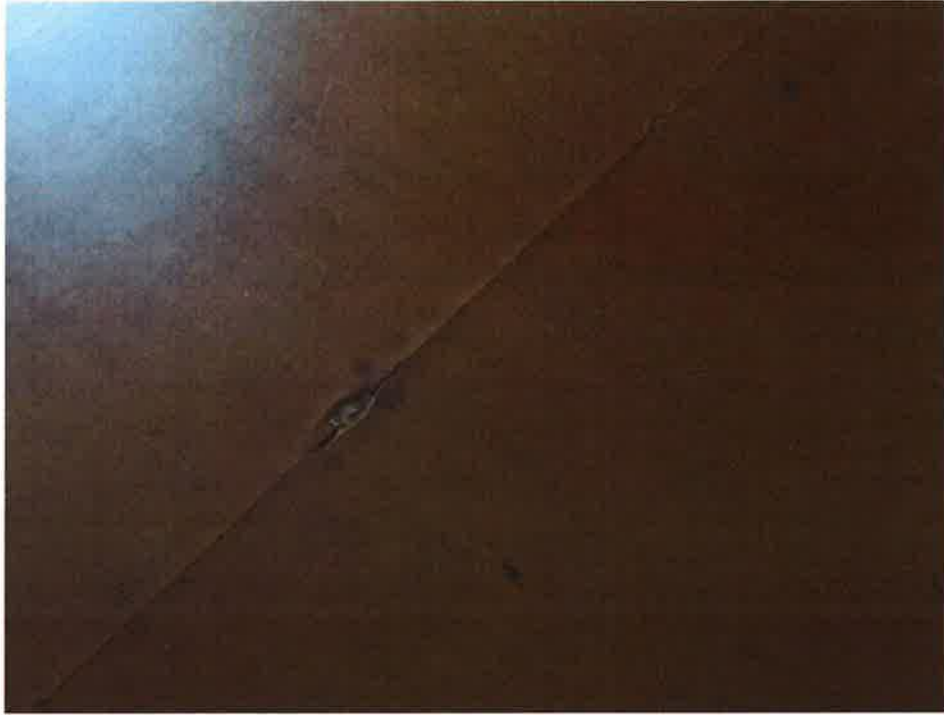
The sheet linoleum flooring in the courtroom, replaced in 1988, is curling slightly at the edges and breaking away in some locations.

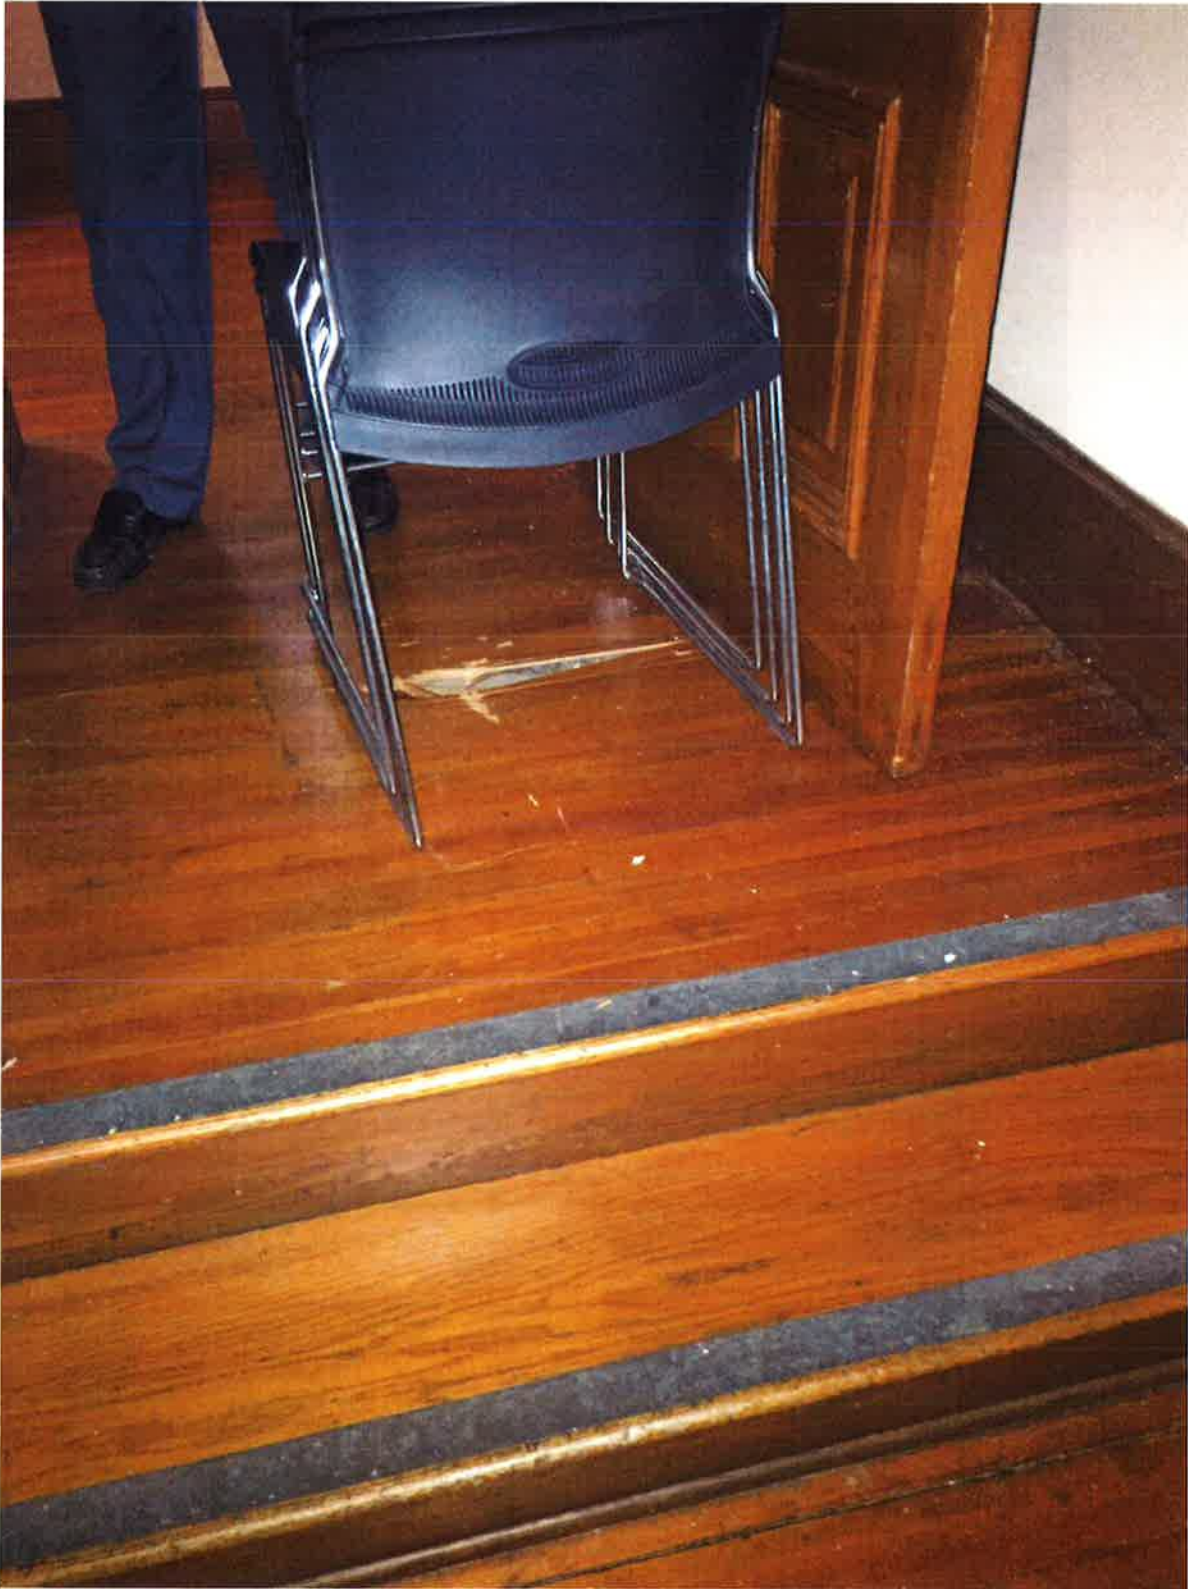
Flooring in the north stair hall was damaged by a past film crew.

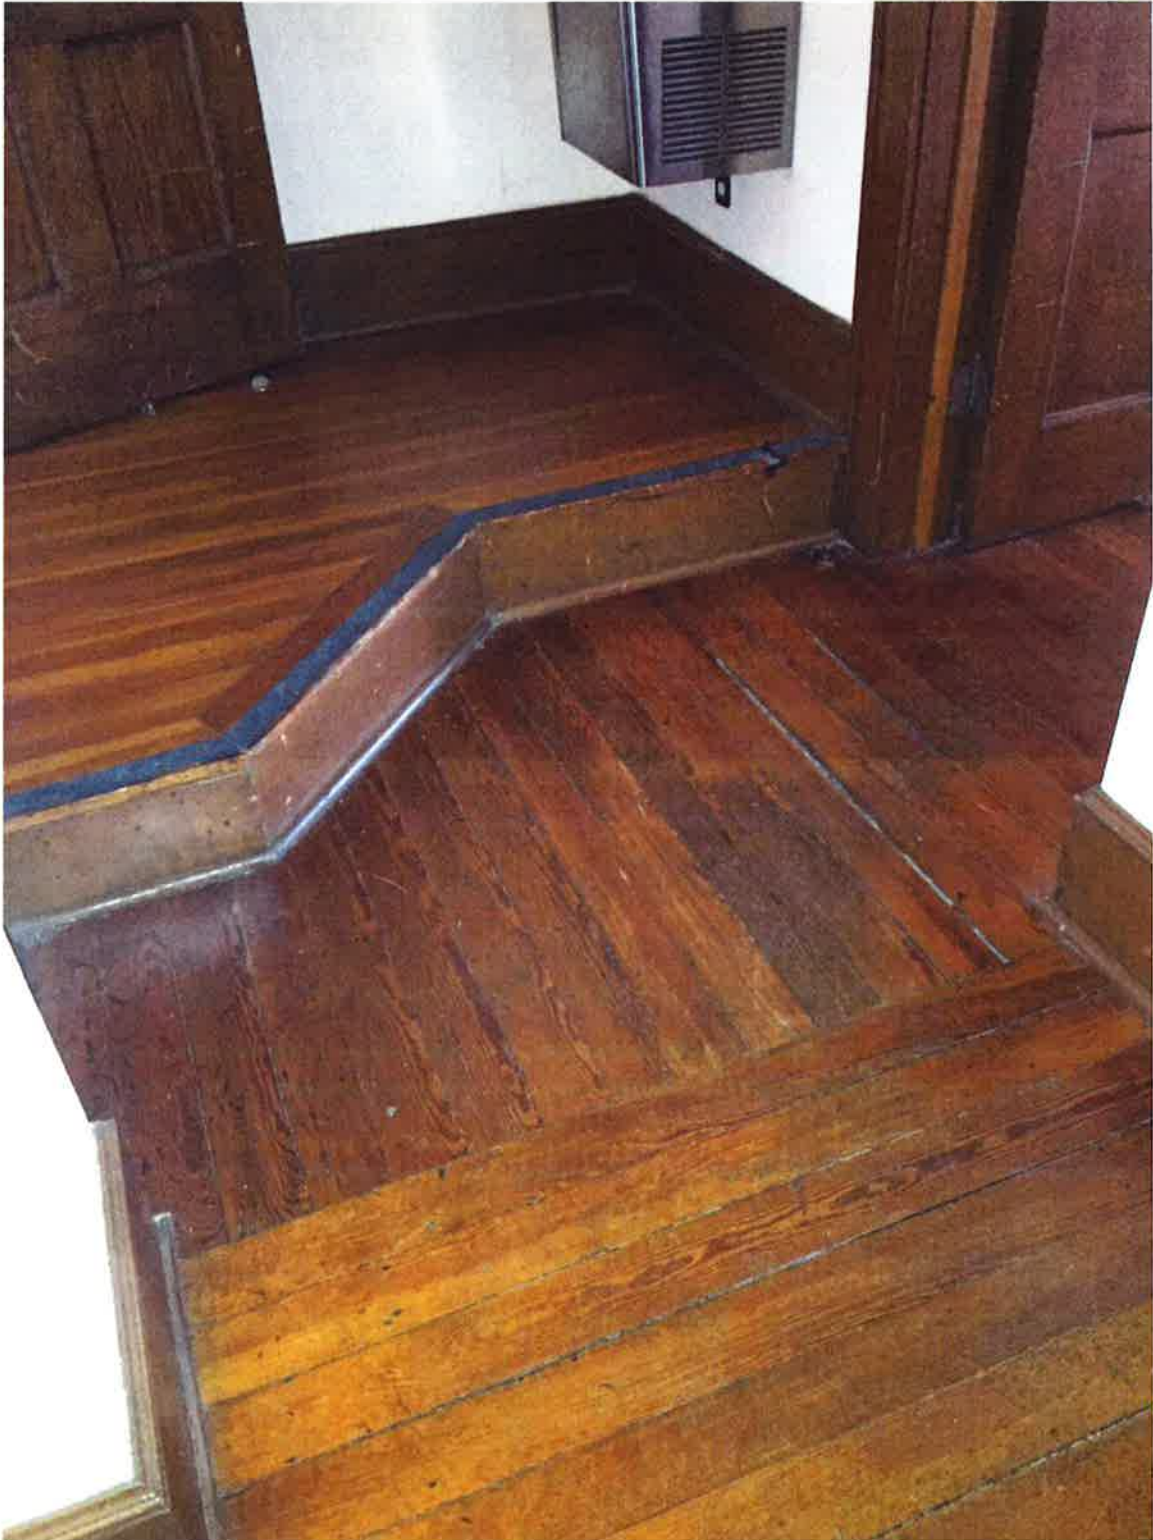
Flooring in the north hall is showing water damage from a plumbing leak in the bathroom in the adjacent holding cell.

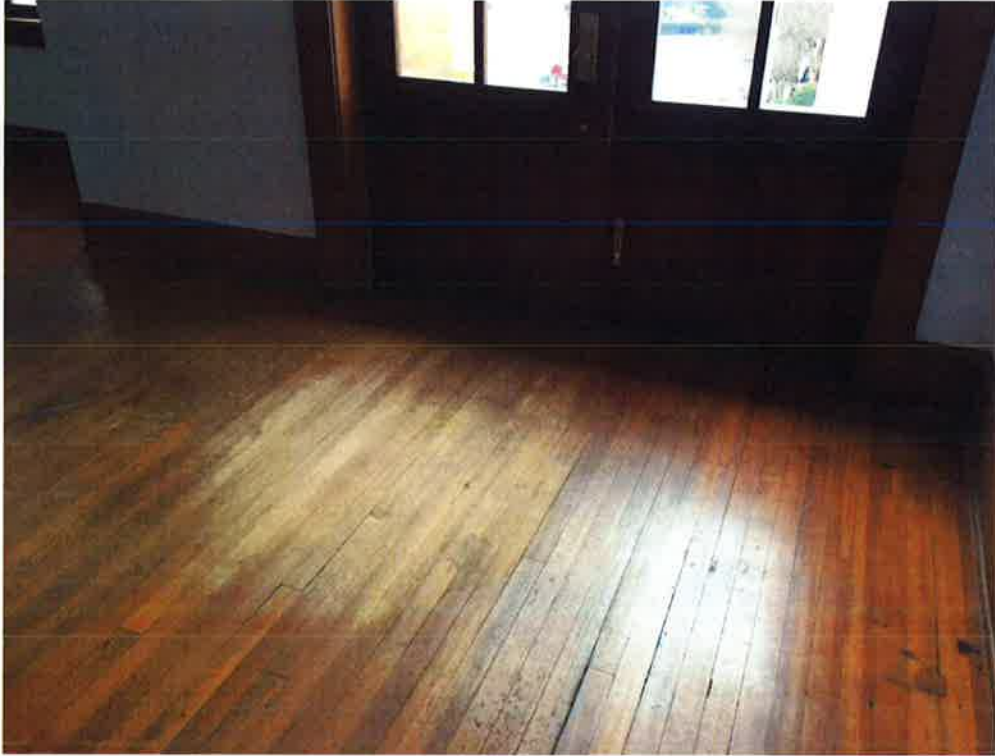
Flooring in the NW room on the second floor shows isolated signs of wear at previous cubicle locations, heightened near the balcony door due to UV light.

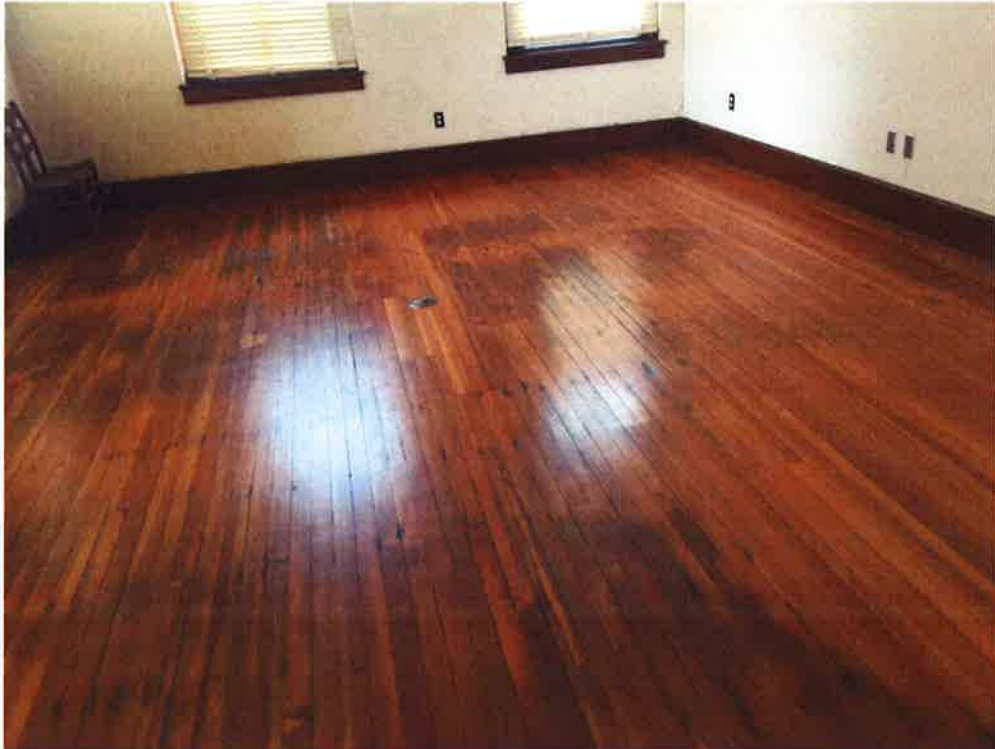
Flooring in the SE room on the second floor shows water staining, most likely from a past roof failure in this area.

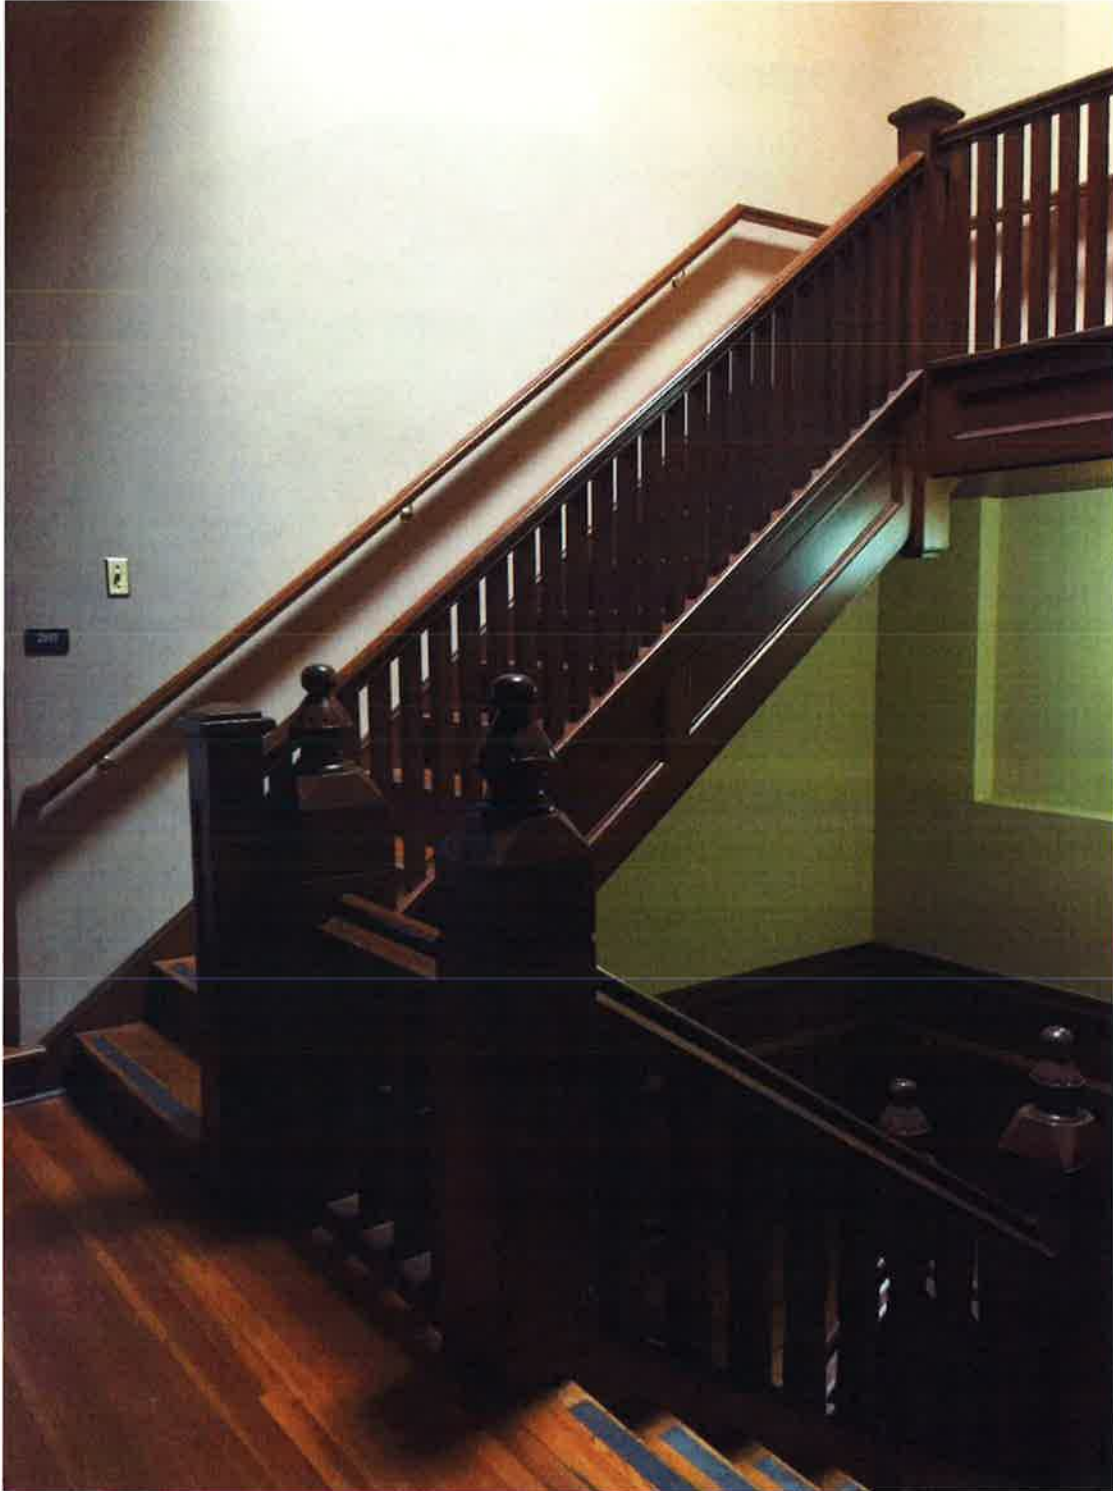
In 1888, the south monumental staircase led only as far as the second floor landing. There may have been a lesser stair for accessing the attic, similar to the one currently in place at the north stair. In 1928, when the courtroom was re-oriented and the balcony was added, the monumental staircase was extended to the attic level.

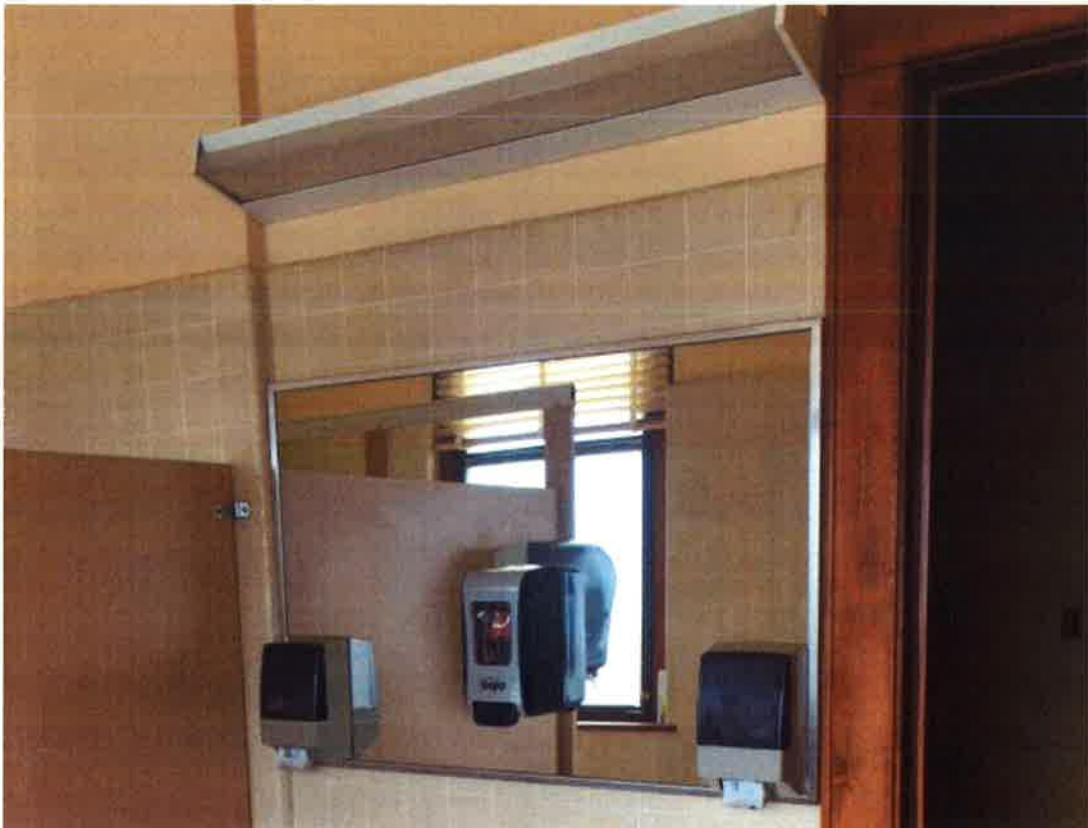
Modern life safety lighting and signage, and bathroom lighting, were also added during the 1988 renovation.

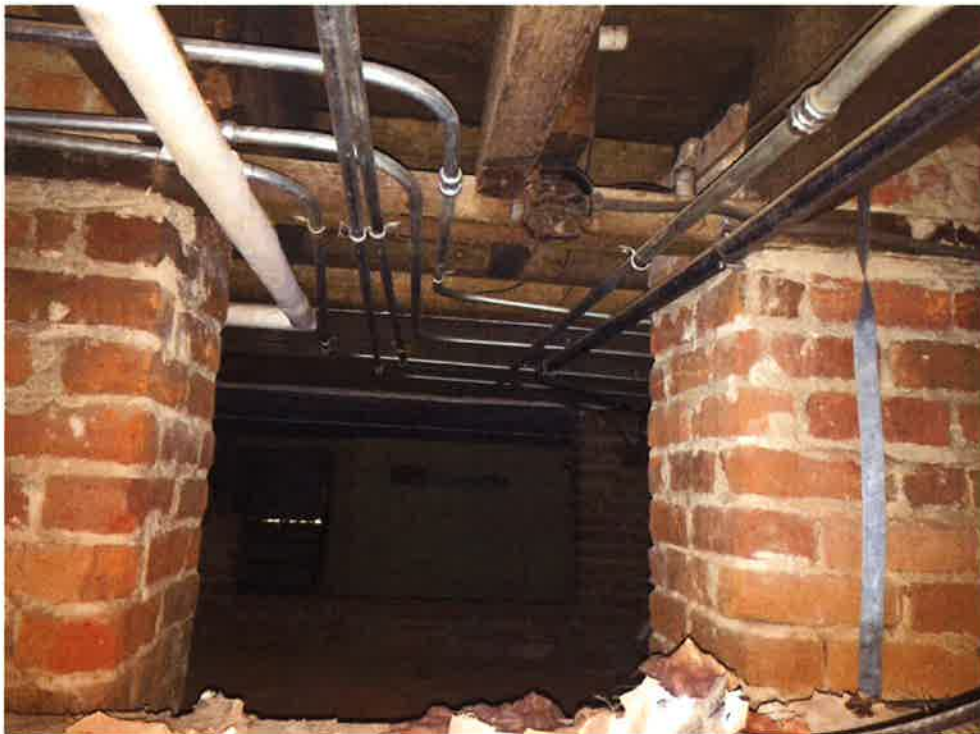
View from beneath corridor toward added basement mechanical room

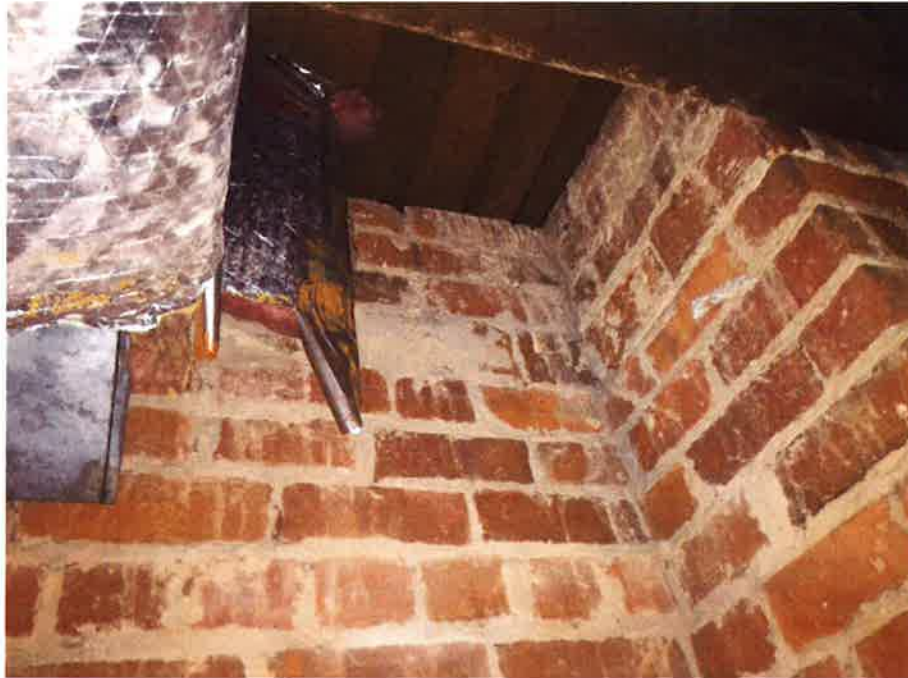
Exterior foundation wall in crawlspace

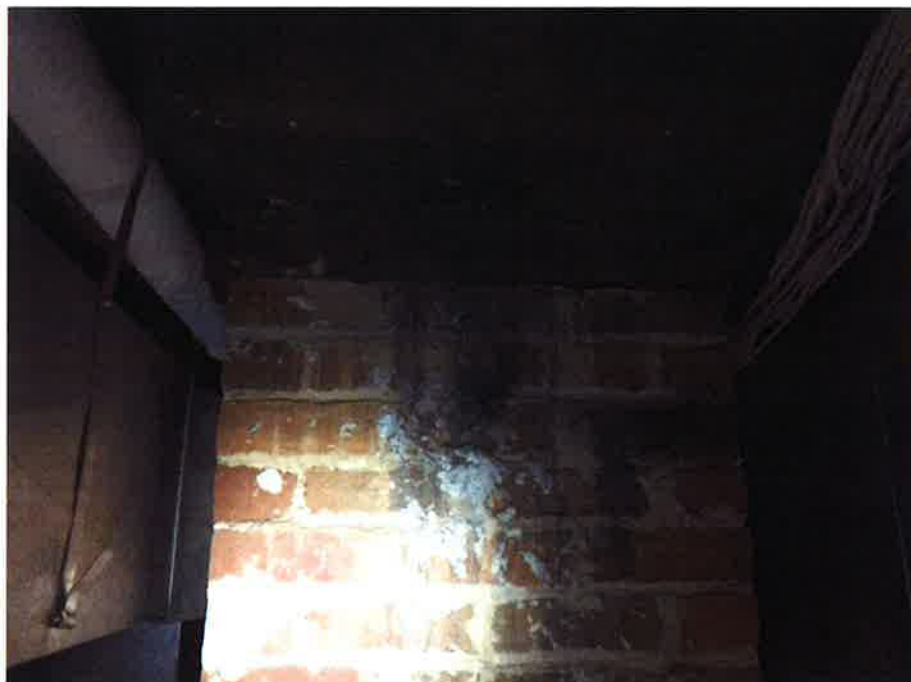
Center pier beneath corridor.

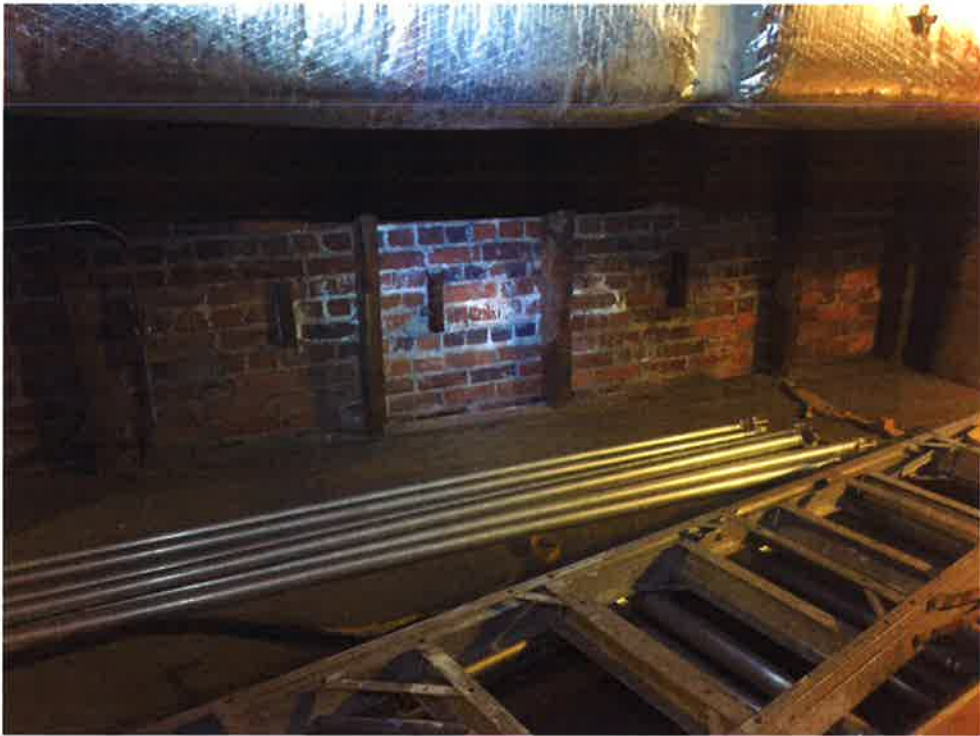
Exterior wall support and outriggers.

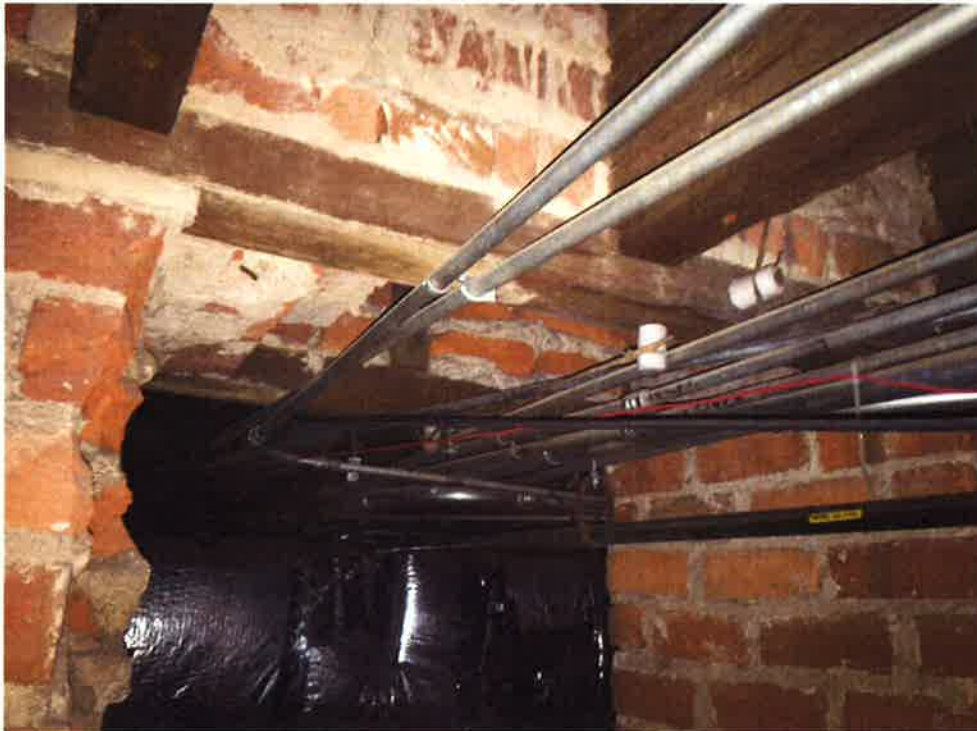
Crawlspace framing and foundation wall at wall penetration

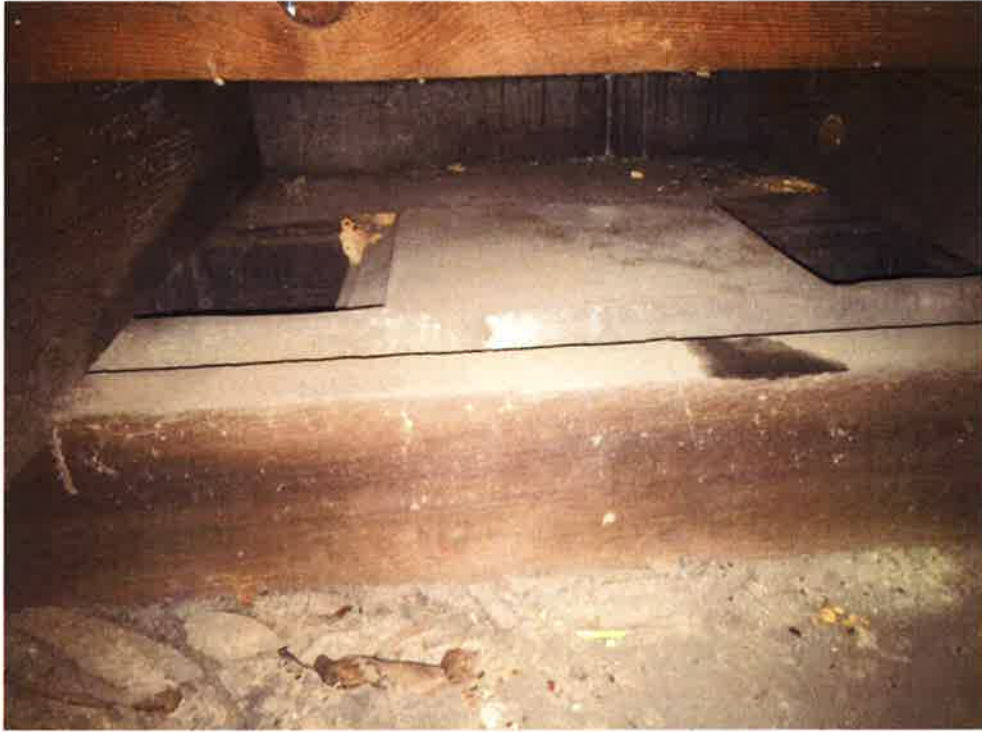
View of outrigger extension beneath exterior gutter. Note concealed top side of exterior decorative metal soffit.

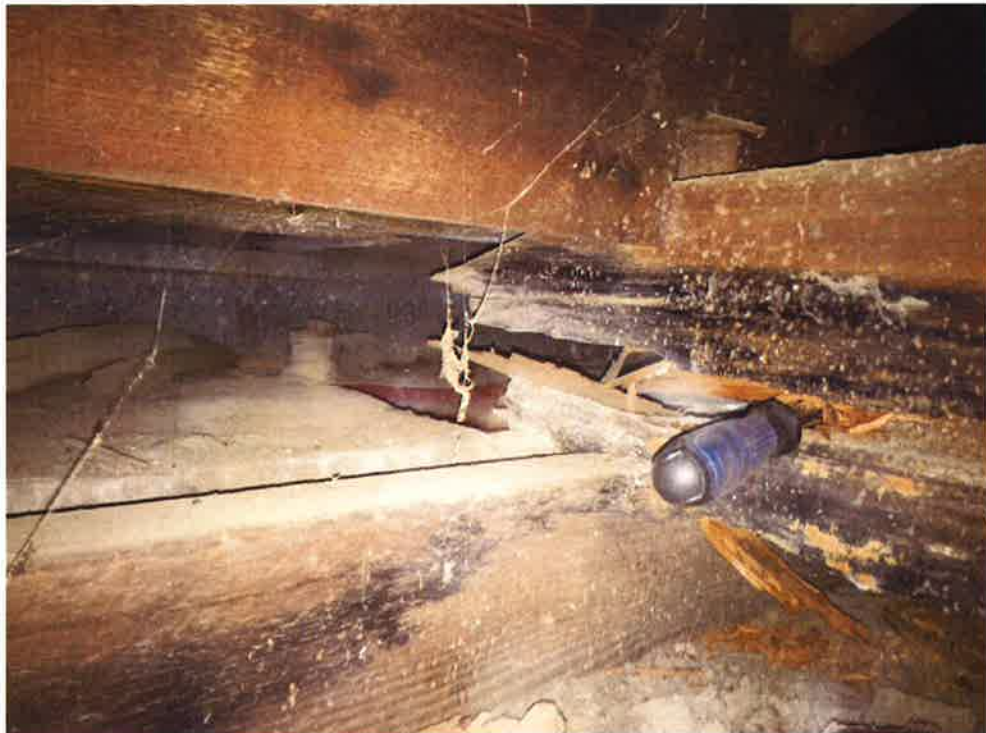
Deteriorated and crushed outrigger supporting gutter.

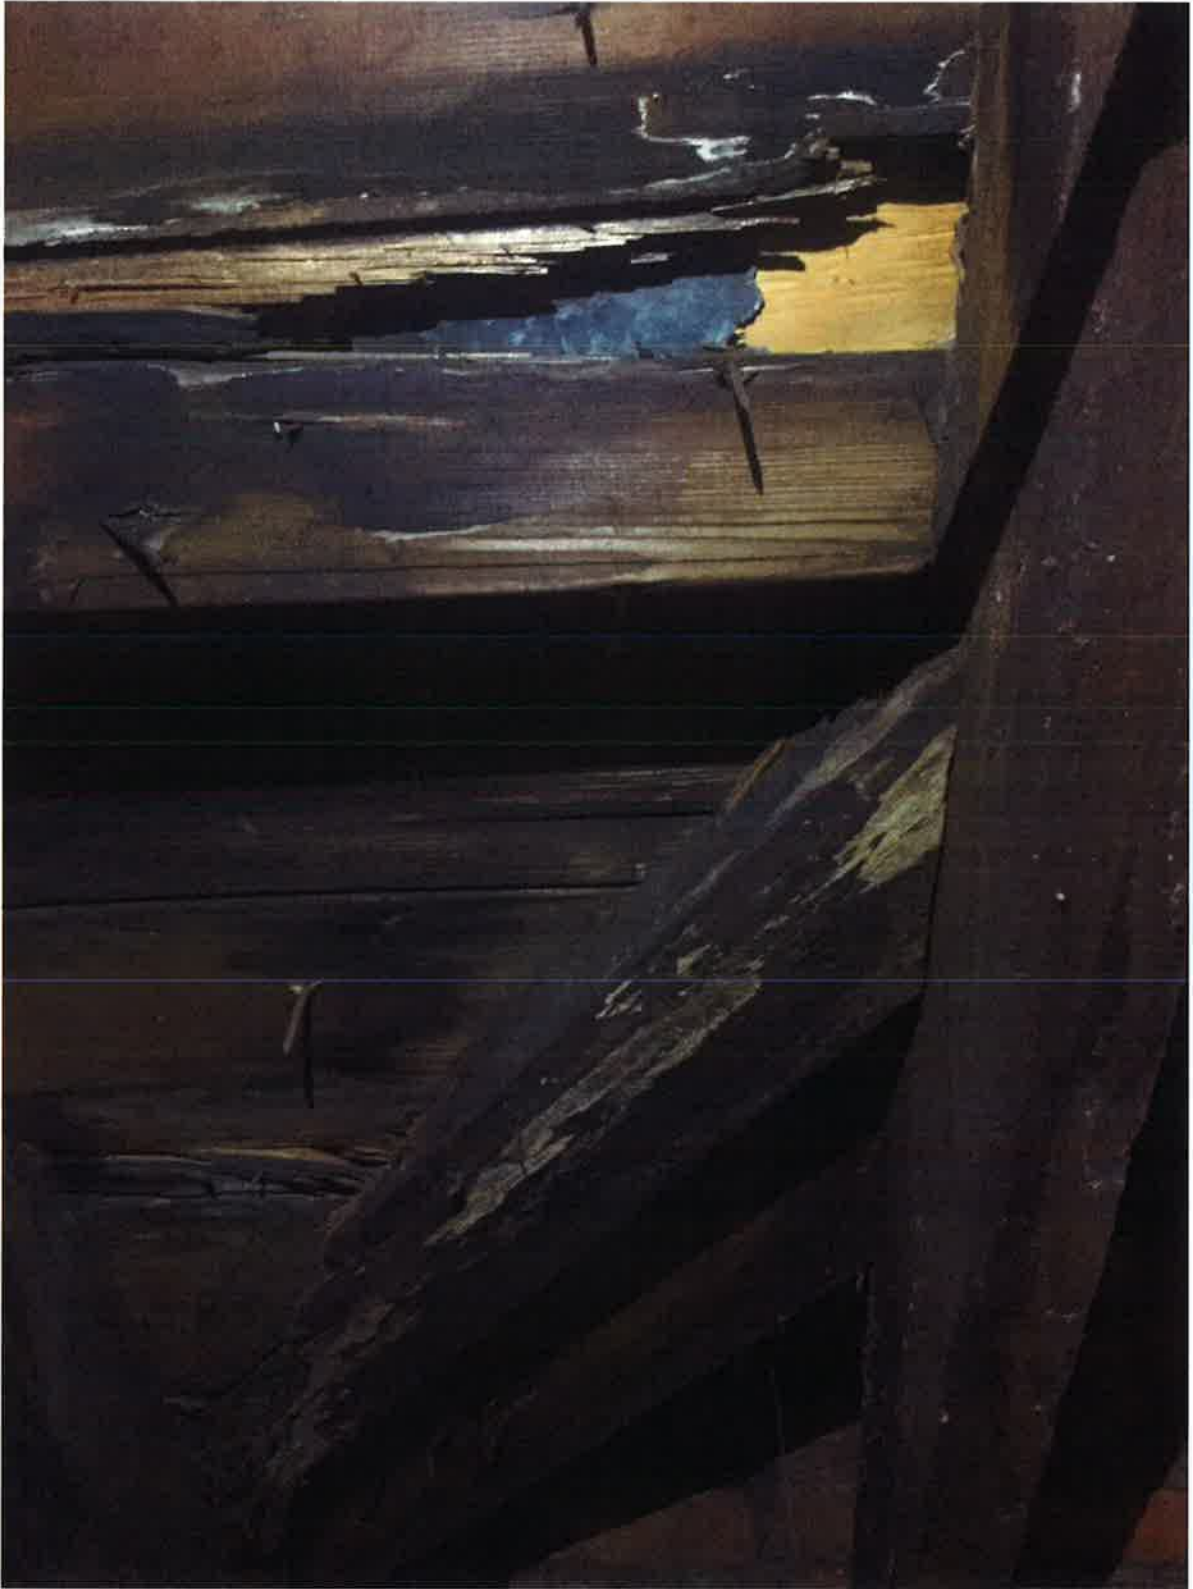
Deteriorated framing at gutter.

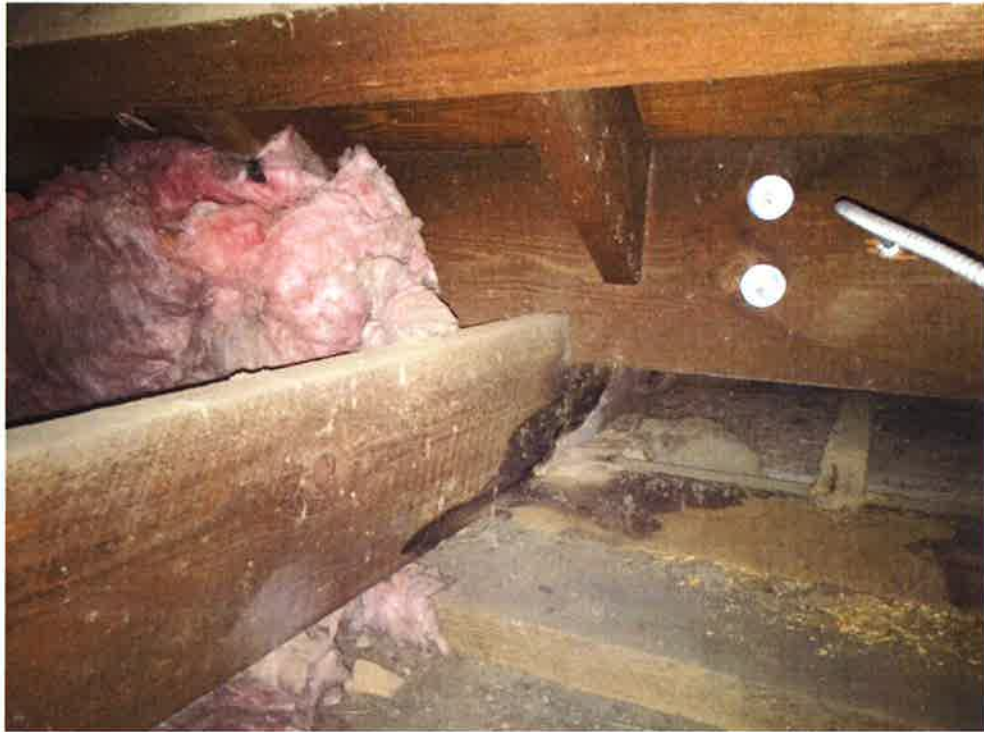
Deteriorated outrigger extension supporting roof framing.

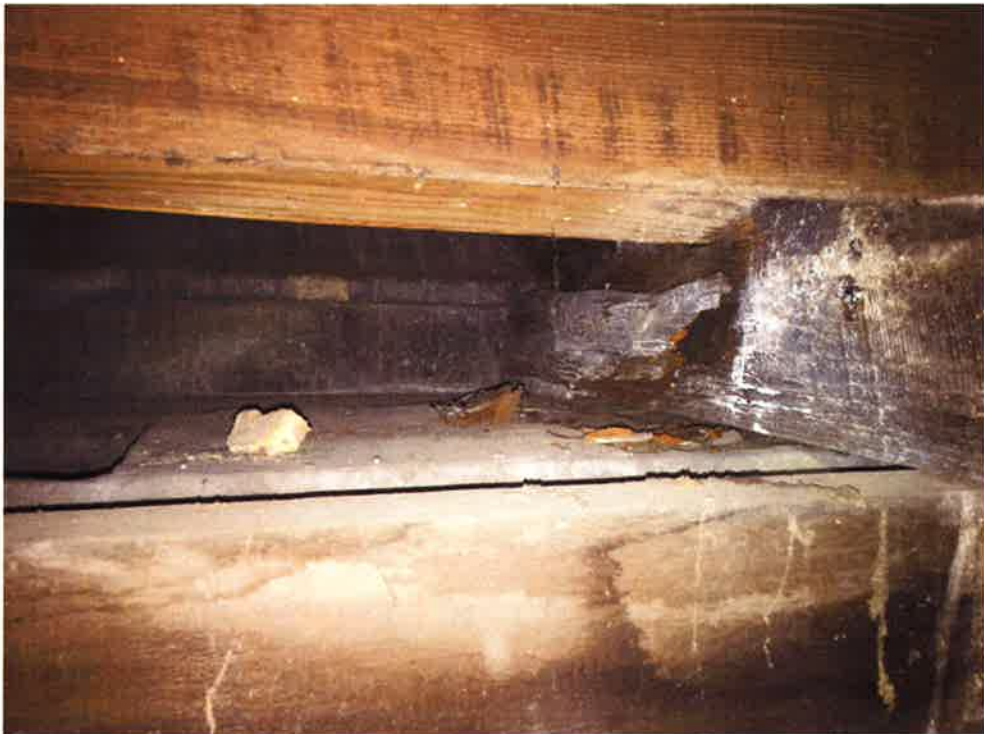
Crushed and deteriorated outrigger supporting roof purlin.
