HISTORIC UNION COUNTY COURTHOUSE

HISTORIC STRUCTURE REPORT & RELATED SERVICES
JANUARY 23, 2017

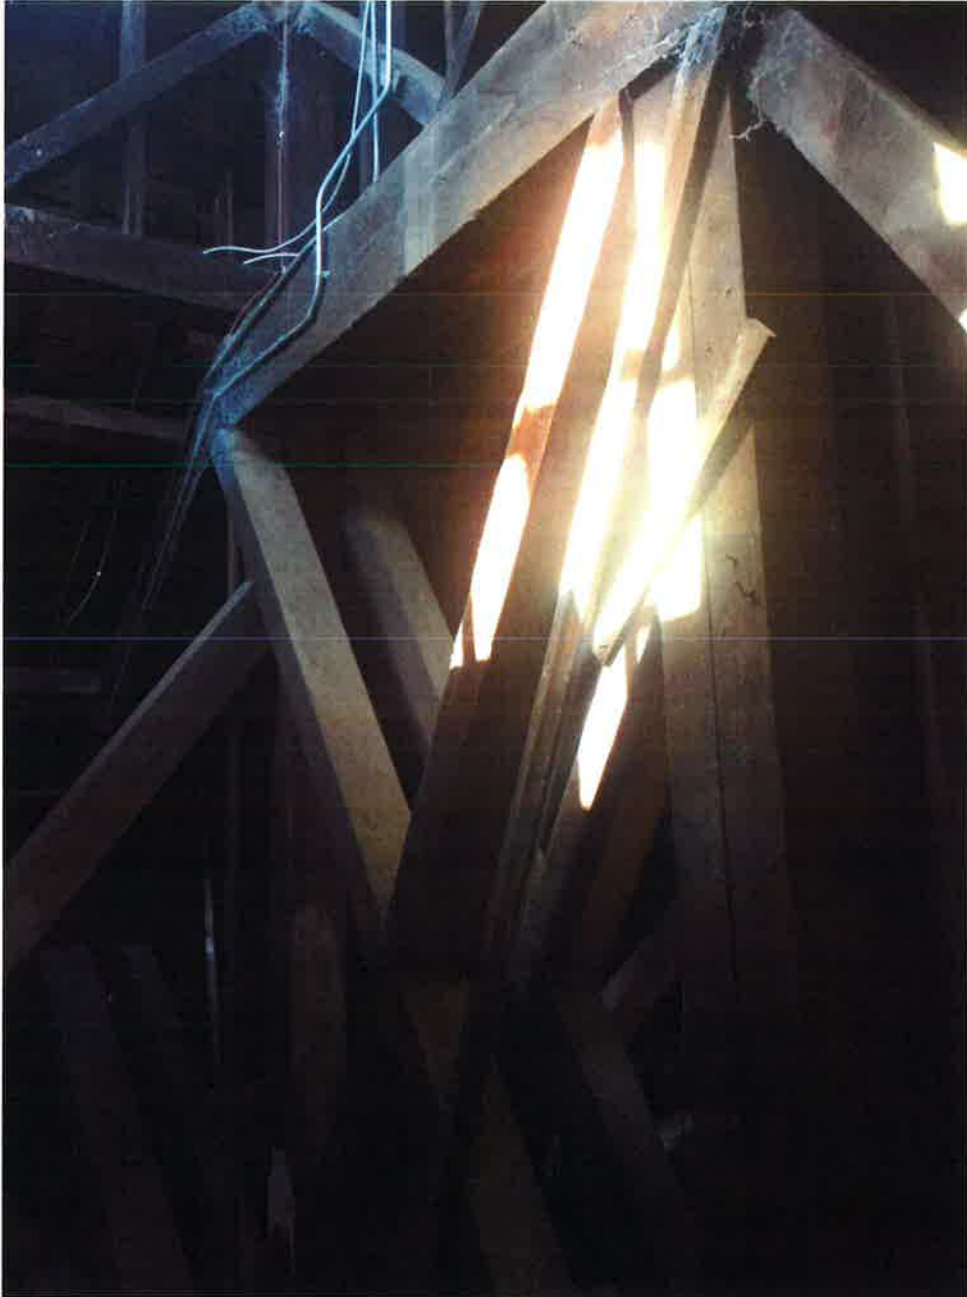
Diagonal web members of main roof trusses.
In some cases these diagonal web members are loose.

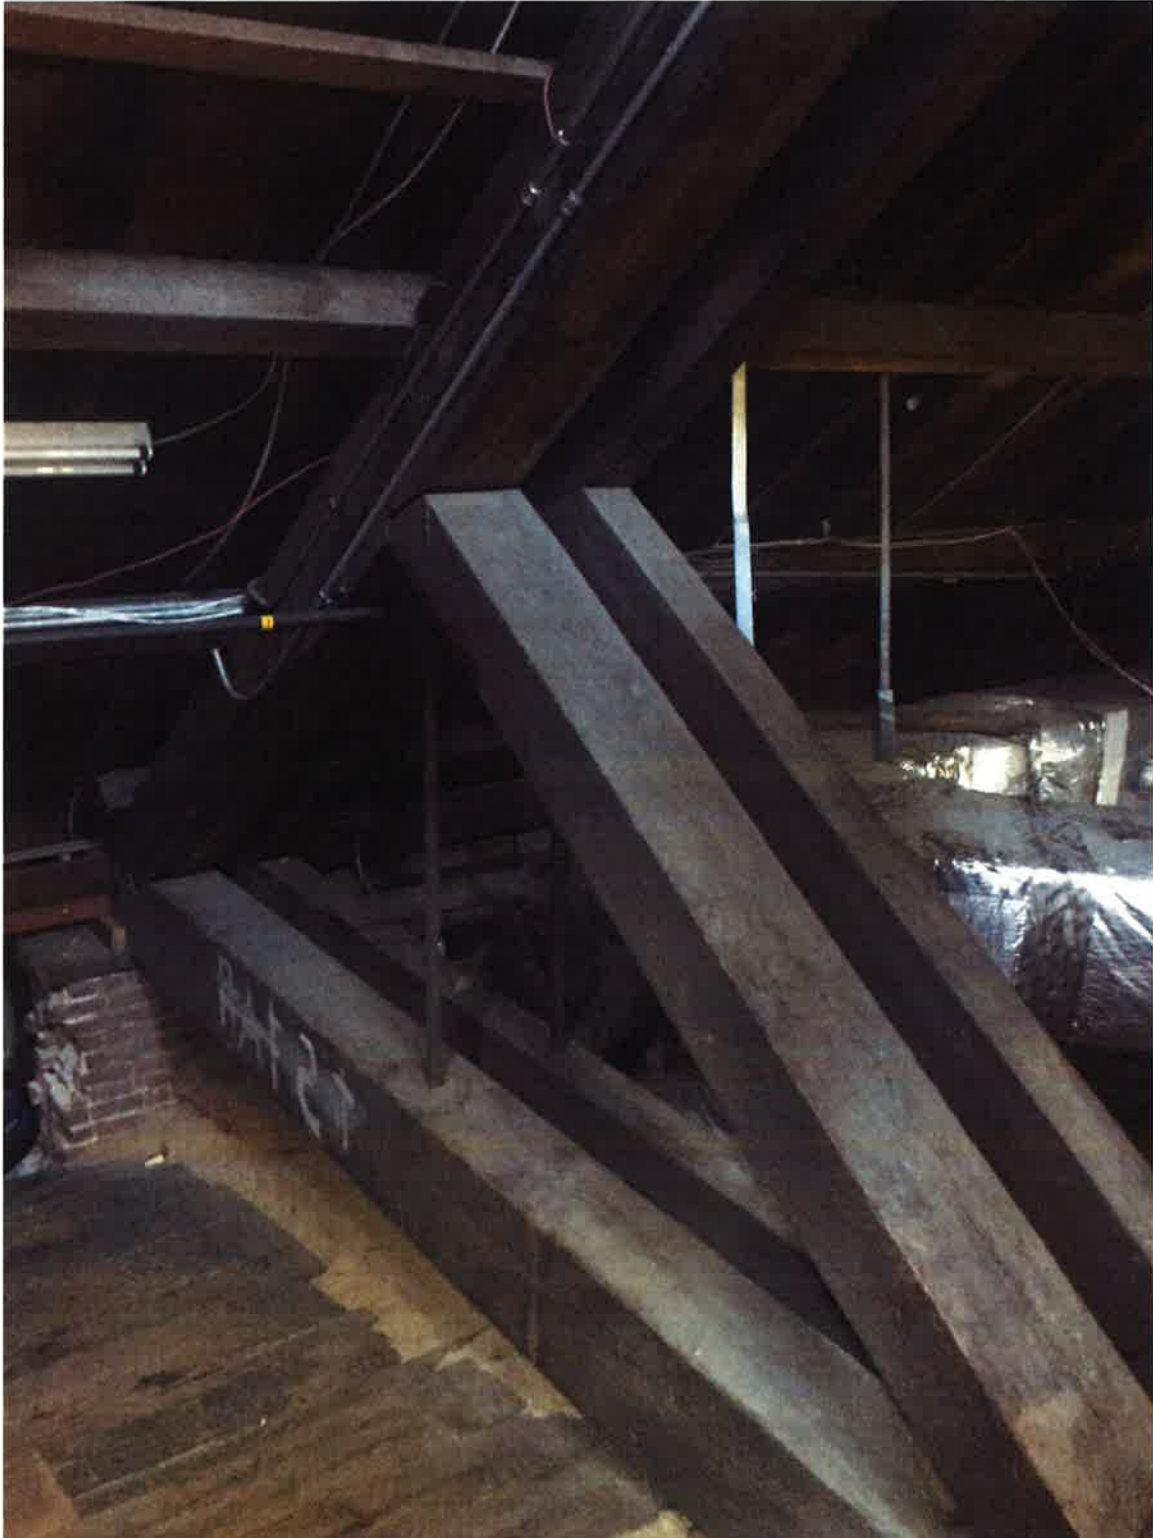
Roof truss web members. Note gap between timber web and chords.
Integrity of connection depends on bolt tension on connection.

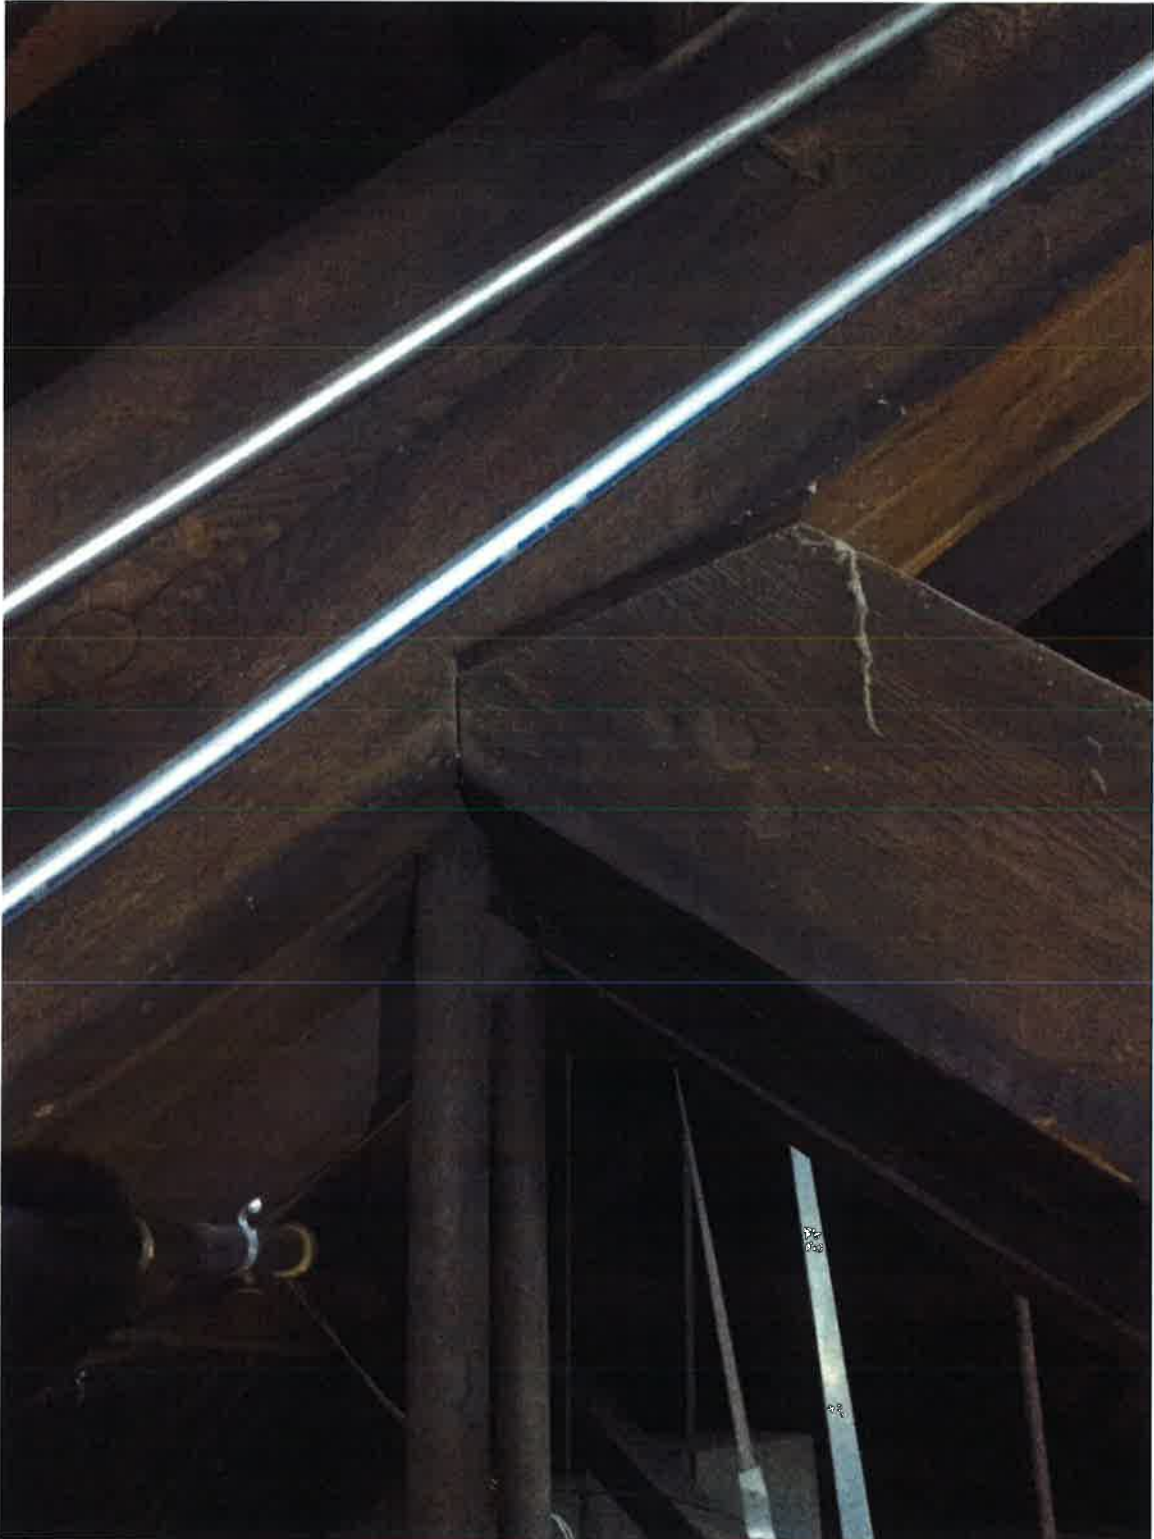
Loosened roof truss connection.

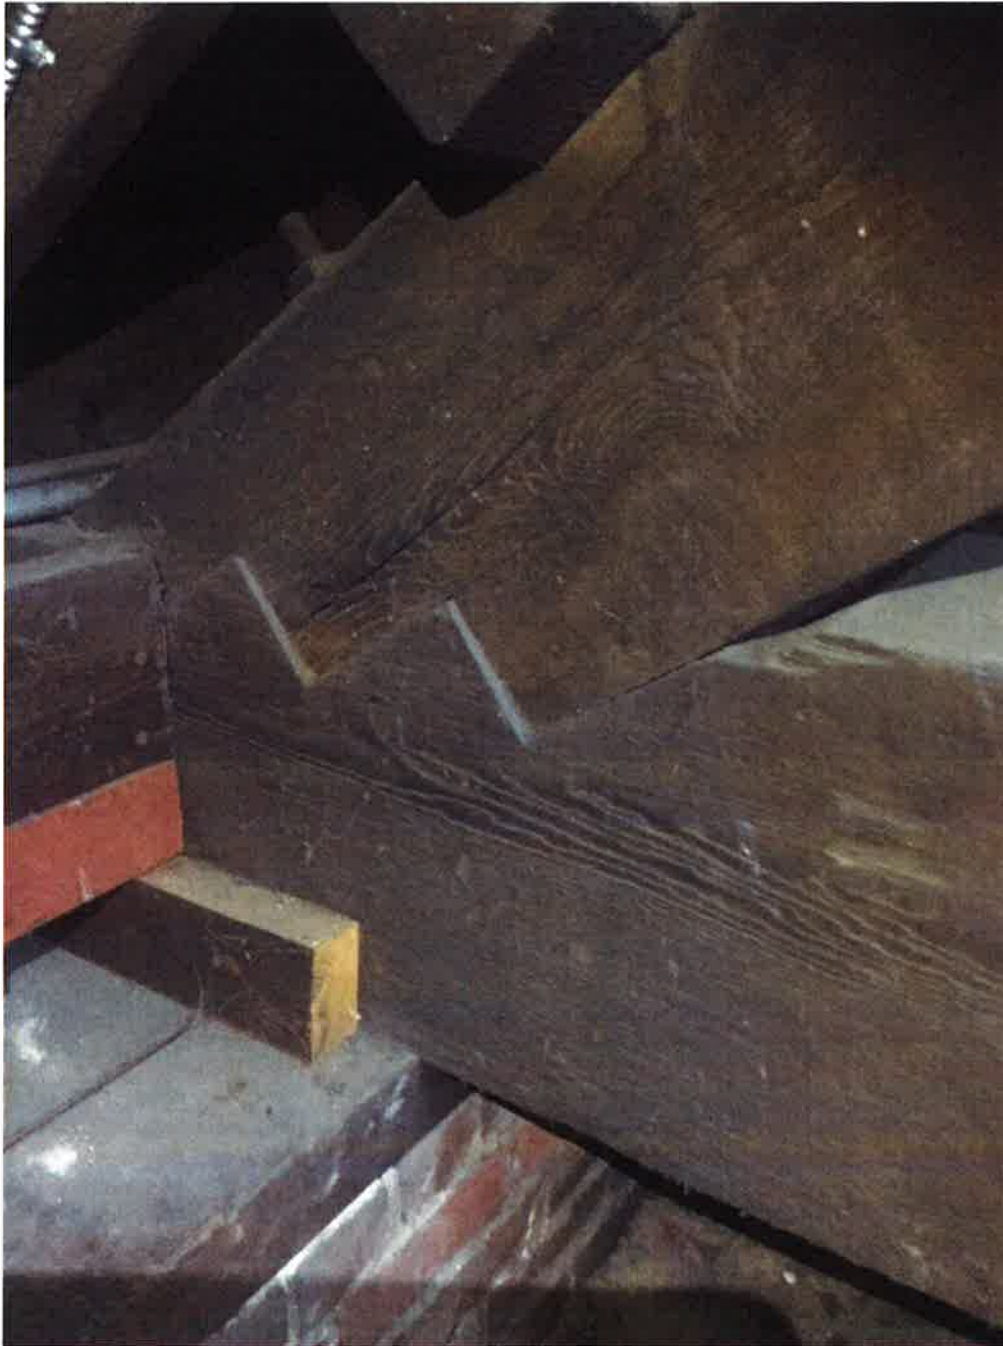
Roof truss bearing. Note notched truss connection with through bolt.

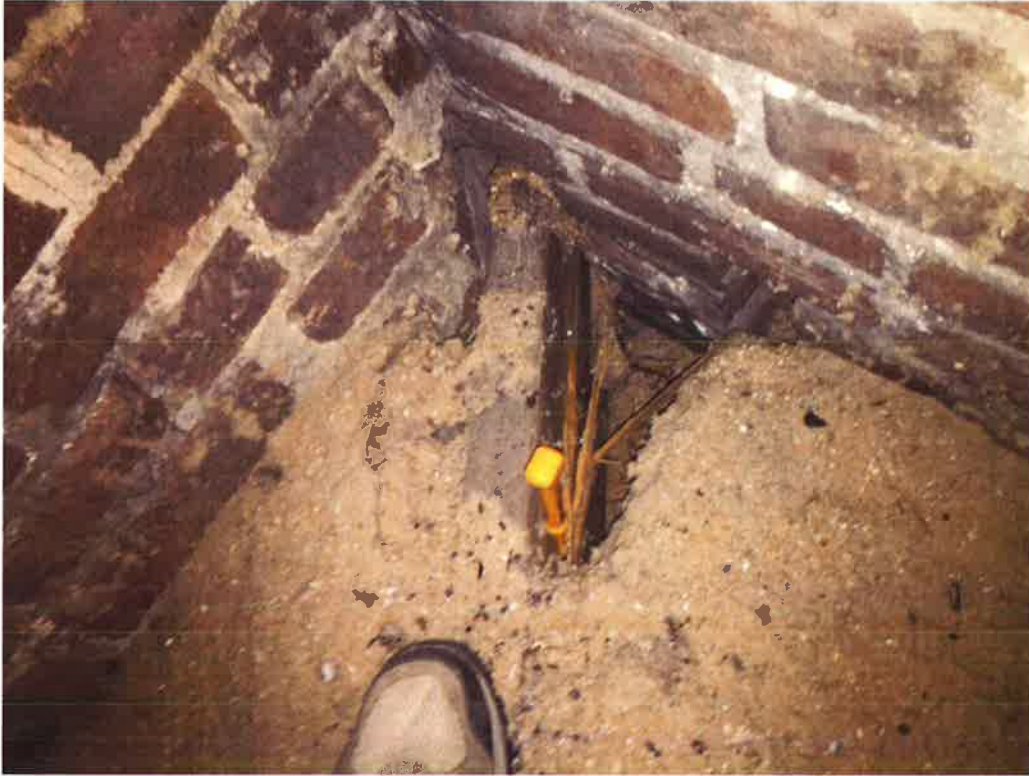
"Hip" beam bearing supporting courtroom ceiling. Note deterioration.

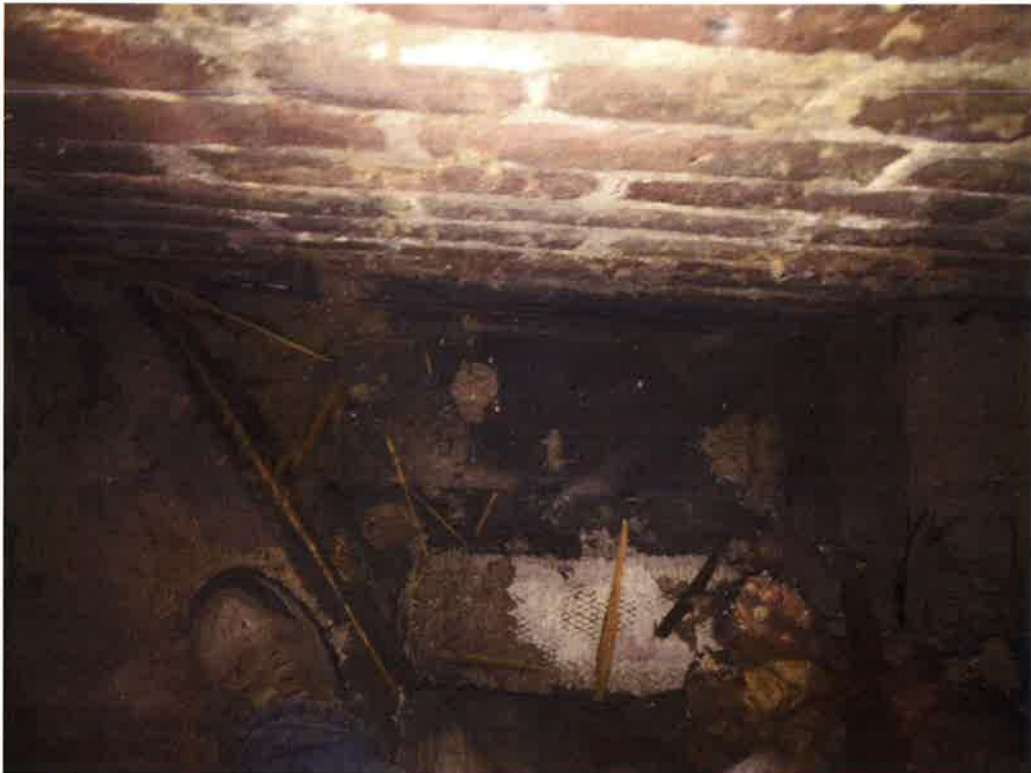
"Hip" beam bearing supporting courtroom ceiling. Note deterioration.

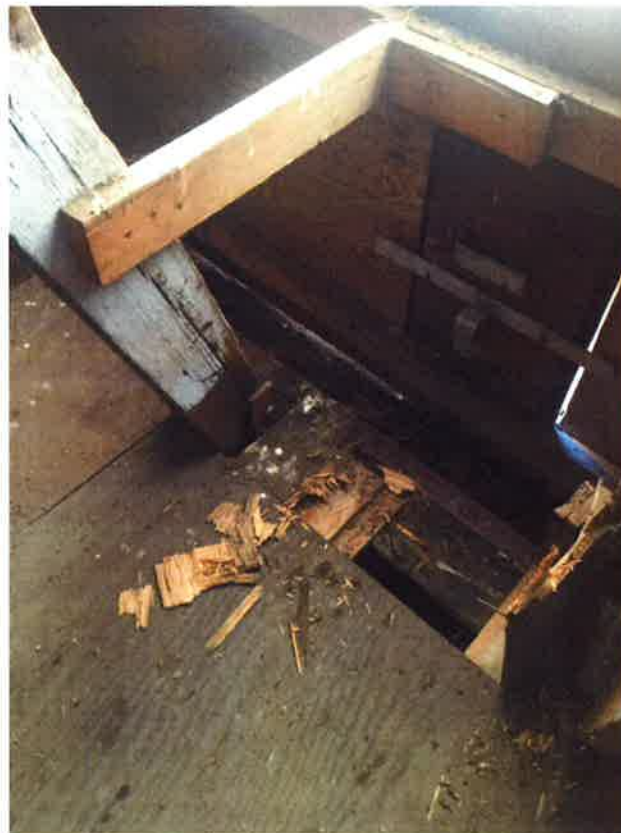
Isolated deterioration of clock tower framing.

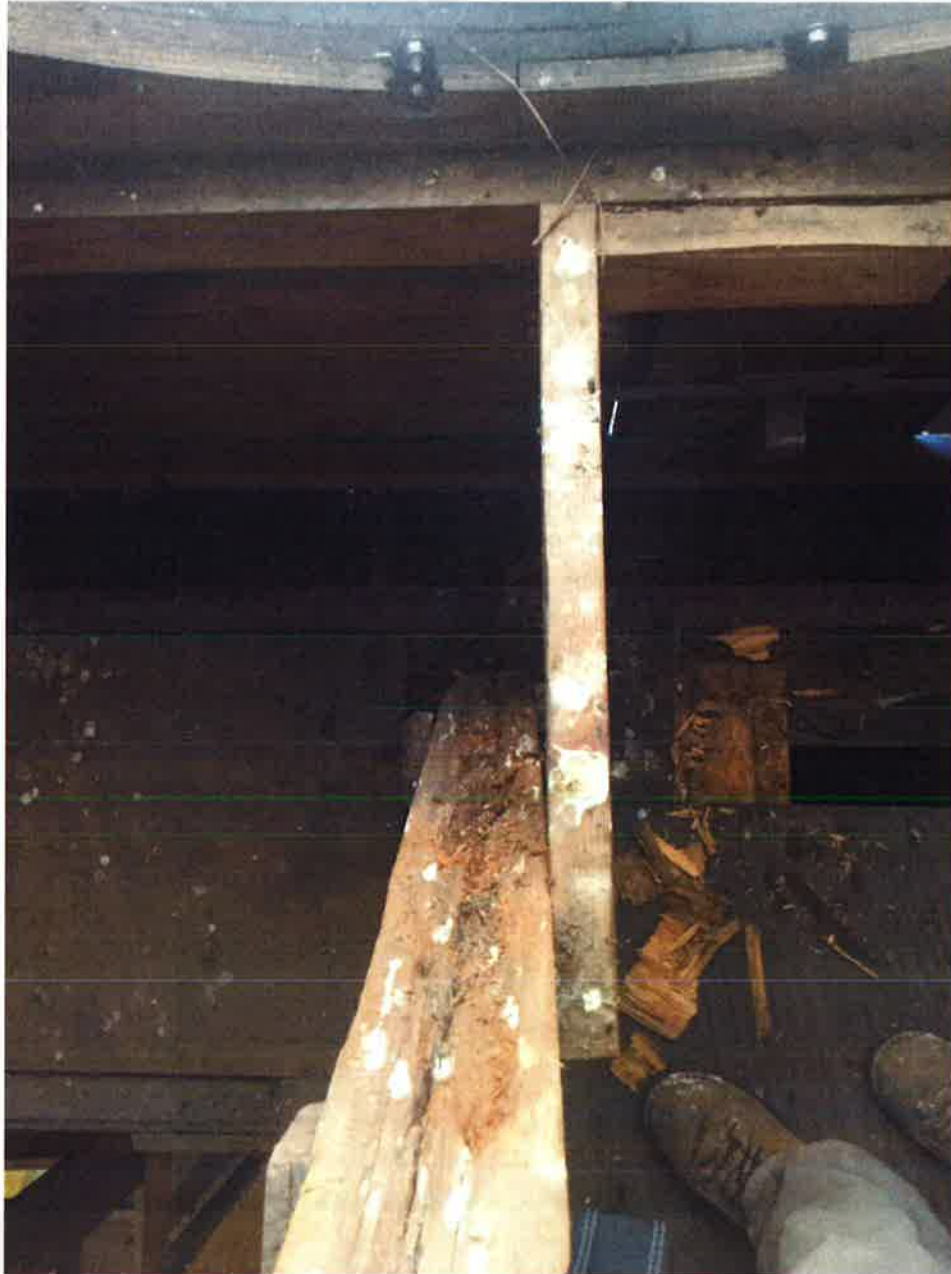
Isolated deterioration of clock tower framing.

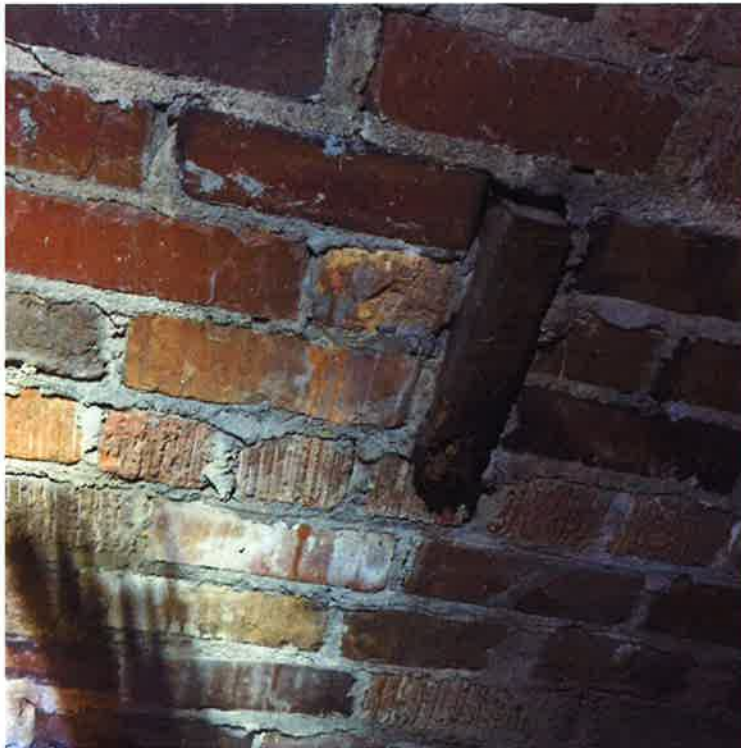
Deteriorated Outrigger.

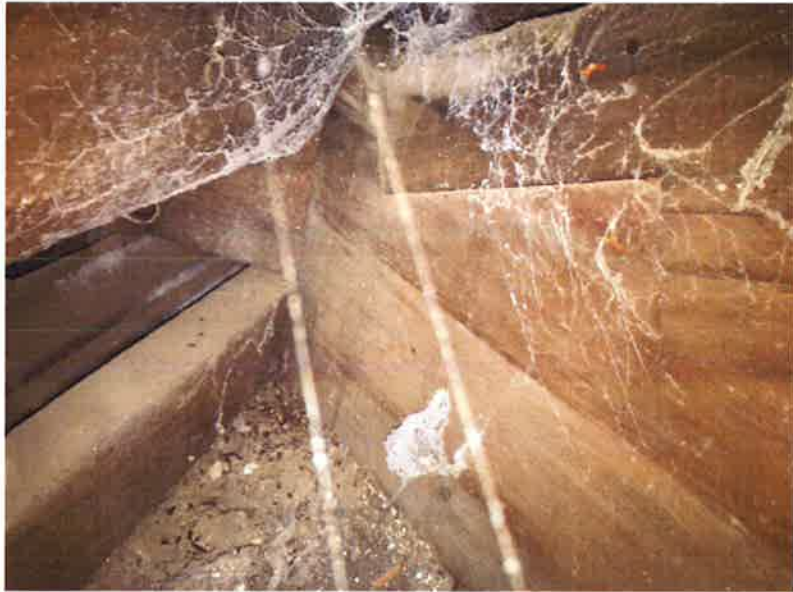
Corner jack truss bearing.

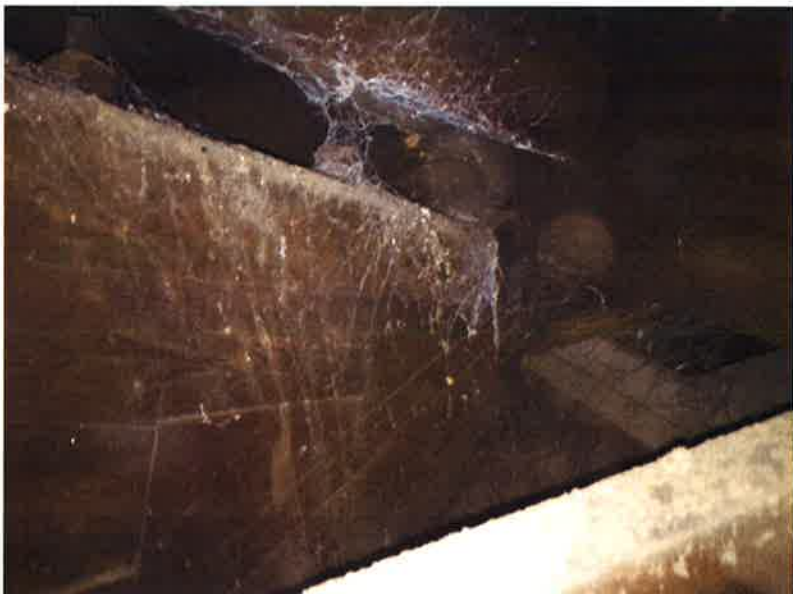
Corner jack truss bearing.

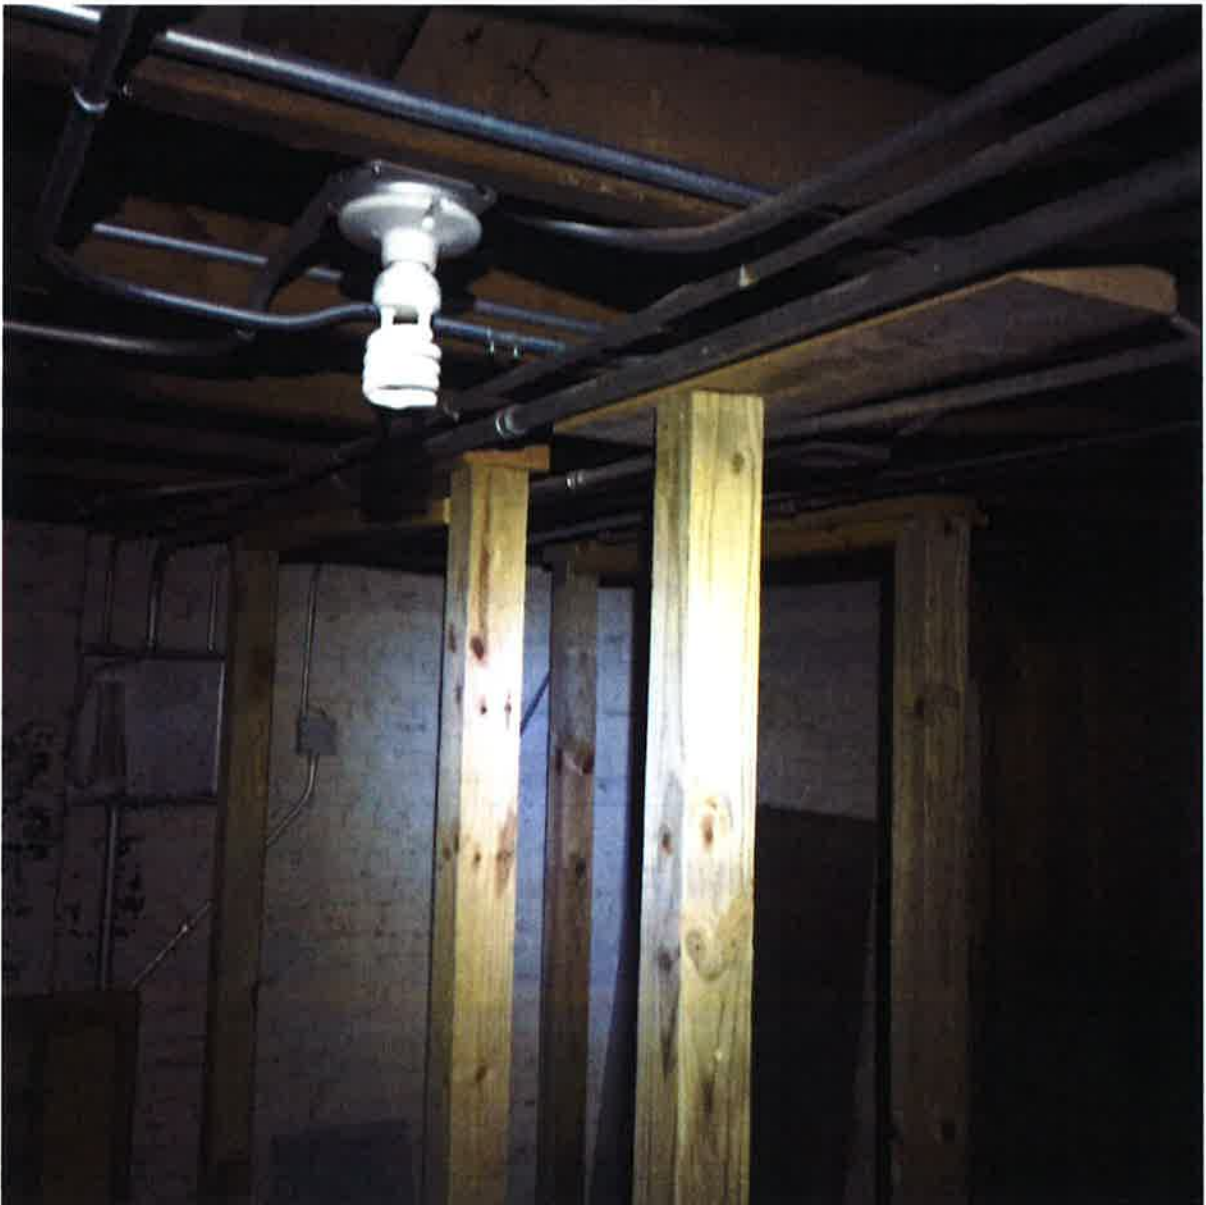
Supplemental framing of roof top units.

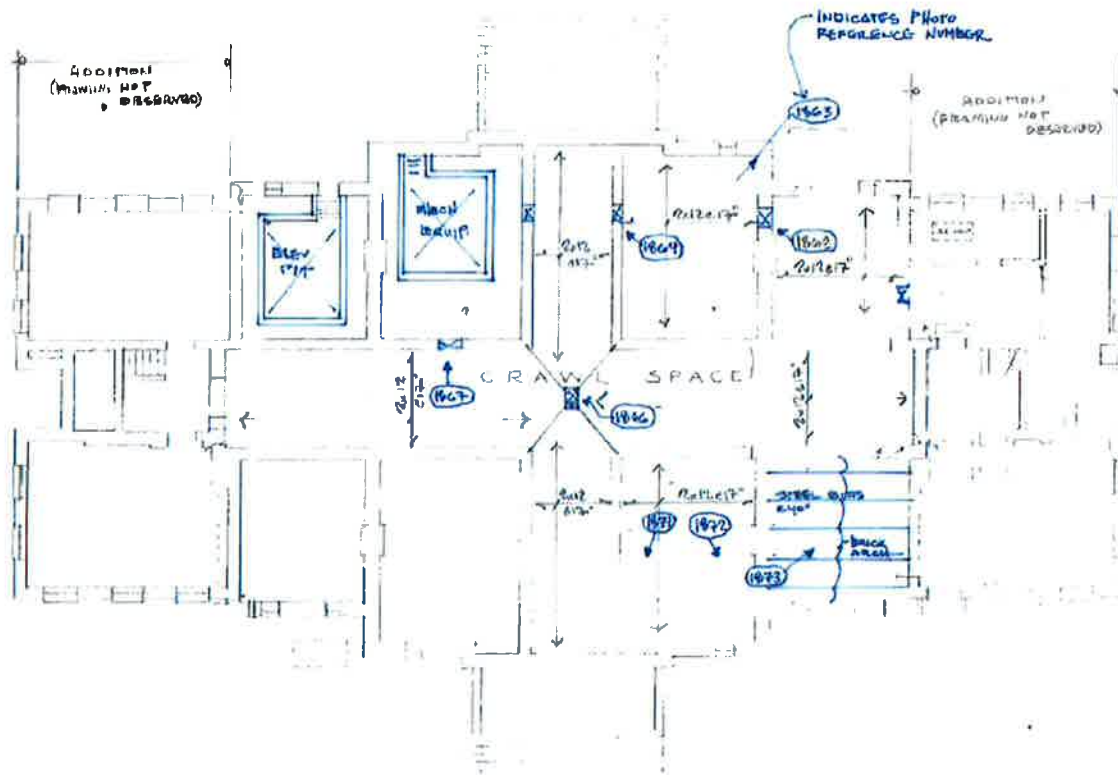
BASEMENT PLAN / FIRST FLOOR FRAMING

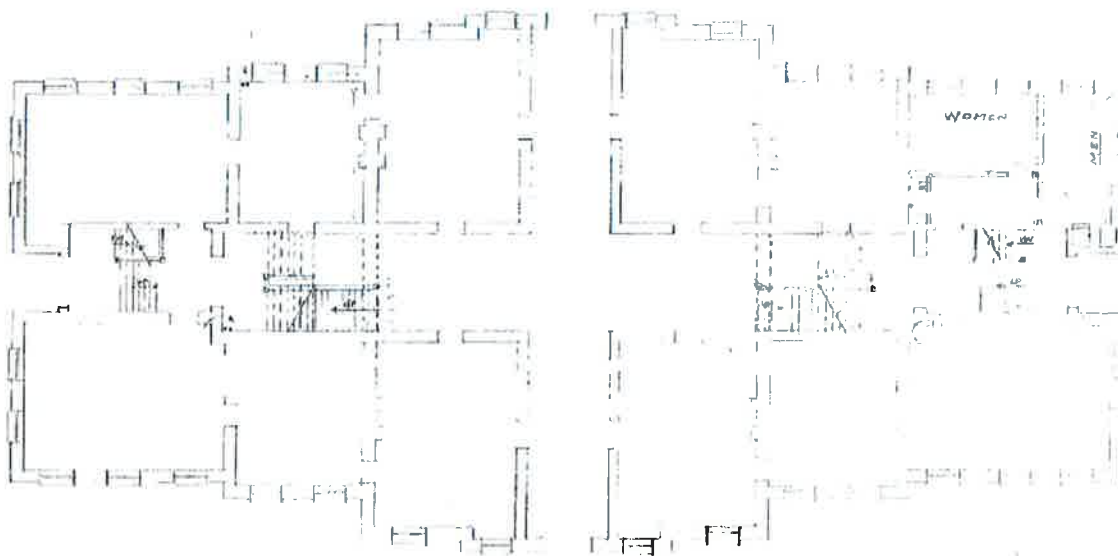
FIRST FLOOR PLAN / 2ND FLOOR FRAMING

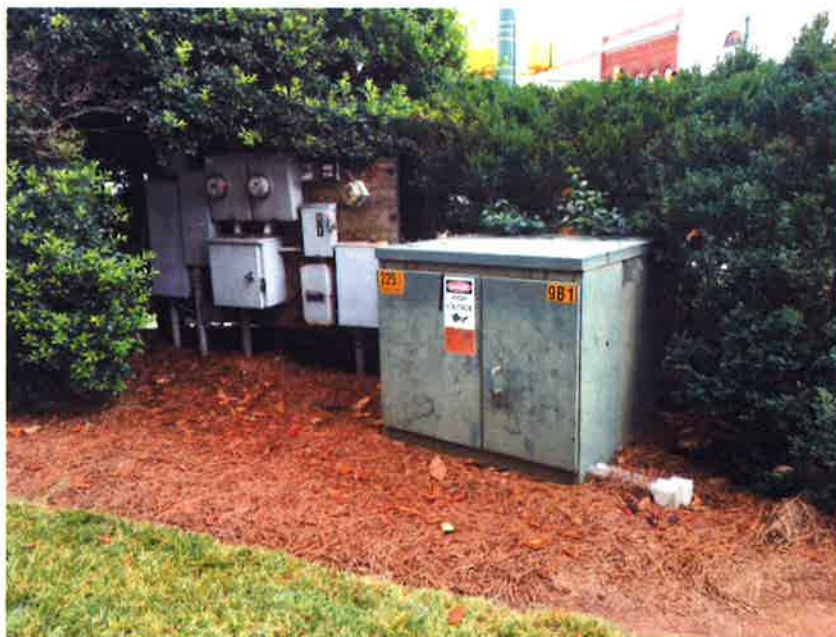
Outside – Electric utility transformer.

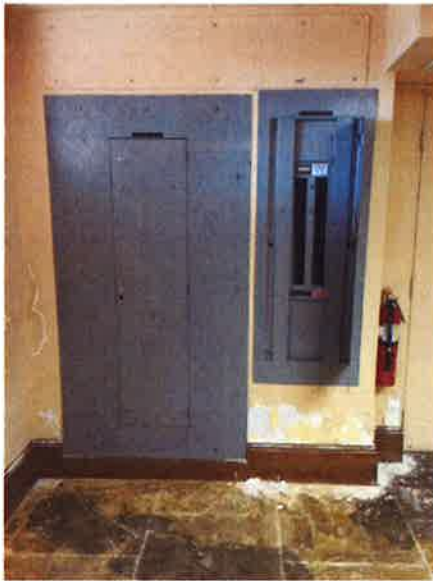
Basement – Flooding at main panel.

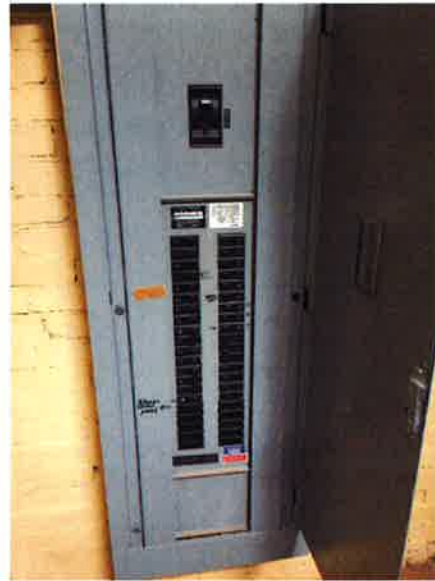
Typical basement electrical panel.

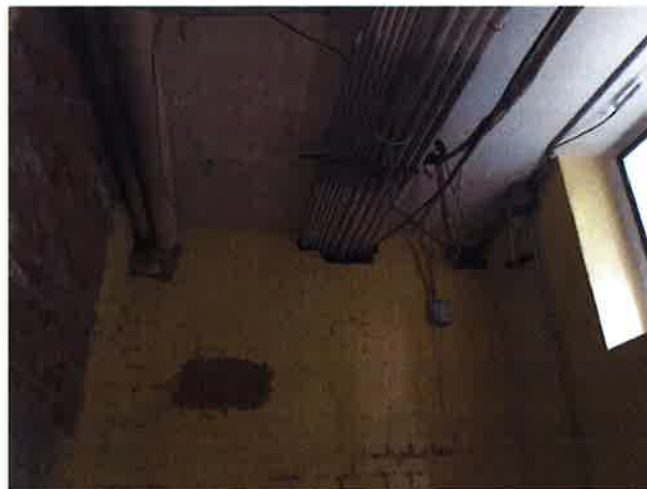
Basement – Conduit penetrations not fire-sealed.

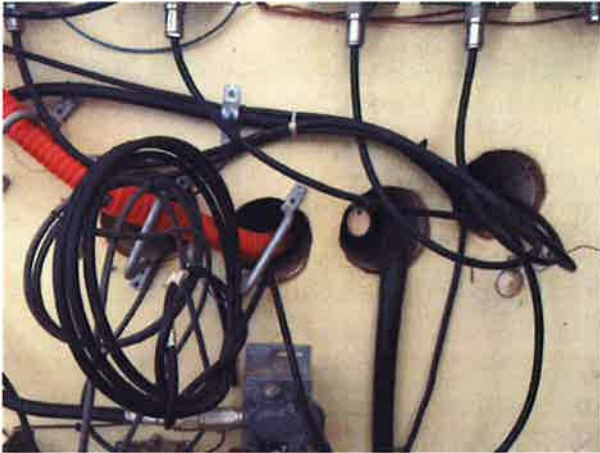
Basement – Telephone cable entrance.

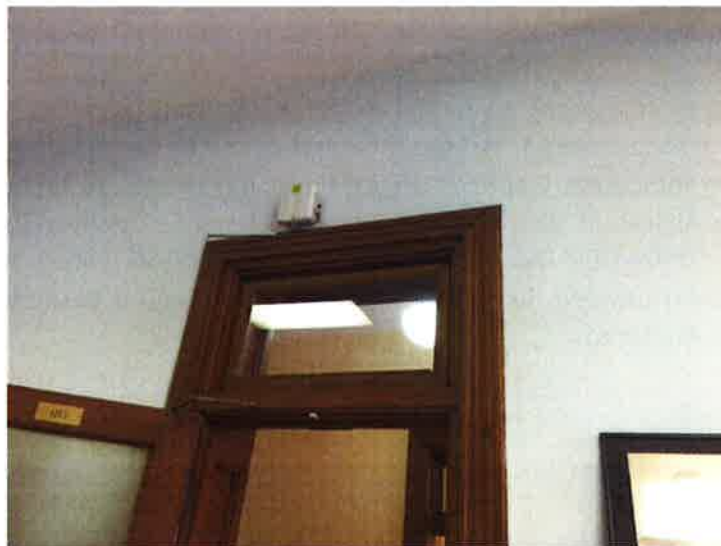
First Floor - Wireless access point.

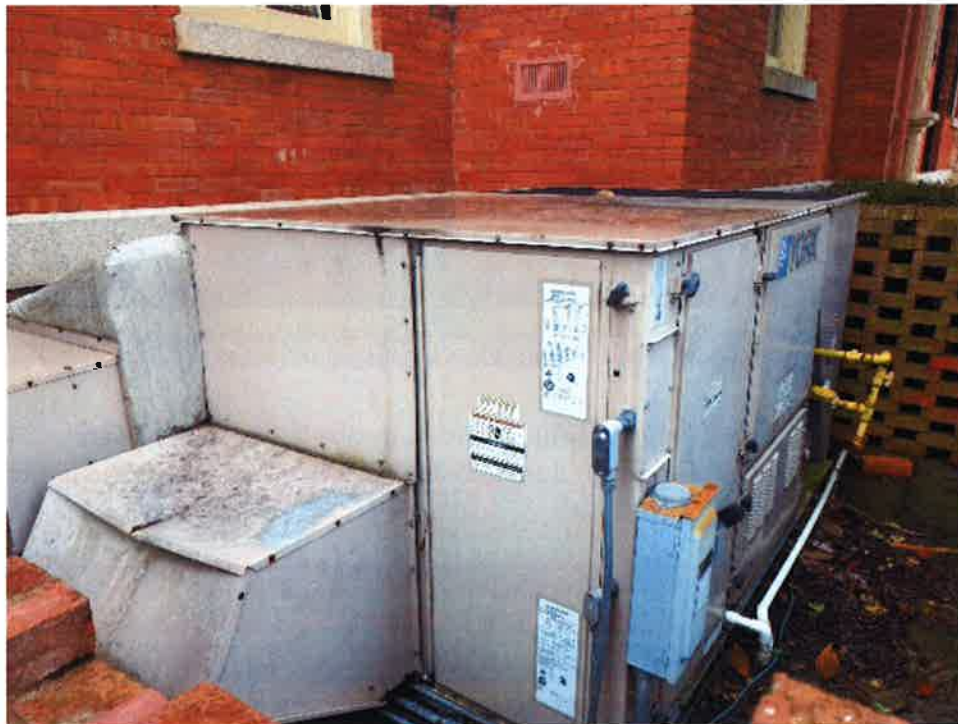
DX Air handling unit on grade behind screen wall.

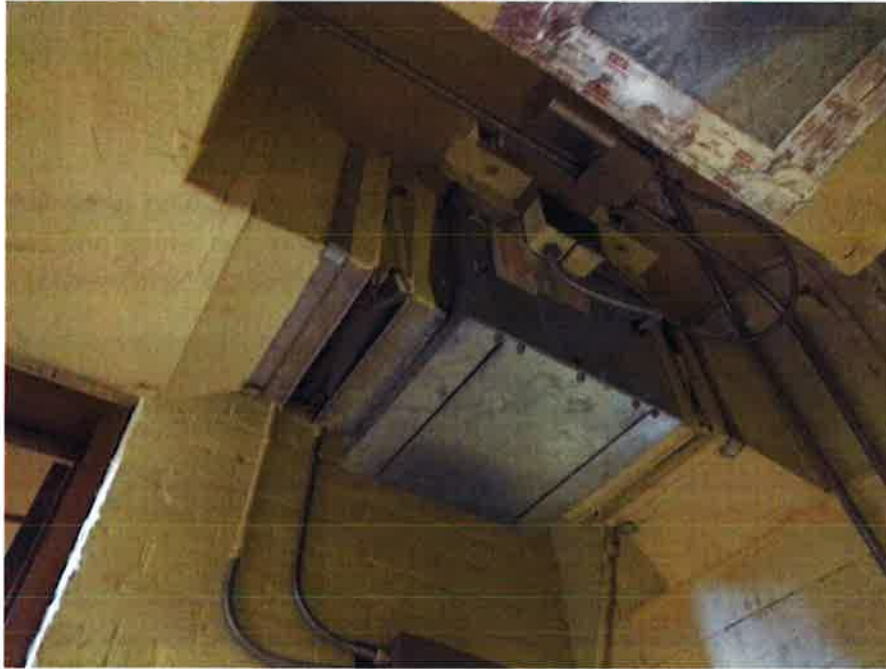
Basement – Exhaust fan installed in utility room.

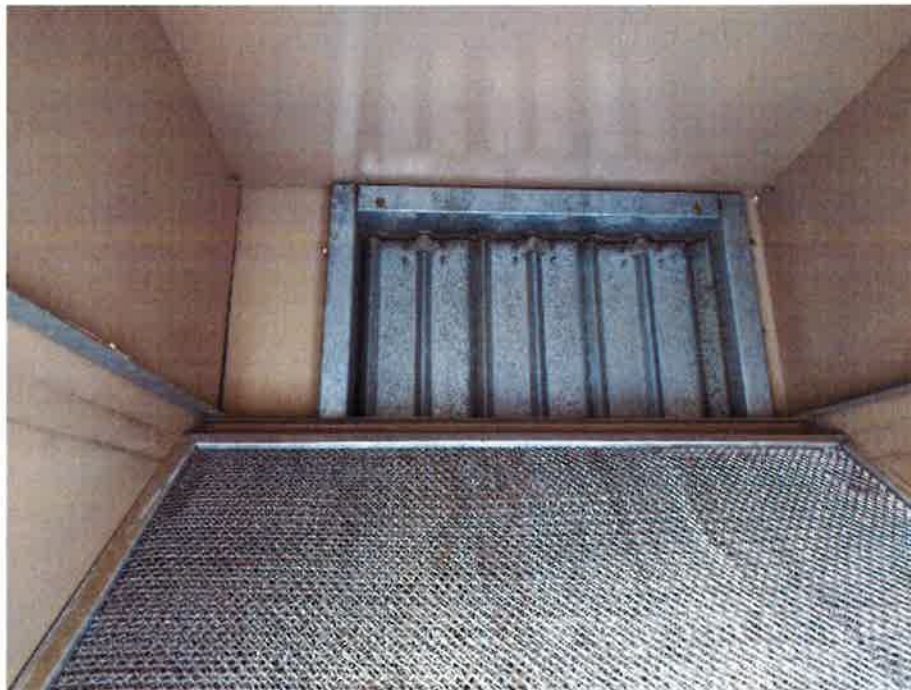
DX air handling unit outside air damper closed.

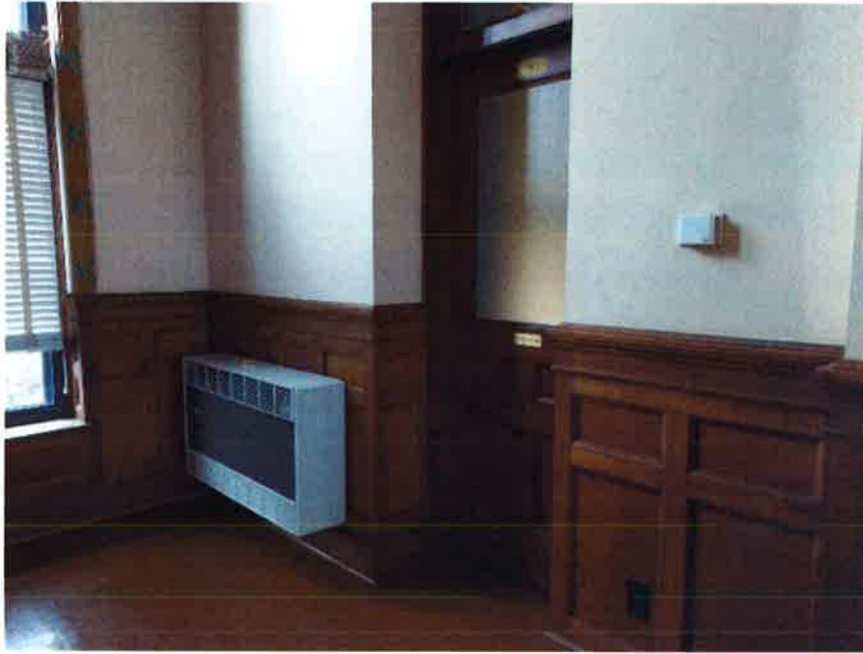
Second Floor – Electric heater in courtroom.

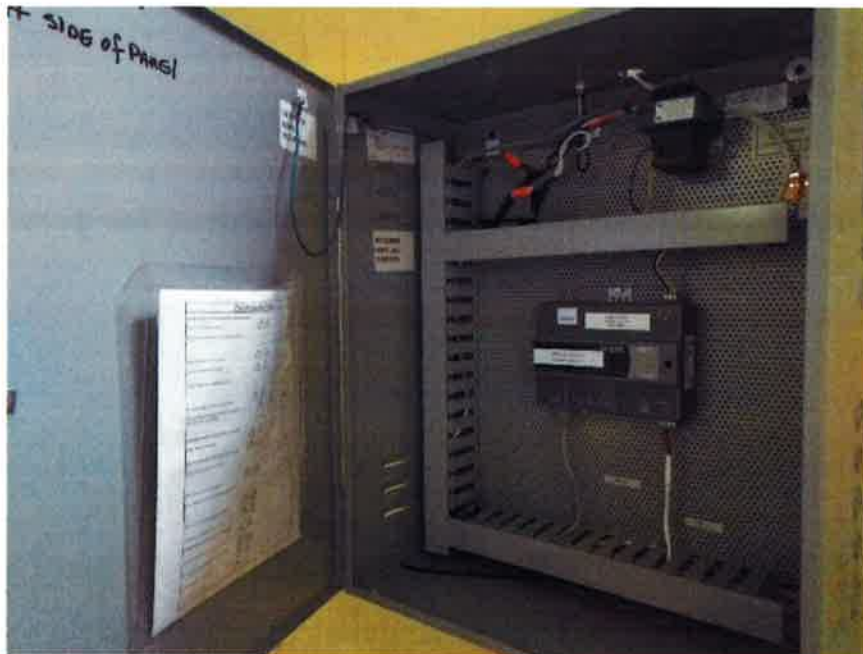
Basement – Johnson Controls building automation panel in utility room.

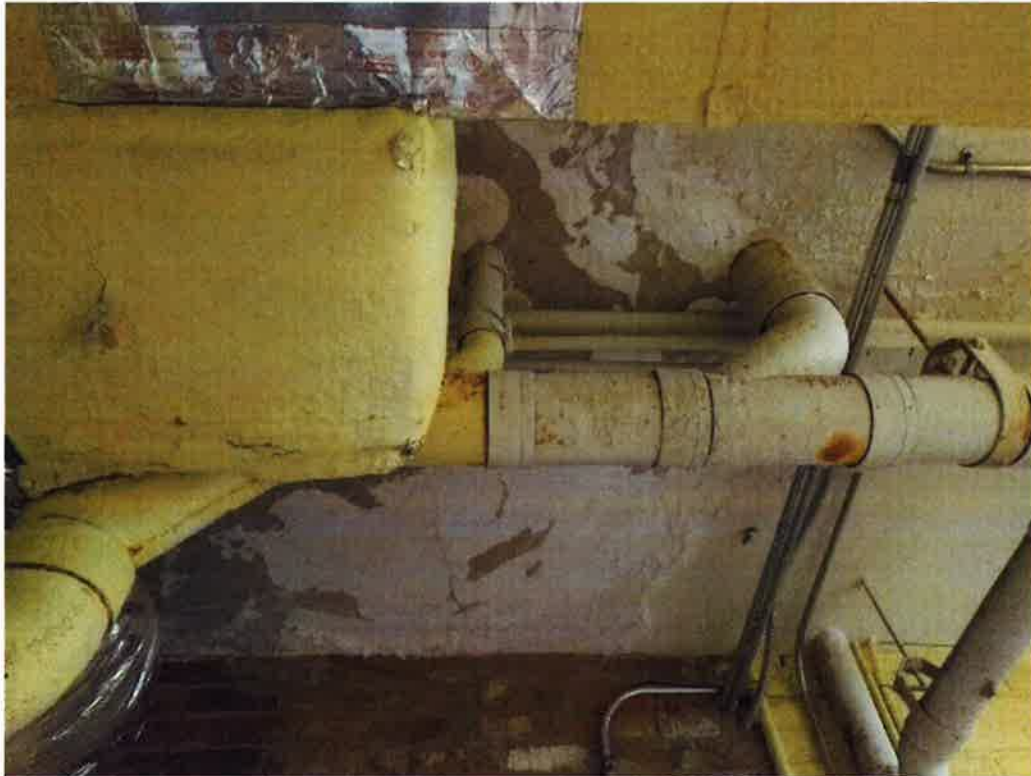
Basement – Cast iron waste pipe.

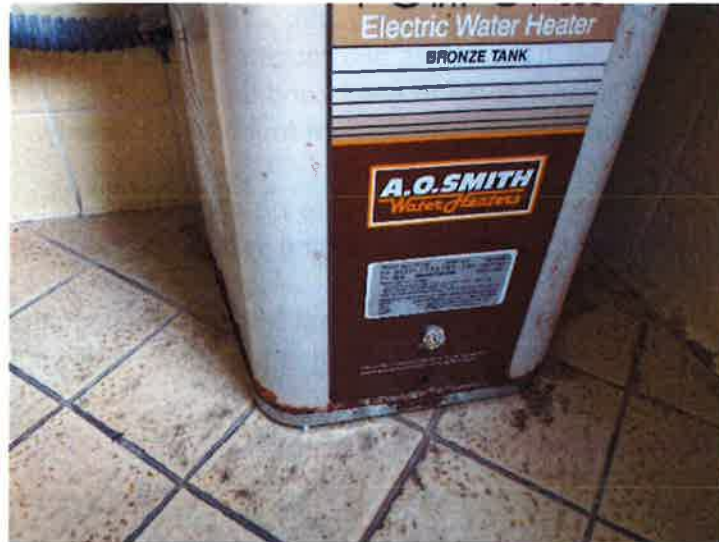
Instantaneous water heater beginning to rust at base of unit.

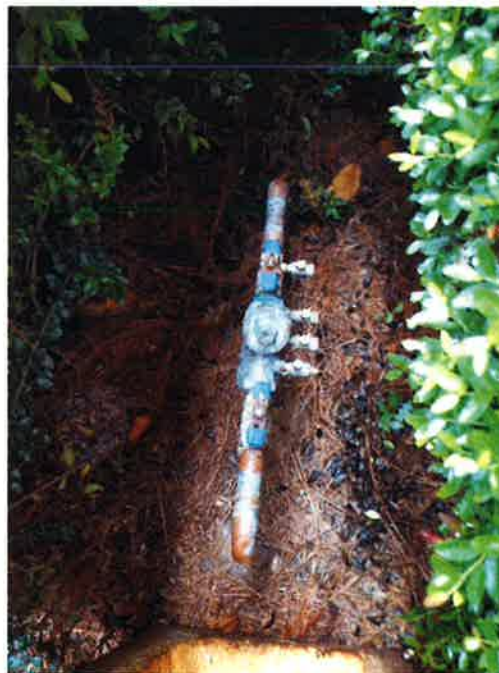
Domestic water backflow preventer adjacent to crawlspace.

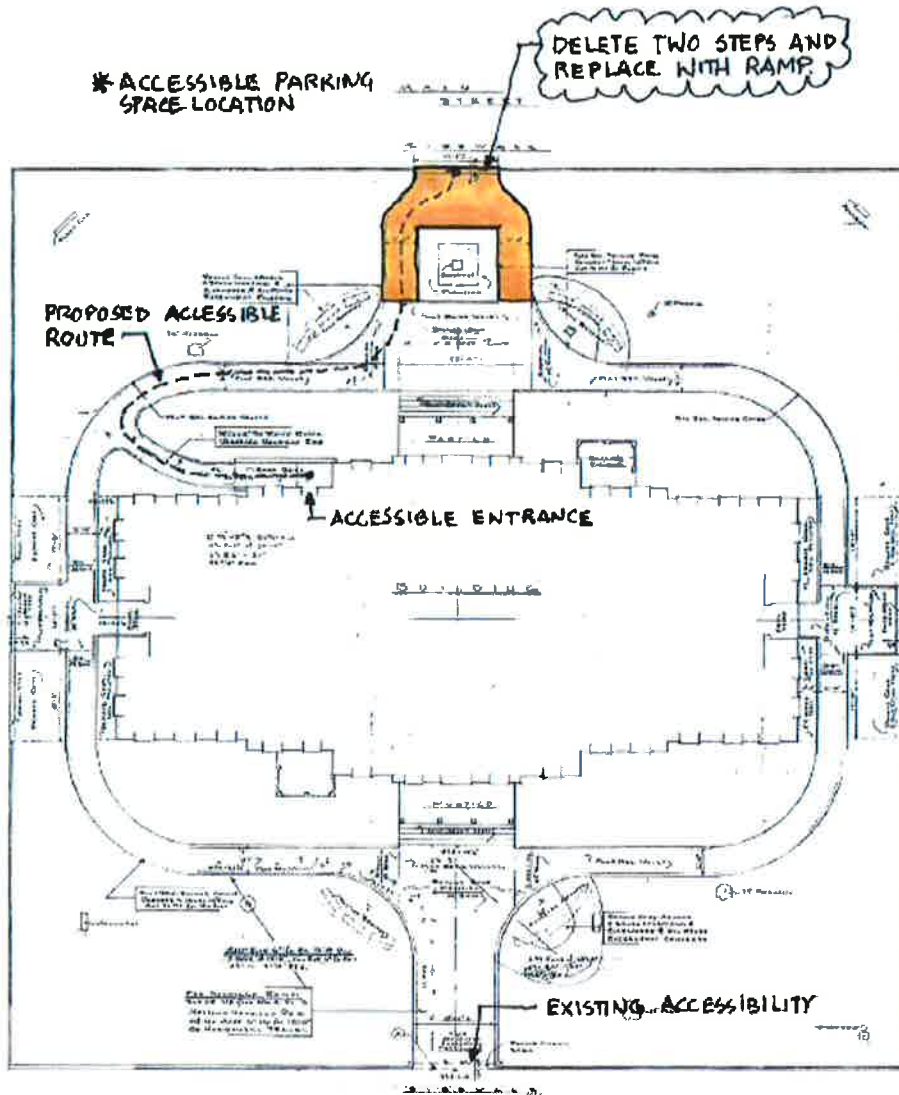
Recommended Action: Replace the two granite risers between the concrete city sidewalk and the brick walkway paving on the west side with a brick ramp at a five percent (5%) slope or less.

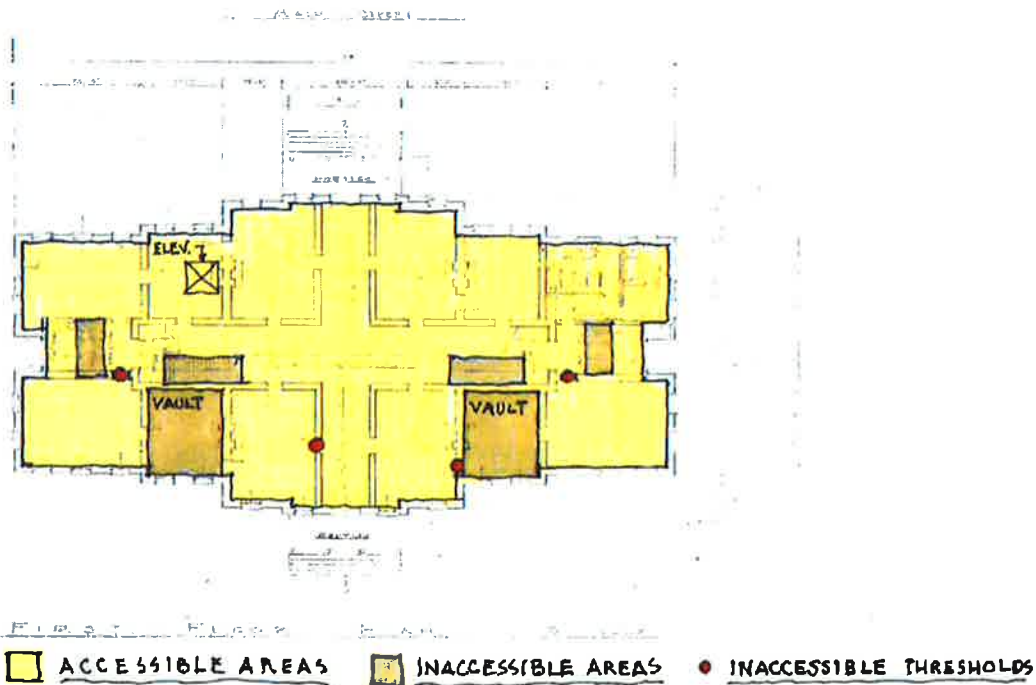
Recommended Action: Remove flooring and sub-floor inside rooms and provide flooring level with adjacent spaces in future renovation.

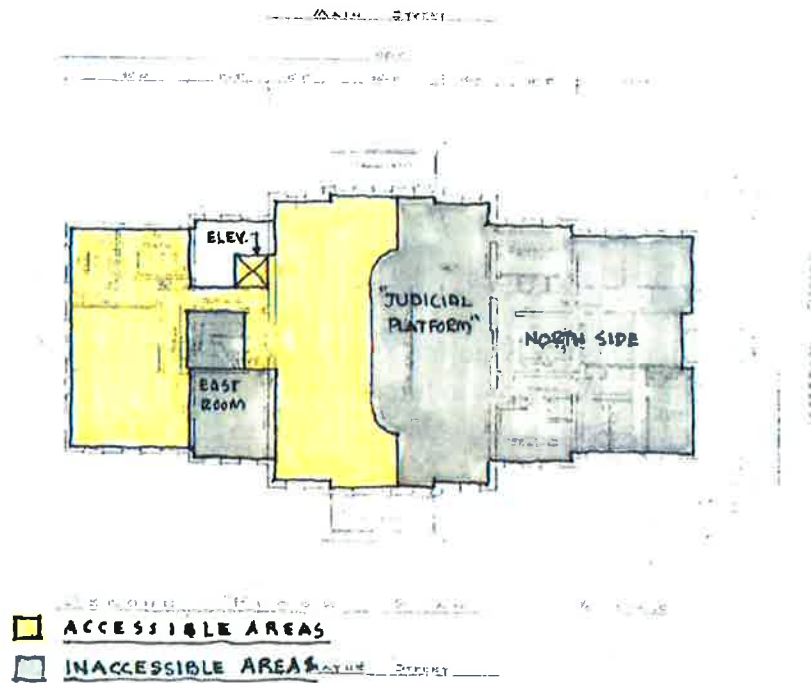
Recommended Action: Remove judicial platform (retain railing, judge's dias and jury dias) and raised floors in other areas of the second floor to allow free passage.
