HISTORIC UNION COUNTY COURTHOUSE

HISTORIC STRUCTURE REPORT & RELATED SERVICES
JANUARY 23, 2017

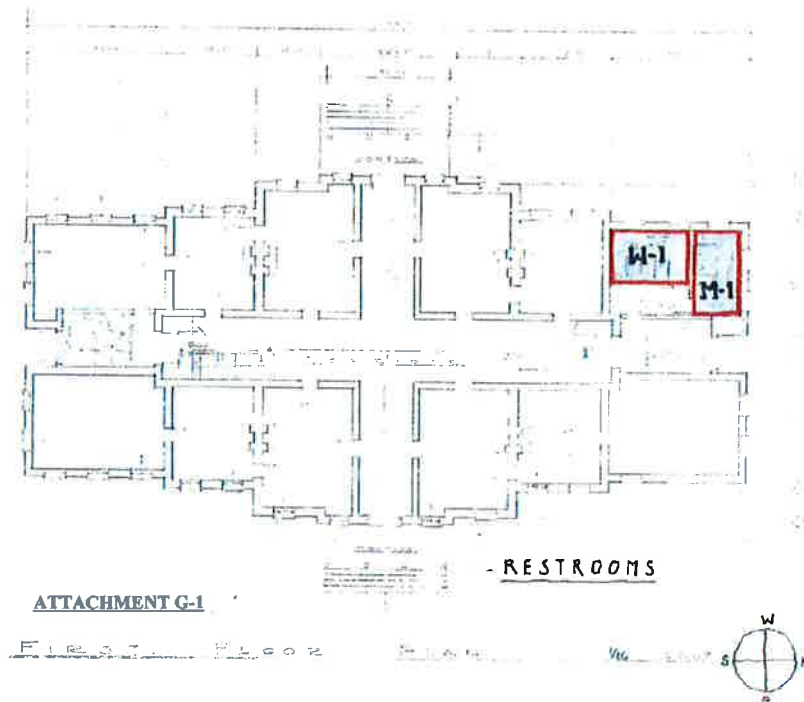
M-2 MEN'S RESTROOM_(See Attachments G-2 and G-3)

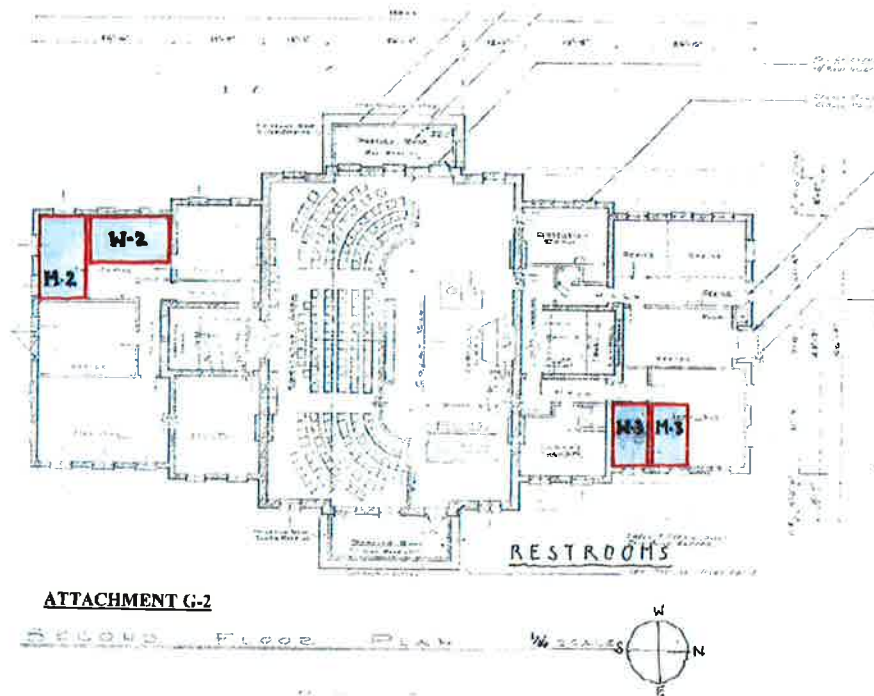
Recommended Action: If an accessible route is not provided to restrooms W-3 and M-3, do not renovate and provide a Uni-Sex Assisted-Use Toilet Room adjacent to the elevator on the 2nd floor.

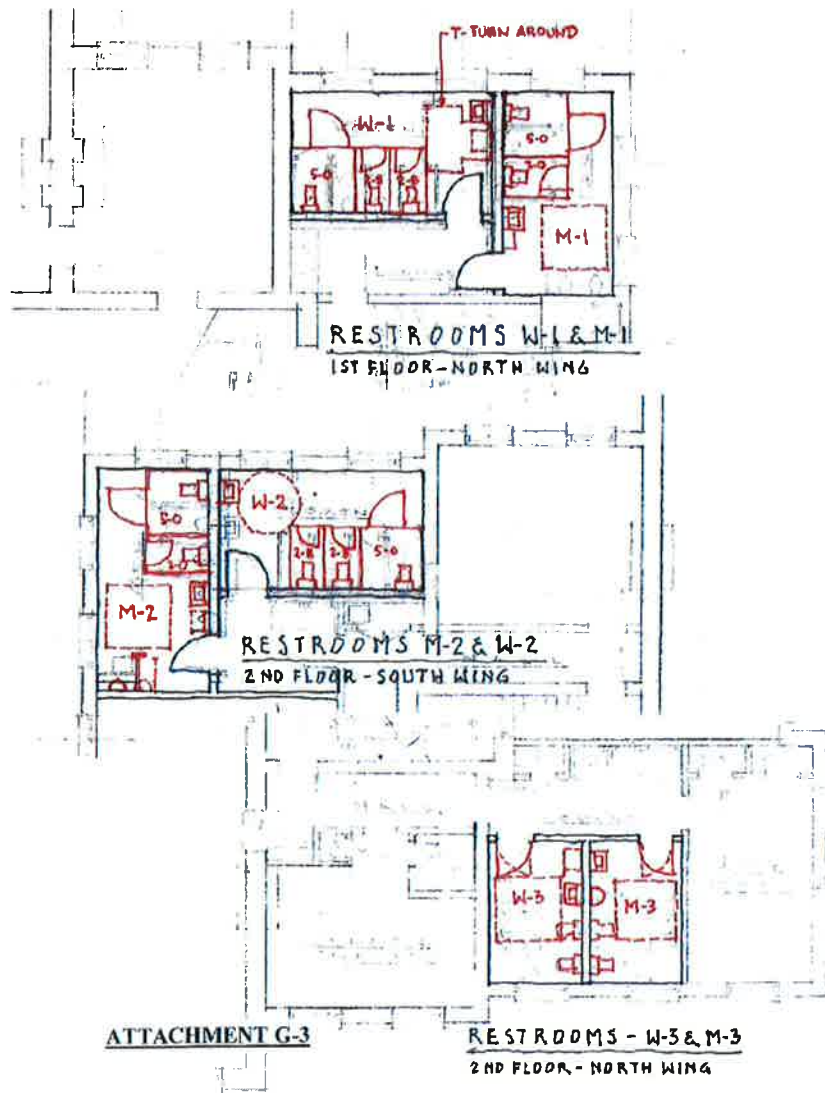
BUILDING CODE COMPLIANCE STUDY

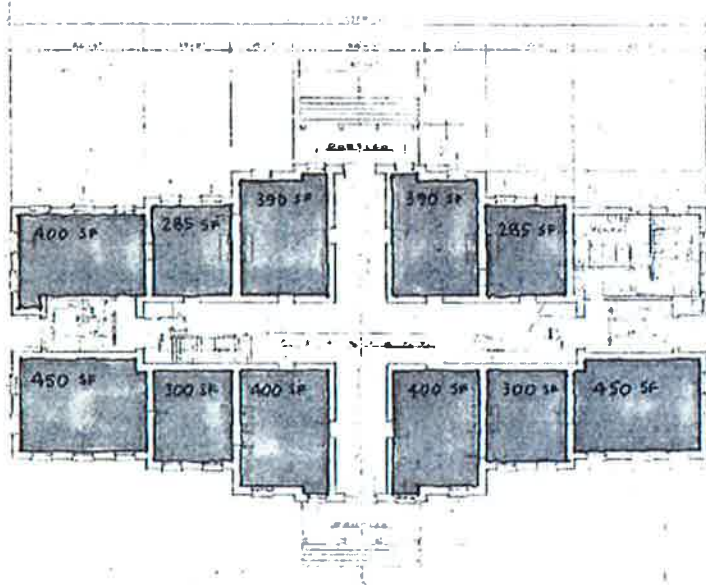
FIRST FLOOR PLAN 1/8" SCALE
 1 - OCCUPANT LOAD: 4050 S.F. NET AREA / 30 S.F. = 135 PERSONS TOTAL (MUSEUM USE)

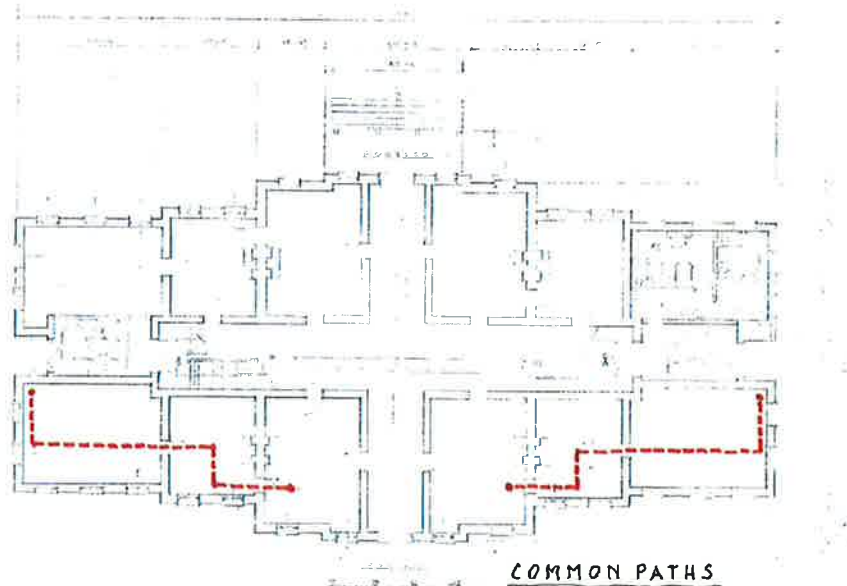
Recommended Action: None

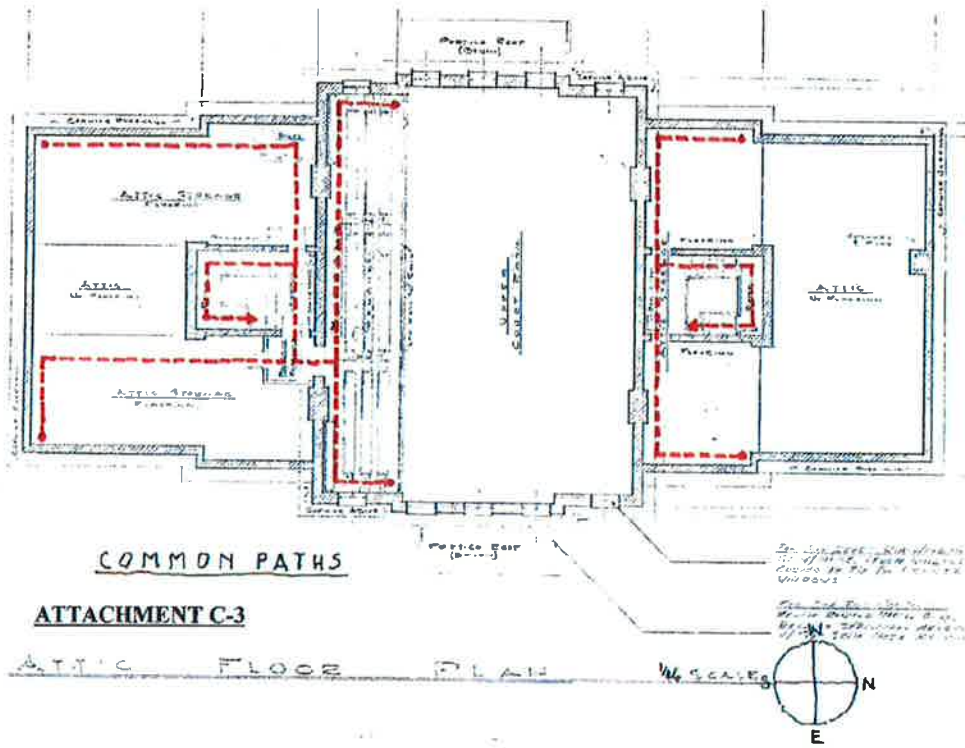
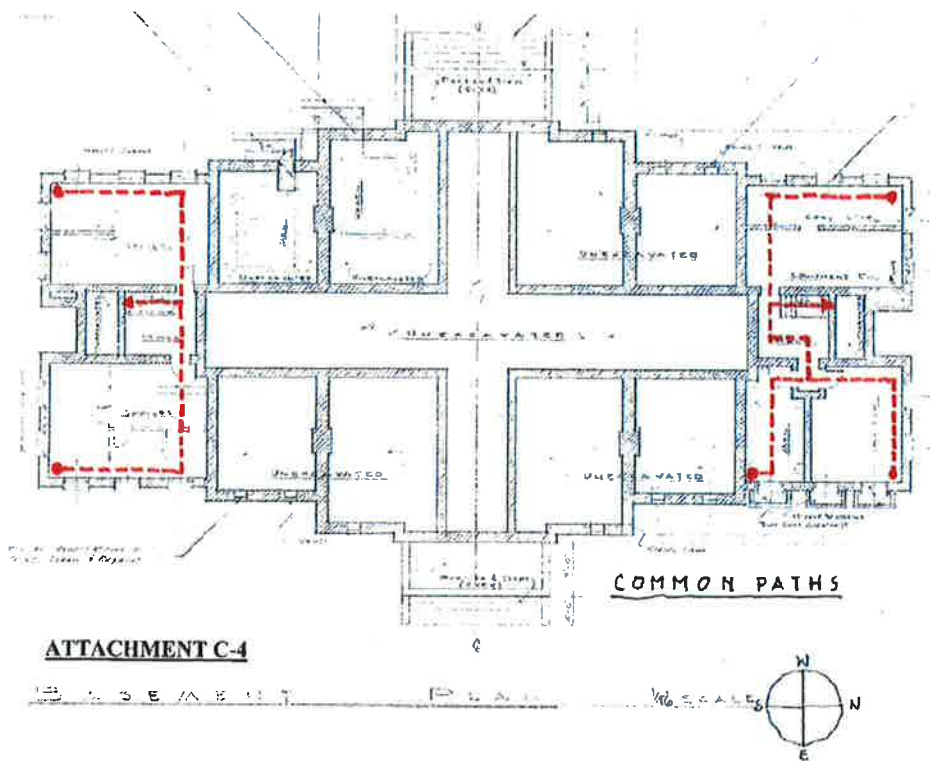
EMERGENCY EGRESS (See attachments D-1, D-2, D-3 & D-4)

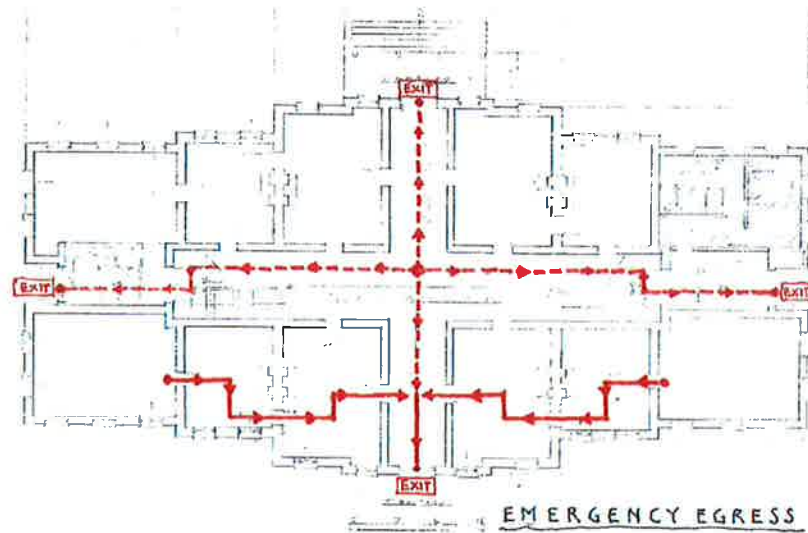
Recommended Action: None
